DEPARTMENT OF TRANSPORTATION

Contract #: 04-0120F4Cty: SF/ALA Rte: 80 PM: 13.2/13.9File #: 69.28**WELDING INSPECTION REPORT****Resident Engineer:** Siegenthaler, Peter**Address:** 333 Burma Road**City:** Oakland, CA 94607**Report No:** WIR-021129**Date Inspected:** 10-Oct-2010**Project Name:** SAS Superstructure**OSM Arrival Time:** 700**Prime Contractor:** American Bridge/Fluor Enterprises, a JV**OSM Departure Time:** 1900**Contractor:** Zhenhua Port Machinery Company, Ltd (ZPMC), Changxing Island **Location:** Shanghai, China**CWI Name:** Xu Tao**CWI Present:** Yes No**Inspected CWI report:** Yes No N/A**Rod Oven in Use:** Yes No N/A**Electrode to specification:** Yes No N/A**Weld Procedures Followed:** Yes No N/A**Qualified Welders:** Yes No N/A**Verified Joint Fit-up:** Yes No N/A**Approved Drawings:** Yes No N/A**Approved WPS:** Yes No N/A**Delayed / Cancelled:** Yes No N/A**Bridge No:** 34-0006**Component:** OBG Segment Assembly**Summary of Items Observed:**

Bay 16 / OBG Segment 13AW

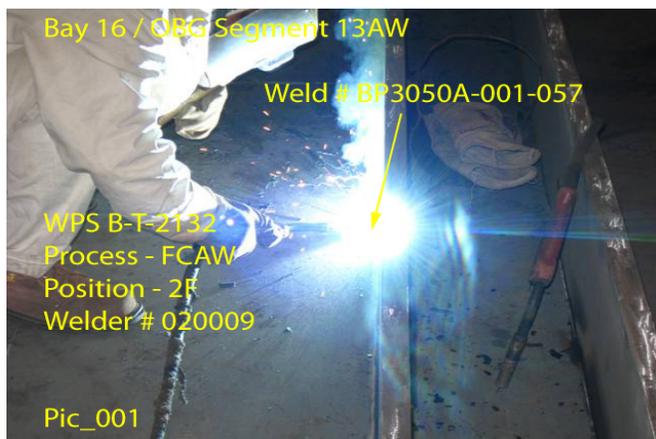
Flux Core Arc Welding (FCAW) in the 2F position of weld joint BP3050A-001-057 located on Bottom Panel. The welder is identified as 020009. ZPMC Quality Control (QC) is identified as Liu Dao Feng. The welding variables recorded by QC appeared to comply with the WPS B-T-2132. See attached photograph Pic_001.

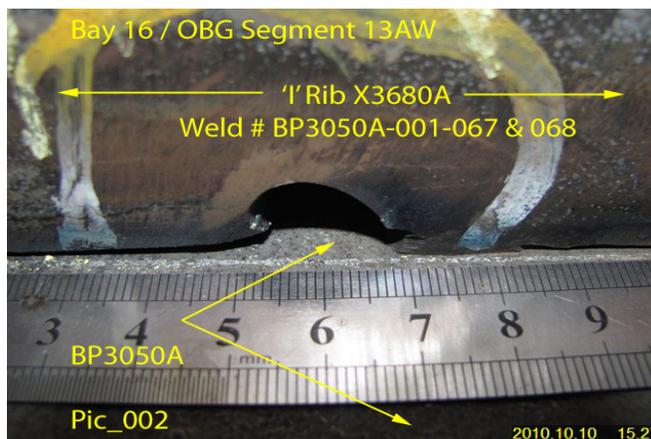
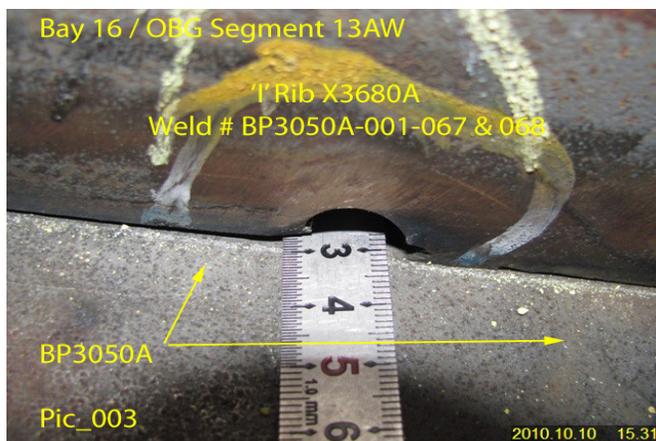
Bay 16/ OBG Segment 13AW

During in process inspection This QA inspector found base metal discontinuity on 'I' rib # X3680A connected to Bottom Panel BP3050A at weld # BP3050A-001-067 & 068. 'I' rib butting face was damaged around 15 mm \varnothing & 28 mm depth. This QA informed this incident to Lead QA & shown to ZPMC QC & ABF QA personnel. ABF QA agreed to for repair & after repair NDT. ZPMC Quality Control (QC) is identified as Liu Dao Feng. See attached Photograph Pic_002 & 003.
