**DEPARTMENT OF TRANSPORTATION**

Contract #: 04-0120F4Cty: SF/ALA Rte: 80 PM: 13.2/13.9File #: 99.28**WELDING INSPECTION REPORT****Resident Engineer:** Siegenthaler, Peter**Address:** 333 Burma Road**City:** Oakland, CA 94607**Report No:** WIR-017763**Date Inspected:** 05-Nov-2010**Project Name:** SAS Superstructure**OSM Arrival Time:** 700**Prime Contractor:** American Bridge/Fluor Enterprises, a JV**OSM Departure Time:** 1900**Contractor:** Zhenhua Port Machinery Company, Ltd (ZPMC)**Location:** Shanghai, China**CWI Name:** Li Yang and Zhu Zhong Hai**CWI Present:** Yes No**Inspected CWI report:** Yes No N/A**Rod Oven in Use:** Yes No N/A**Electrode to specification:** Yes No N/A**Weld Procedures Followed:** Yes No N/A**Qualified Welders:** Yes No N/A**Verified Joint Fit-up:** Yes No N/A**Approved Drawings:** Yes No N/A**Approved WPS:** Yes No N/A**Delayed / Cancelled:** Yes No N/A**Bridge No:** 34-0006**Component:** OBG Trial Assembly**Summary of Items Observed:**

Orthotropic Box Girder (OBG) at Trial Assembly Areas

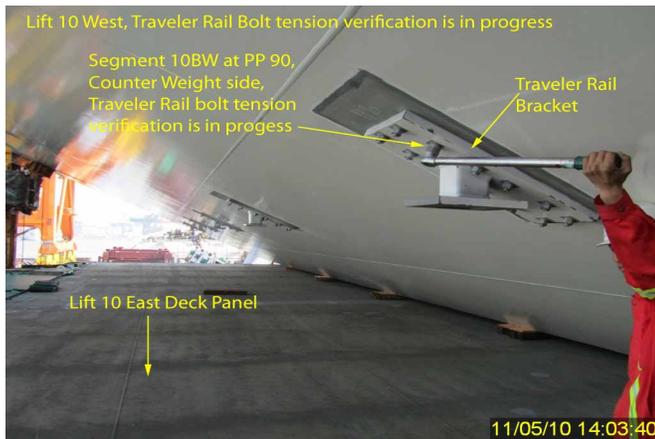
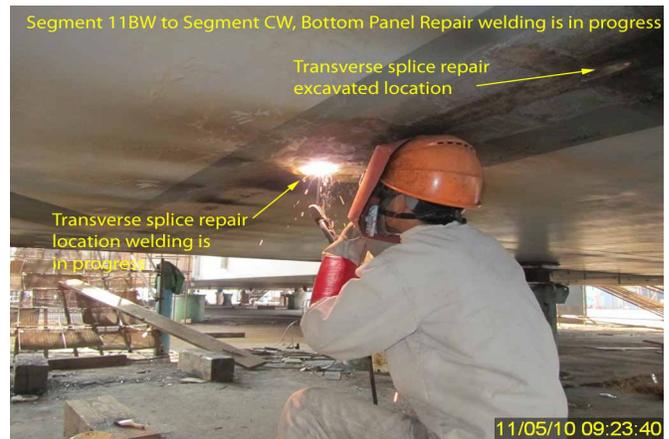
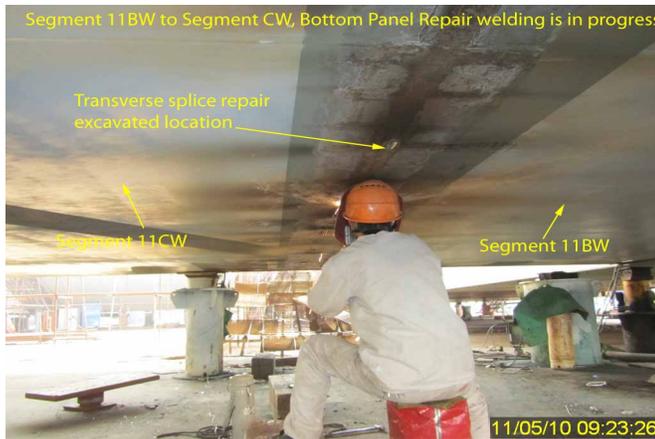
This QA Inspector observed the repair welding by Shielded Metal Arc Welding (SMAW) process on a Complete Joint Penetration (CJP) groove weld. The Weld joint was designated as OBW11B-008. The welder identification

was 046709 and was observed welding in the 4G (Overhead) position using approved Welding Procedure Specification WPS-345-SMAW-4G(4F)-FCM-Repair-1. The piece mark was identified as the Bottom Panel, transverse splice weld. The repair work was in progress against the welding repair report B-WR16518.
