DEPARTMENT OF TRANSPORTATION

Contract #: 04-0120F4Cty: SF/ALA Rte: 80 PM: 13.2/13.9File #: 99.28**WELDING INSPECTION REPORT****Resident Engineer:** Siegenthaler, Peter**Address:** 333 Burma Road**City:** Oakland, CA 94607**Report No:** WIR-017834**Date Inspected:** 08-Nov-2010**Project Name:** SAS Superstructure**OSM Arrival Time:** 700**Prime Contractor:** American Bridge/Fluor Enterprises, a JV**OSM Departure Time:** 1900**Contractor:** Zhenhua Port Machinery Company, Ltd (ZPMC)**Location:** Shanghai, China

| Bridge No: | 34-0006 | Component: | OBG Trial Assembly | |

Orthotropic Box Girder (OBG) at Trial Assembly Areas

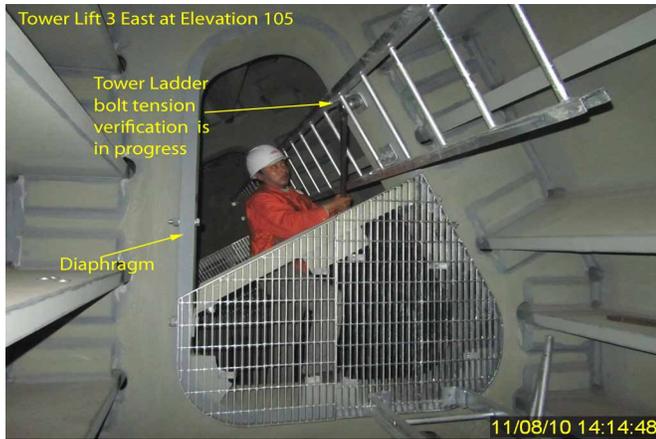
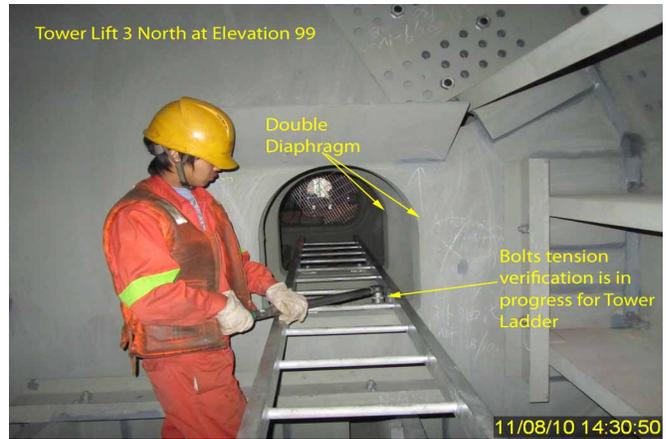
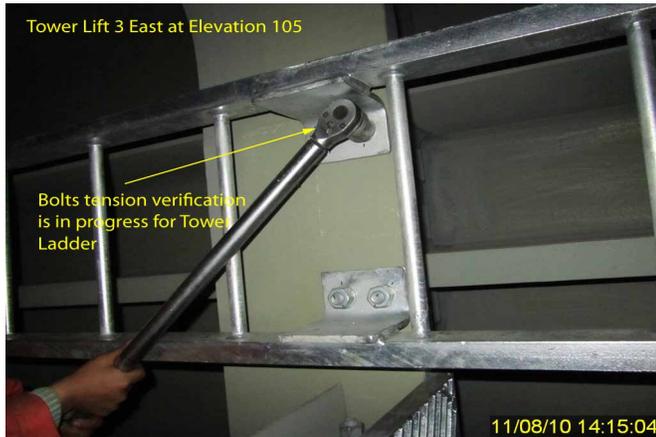
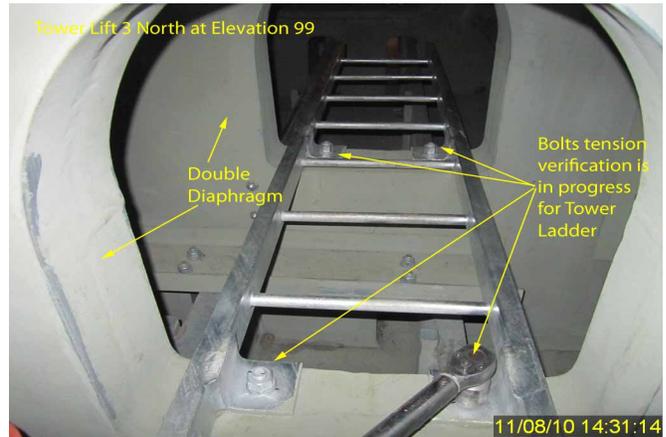
This Quality Assurance (QA) Inspector witnessed final bolt tension verification for Tower Lift 3 East, Lift 3 West, Lift 3 South and Lift 3 North. Bolts are installed for Tower Ladder. Inspected 10% on a random basis and found the tension to be in general compliance. Inspection was performed against the Notification No. 00545 Dated November 08, 2010. Tower Ladder bolts are installed at elevations 89 meter, 92 meter, 95 meter, 99 meter, 102 meter, 105 meter, 109 meter and 112 meter.

The bolt sizes used were M22 x 65 RC Lot # DHGM220033 and final torque required was 470 N-m.

The bolt sizes used were M22 x 110 RC Lot # DHGM220067 and final torque required was 500 N-m.

Please reference the pictures attached for more comprehensive details.
