DEPARTMENT OF TRANSPORTATION

Office of Structural Materials

Contract #: 04-0120F4Cty: SF/ALA Rte: 80 PM: 13.2/13.9File #: 69.28**WELDING INSPECTION REPORT****Resident Engineer:** Siegenthaler, Peter**Address:** 333 Burma Road**City:** Oakland, CA 94607**Report No:** WIR-018093**Date Inspected:** 05-Nov-2010**Project Name:** SAS Superstructure**OSM Arrival Time:** 700**Prime Contractor:** American Bridge/Fluor Enterprises, a JV**OSM Departure Time:** 1900**Contractor:** Zhenhua Port Machinery Company, Ltd (ZPMC), Changxing Island **Location:** Shanghai, China**CWI Name:** Qiu Wen**CWI Present:** Yes No**Inspected CWI report:** Yes No N/A**Rod Oven in Use:** Yes No N/A**Electrode to specification:** Yes No N/A**Weld Procedures Followed:** Yes No N/A**Qualified Welders:** Yes No N/A**Verified Joint Fit-up:** Yes No N/A**Approved Drawings:** Yes No N/A**Approved WPS:** Yes No N/A**Delayed / Cancelled:** Yes No N/A**Bridge No:** 34-0006**Component:** TOWER & OBG Components**Summary of Items Observed:**

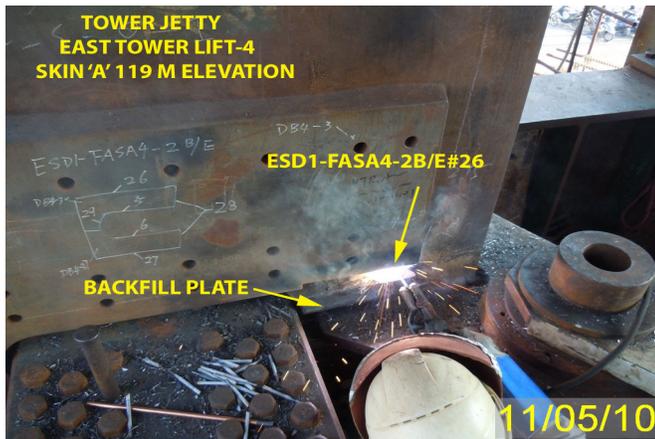
Weld joint # 14 located on South tower Lift-4 Skin 'A', 119 M Backfill plate SSD1 – FASA4 – 1B/E. Welder is identified as 057220. ZPMC Quality Control (QC) Inspector is identified Sun Zi Wang. The welding variables recorded by QC appeared to comply with the WPS – B – T – 3212 – B – U2a – 2.

Weld joint # 26 located on West tower Lift-4 Skin 'A', 119 M Backfill plate WSD1 – FASA4 – 2B/E. Welder is identified as 040690. ZPMC Quality Control (QC) Inspector is identified Sun Zi Wang. The welding variables recorded by QC appeared to comply with the WPS – B – T – 3212 – B – U2a – 2.

Weld joint # 26 located on East tower Lift-4 Skin 'A', 119 M Backfill plate ESD1 – FASA4 – 2B/E. Welder is identified as 046769. ZPMC Quality Control (QC) Inspector is identified Sun Zi Wang. The welding variables recorded by QC appeared to comply with the WPS – B – T – 3212 – B – U2a – 2.

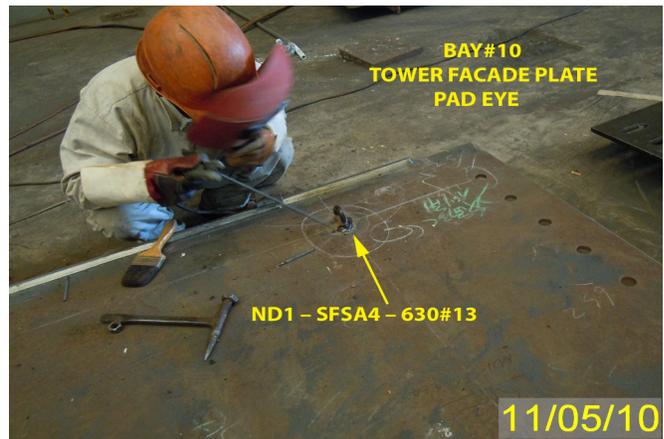
Weld joint # 13 located on Tower Façade plate pad eye ND1 – SFSA4 – 630. Welder is identified as 050038. ZPMC Quality Control (QC) Inspector is identified as Wang Hao. The welding variables recorded by QC appeared to comply with the WPS – B – P – 2112. (See attached photo)
