DEPARTMENT OF TRANSPORTATION

Contract #: 04-0120F4Cty: SF/ALA Rte: 80 PM: 13.2/13.9File #: 99.28**WELDING INSPECTION REPORT****Resident Engineer:** Siegenthaler, Peter**Address:** 333 Burma Road**City:** Oakland, CA 94607**Report No:** WIR-018149**Date Inspected:** 16-Nov-2010**Project Name:** SAS Superstructure**OSM Arrival Time:** 700**Prime Contractor:** American Bridge/Fluor Enterprises, a JV**OSM Departure Time:** 1900**Contractor:** Zhenhua Port Machinery Company, Ltd (ZPMC)**Location:** Shanghai, China**CWI Name:** Li Yang and Zhu Zhong Hai**CWI Present:** Yes No**Inspected CWI report:** Yes No N/A**Rod Oven in Use:** Yes No N/A**Electrode to specification:** Yes No N/A**Weld Procedures Followed:** Yes No N/A**Qualified Welders:** Yes No N/A**Verified Joint Fit-up:** Yes No N/A**Approved Drawings:** Yes No N/A**Approved WPS:** Yes No N/A**Delayed / Cancelled:** Yes No N/A**Bridge No:** 34-0006**Component:** OBG Trial Assembly**Summary of Items Observed:**

Orthotropic Box Girder (OBG) at Trial Assembly Areas

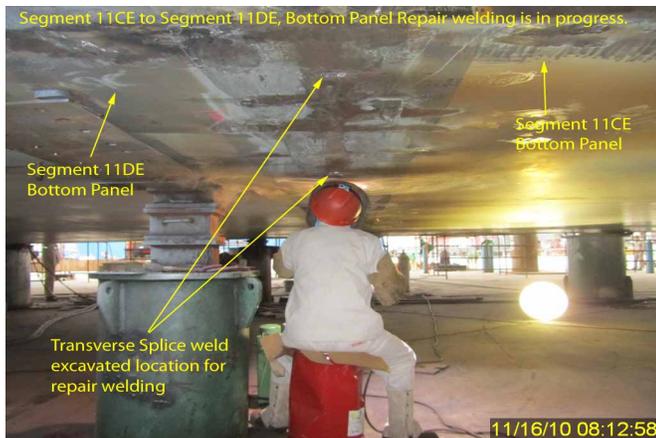
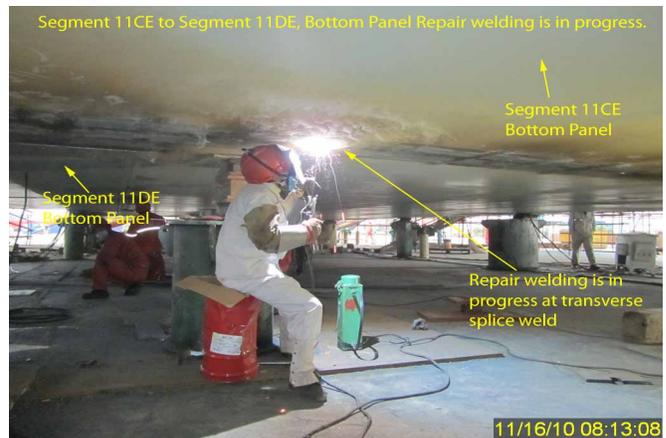
This QA Inspector observed the repair welding by Shielded Metal Arc Welding (SMAW) process on a Complete Joint Penetration (CJP) groove weld. The Weld joint was designated as OBE11C-003. The welder identification was 044515 and 053871 and was observed welding in the 4G (Overhead) position using approved Welding Procedure Specification WPS-345-SMAW-4G(4F)-Repair-FCM-1. The piece mark was identified as the Bottom Panel, transverse splice weld. ZPMC performed repair welding in accordance with Welding Repair Report B-WR 17063.
