Contract #: 04-0120F4Cty: SF/ALA Rte: 80 PM: 13.2/13.9File #: 69.28**WELDING INSPECTION REPORT****Resident Engineer:** Siegenthaler, Peter**Address:** 333 Burma Road**City:** Oakland, CA 94607**Report No:** WIR-018154**Date Inspected:** 15-Nov-2010**Project Name:** SAS Superstructure**OSM Arrival Time:** 700**Prime Contractor:** American Bridge/Fluor Enterprises, a JV**OSM Departure Time:** 1900**Contractor:** Zhenhua Port Machinery Company, Ltd (ZPMC), Changxing Island **Location:** Shanghai, China**CWI Name:** Mr. Li zhi jiang**CWI Present:** Yes No**Inspected CWI report:** Yes No N/A**Rod Oven in Use:** Yes No N/A**Electrode to specification:** Yes No N/A**Weld Procedures Followed:** Yes No N/A**Qualified Welders:** Yes No N/A**Verified Joint Fit-up:** Yes No N/A**Approved Drawings:** Yes No N/A**Approved WPS:** Yes No N/A**Delayed / Cancelled:** Yes No N/A**Bridge No:** 34-0006**Component:** Orthotropic Box Girder (OBG)**Summary of Items Observed:**

This CALTRANS OSM Quality Assurance Inspector (QA) Surendra Prabhu was present during the times noted above for observations relative to the fabrication of the Self Anchored Suspension (SAS) Superstructure being performed by Zhenhu

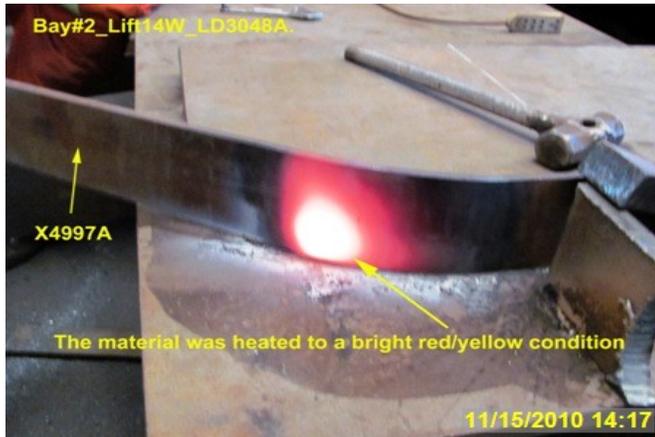
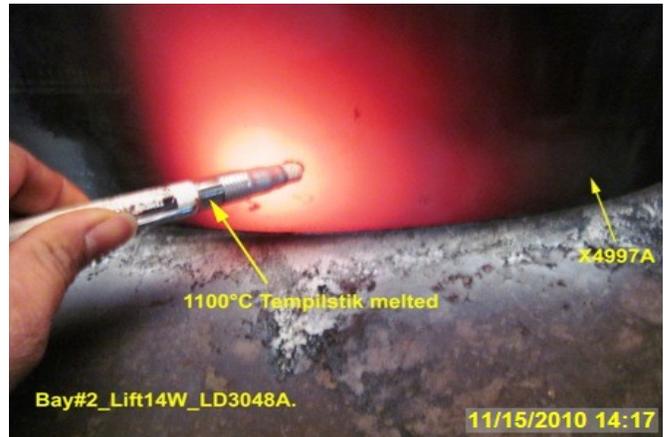
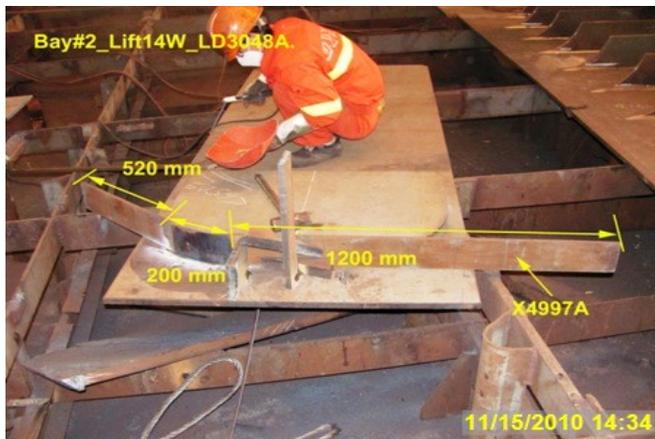
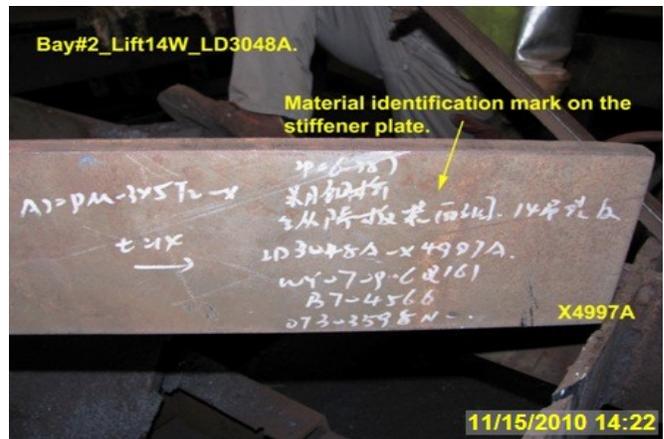
FCAW of weld joint FB3343-001-199. Welder is identified as 045227. ZPMC Quality Control (QC) is identified as Mr. Zhu jun. The welding variables appeared to comply with the Applicable WPS: WPS-B- T-2233-TC- U4b-F. During the Caltrans QA in-process observations of the fabrication of Longitudinal Diaphragm LD3048A, this QA observed ZPMC personnel performing hot bending on the longitudinal shear plate manway stiffener identified as X4997A. The material was heated to a bright red/yellow condition. This QA Inspector observed that an 1100°C Tempilstik melted when struck against the heated area of the material. A temperature indicating crayon, digital temperature measurement gauge, or other similar means of monitoring the temperature was not utilized by ZPMC QC and the actual maximum attained temperature was not measured. The length of the heated area is approximately 200 mm. The Y location is approximately 520 mm and 1200 mm as measured from each end of the stiffener. The stiffener length is approximately 1920 mm. The LD stiffener plate material thickness is 14 mm.

This QA Inspector generated an incident report on this date for the above issue, for further information see the incident report and attached photos.
