Contract #: 04-0120F4Cty: SF/ALA Rte: 80 PM: 13.2/13.9File #: 99.28**WELDING INSPECTION REPORT****Resident Engineer:** Siegenthaler, Peter**Address:** 333 Burma Road**City:** Oakland, CA 94607**Report No:** WIR-018290**Date Inspected:** 24-Nov-2010**Project Name:** SAS Superstructure**OSM Arrival Time:** 700**Prime Contractor:** American Bridge/Fluor Enterprises, a JV**OSM Departure Time:** 1900**Contractor:** Zhenhua Port Machinery Company, Ltd (ZPMC)**Location:** Shanghai, China**CWI Name:** Li Yang and Zhu Zhong Hai**CWI Present:** Yes No**Inspected CWI report:** Yes No N/A**Rod Oven in Use:** Yes No N/A**Electrode to specification:** Yes No N/A**Weld Procedures Followed:** Yes No N/A**Qualified Welders:** Yes No N/A**Verified Joint Fit-up:** Yes No N/A**Approved Drawings:** Yes No N/A**Approved WPS:** Yes No N/A**Delayed / Cancelled:** Yes No N/A**Bridge No:** 34-0006**Component:** OBG Trial Assembly**Summary of Items Observed:**

Orthotropic Box Girder (OBG) at Trial Assembly Areas

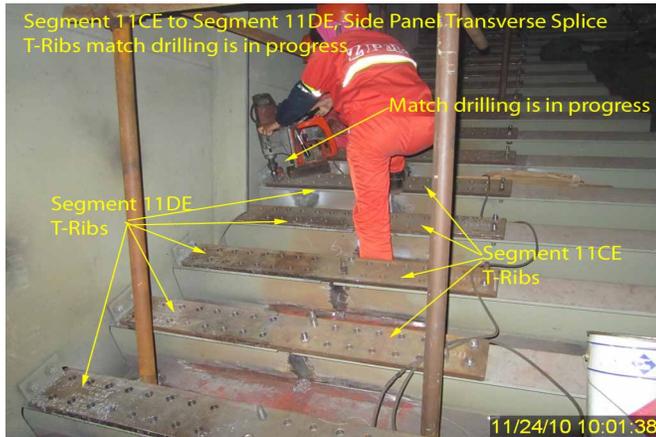
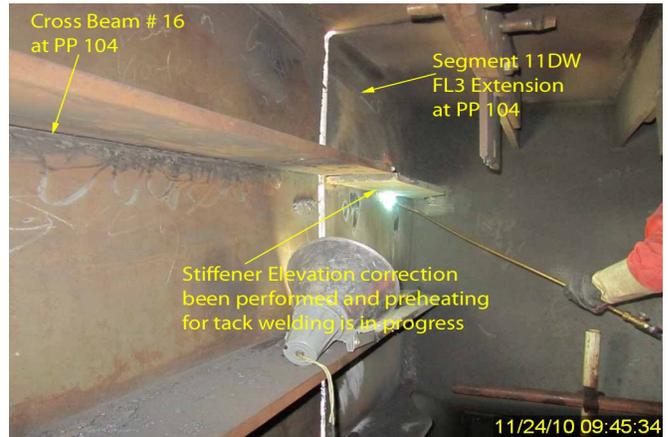
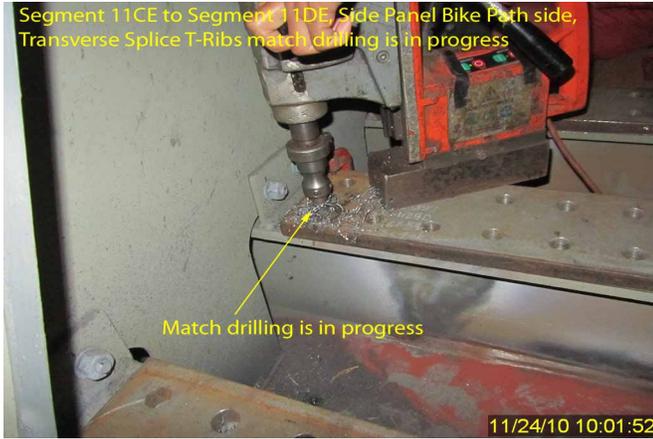
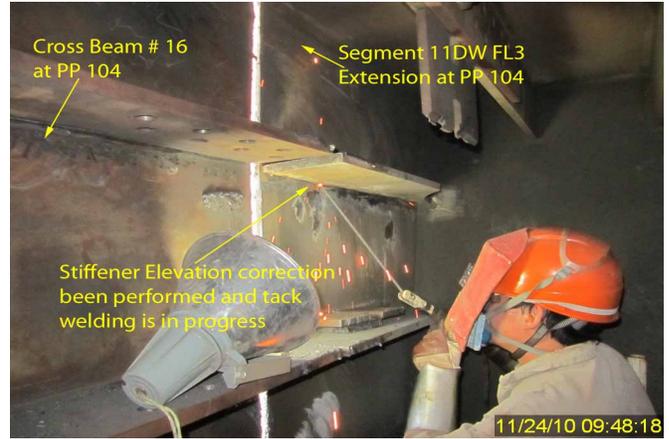
This QA Inspector observed the fit-up is in progress for the horizontal stiffeners at FL3 location at Panel Point (PP) 104, observed stiffeners was removed from earlier installed locations as they were installed at wrong elevations. ZPMC was performing this repair work against the Welding Repair Report B-WR16212.

This QA Inspector observed ZPMC personnel performing match drilling for the Transverse Splice T-Ribs (Side Panel Cross Beam, Bike Path side and at Bottom Panel).
