DEPARTMENT OF TRANSPORTATION

Contract #: 04-0120F4Cty: SF/ALA Rte: 80 PM: 13.2/13.9File #: 69.28**WELDING INSPECTION REPORT****Resident Engineer:** Siegenthaler, Peter**Address:** 333 Burma Road**City:** Oakland, CA 94607**Report No:** WIR-018328**Date Inspected:** 30-Nov-2010**Project Name:** SAS Superstructure**OSM Arrival Time:** 700**Prime Contractor:** American Bridge/Fluor Enterprises, a JV**OSM Departure Time:** 1900**Contractor:** Zhenhua Port Machinery Company, Ltd (ZPMC), Changxing Island **Location:** Shanghai, China**CWI Name:** Zhu Zhong Hai**CWI Present:** Yes No**Inspected CWI report:** Yes No N/A**Rod Oven in Use:** Yes No N/A**Electrode to specification:** Yes No N/A**Weld Procedures Followed:** Yes No N/A**Qualified Welders:** Yes No N/A**Verified Joint Fit-up:** Yes No N/A**Approved Drawings:** Yes No N/A**Approved WPS:** Yes No N/A**Delayed / Cancelled:** Yes No N/A**Bridge No:** 34-0006**Component:** Orthotropic Box Girder (OBG)**Summary of Items Observed:**

OBG # TRIAL ASSEMBLY YARD

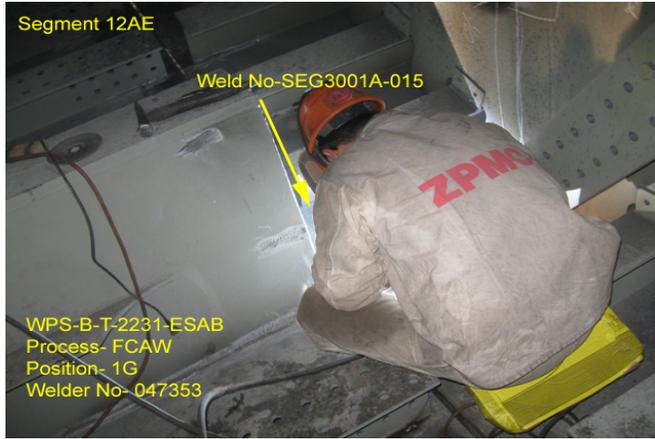
WELDING:**Segment 12AE**

This QA Inspector observed ZPMC qualified welding personnel identified as 047353 perform Flux Core Arc Welding (FCAW), weld joint identified as SEG3001A-015; located On Orthotropic Box Girder (OBG) Bottom Plate to Side Plate Transverse CJP Weld; ZPMC Quality Control (QC) is identified as Mr. Wang Li Yang. The welding variables recorded by QC appeared to comply with applicable WPS-B-T-2231-ESAB. See attached photo for further details.

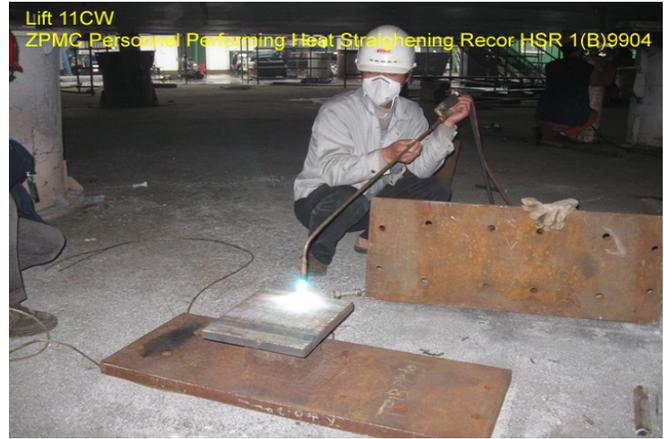
ZPMC personnel heat straightening Orthotropic Box Girder (OBG) member identified as Traveler Rail piece mark (PCMK) TR1B-PP103-004. Distortion appeared to be caused by Welding. ZPMC Quality Control (QC) inspector identified as Mr. Zhu Zhong Hai was present to monitor the heat straightening process. The heat straightening appeared to comply with Heat Straightening Report HSR1 (B) 9904. See attached photo for further details.
