**DEPARTMENT OF TRANSPORTATION**

Contract #: 04-0120F4Cty: SF/ALA Rte: 80 PM: 13.2/13.9File #: 69.28**WELDING INSPECTION REPORT****Resident Engineer:** Siegenthaler, Peter**Address:** 333 Burma Road**City:** Oakland, CA 94607**Report No:** WIR-018336**Date Inspected:** 16-Nov-2010**Project Name:** SAS Superstructure**OSM Arrival Time:** 700**Prime Contractor:** American Bridge/Fluor Enterprises, a JV**OSM Departure Time:** 1900**Contractor:** Zhenhua Port Machinery Company, Ltd (ZPMC), Changxing Island **Location:** Shanghai, China**CWI Name:** Xu Le Feng**CWI Present:** Yes No**Inspected CWI report:** Yes No N/A**Rod Oven in Use:** Yes No N/A**Electrode to specification:** Yes No N/A**Weld Procedures Followed:** Yes No N/A**Qualified Welders:** Yes No N/A**Verified Joint Fit-up:** Yes No N/A**Approved Drawings:** Yes No N/A**Approved WPS:** Yes No N/A**Delayed / Cancelled:** Yes No N/A**Bridge No:** 34-0006**Component:** OBG/TOWER**Summary of Items Observed:**

BAY 11, OBG BIKE PATH, PLUG WELD ON BOTTOM COVER PLATE (NWIT # 07379)

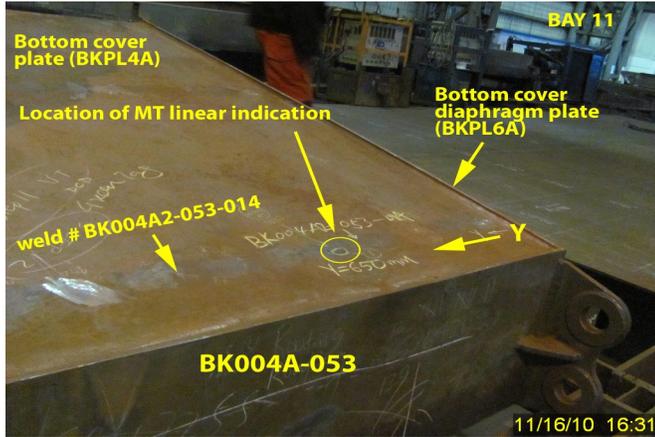
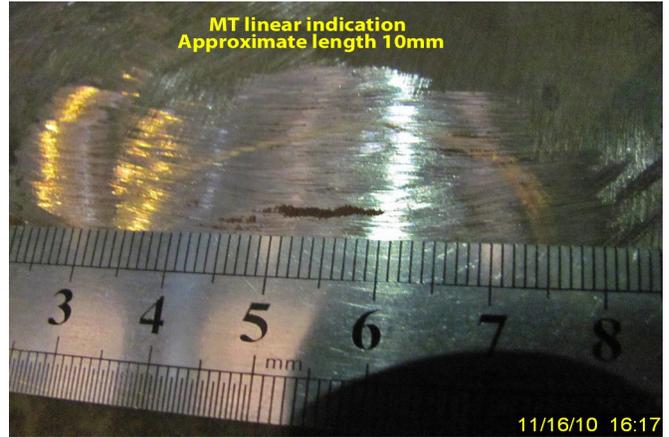
During the Quality Assurance Magnetic Particle Testing (MT) review of plug welds located on OBG bike path BK004A-053, this Quality Assurance (QA) Inspector discovered the following issues:

-One (1) MT linear indication found on the plug weld of bottom cover plate (BKPL4A) measuring approximately 10mm in length.

-Y location of the indication is measured to be 650mm from bottom cover diaphragm plate (BKPL6A) as shown in picture.

-The weld is identified as: BK004A2-053-014.

-The hole is identified as fifth hole from bottom cover diaphragm plate BKPL6A.

-The thickness of the bottom cover plate is measured to be 6mm.

-This weld is a plug weld joining the bottom cover plate (BKPL4A) to the stringer plate flange (BKX7F).

been previously tested and accepted by AB/F Quality Control (QC) personnel. AB/F's QC personnel performed 100% MT inspection of this weld. The attached photographs provide additional detail. This issue has an incident report.
