Contract #: 04-0120F4Cty: SF/ALA Rte: 80 PM: 13.2/13.9File #: 69.28**WELDING INSPECTION REPORT****Resident Engineer:** Siegenthaler, Peter**Address:** 333 Burma Road**City:** Oakland, CA 94607**Report No:** WIR-018360**Date Inspected:** 19-Nov-2010**Project Name:** SAS Superstructure**OSM Arrival Time:** 700**Prime Contractor:** American Bridge/Fluor Enterprises, a JV**OSM Departure Time:** 1900**Contractor:** Zhenhua Port Machinery Company, Ltd (ZPMC), Changxing Island **Location:** Shanghai, China**CWI Name:** Zhao Chen Sun**CWI Present:** Yes No**Inspected CWI report:** Yes No N/A**Rod Oven in Use:** Yes No N/A**Electrode to specification:** Yes No N/A**Weld Procedures Followed:** Yes No N/A**Qualified Welders:** Yes No N/A**Verified Joint Fit-up:** Yes No N/A**Approved Drawings:** Yes No N/A**Approved WPS:** Yes No N/A**Delayed / Cancelled:** Yes No N/A**Bridge No:** 34-0006**Component:** TOWER & OBG Components**Summary of Items Observed:**

TOWER JETTY

MEASUREMENTS OF GAP BETWEEN THE ENDS OF THE GRILLAGE PLATE STIFFENERS

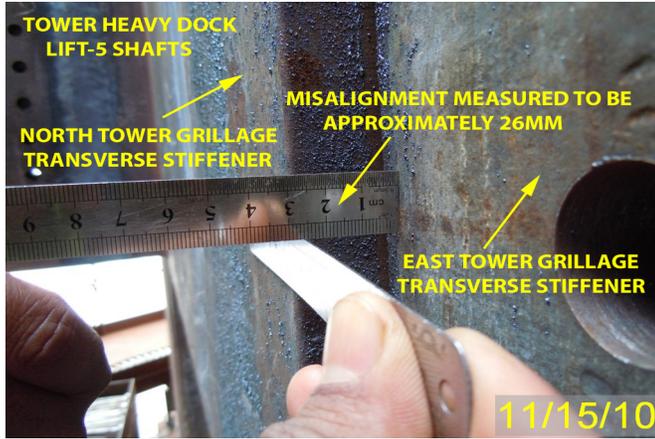
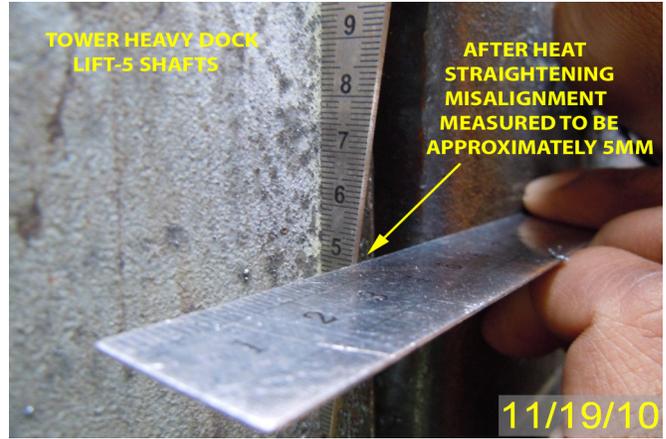
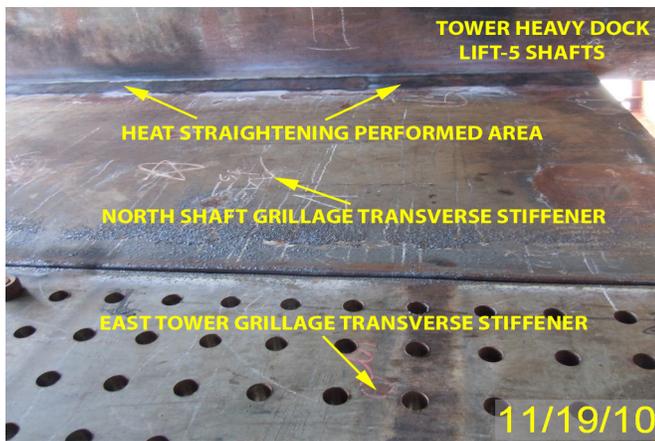
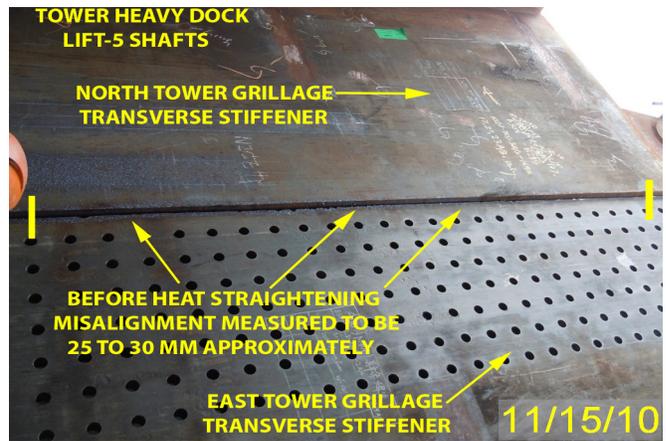
-On date: 11/15/10 observed misalignment between north and east shaft grillage transverse stiffeners measured to be approximately 25 to 30 mm due to the distortion caused by welding.

-ZPMC personnel performed heat straightening on north and east tower grillage shaft transverse stiffeners without prior engineer's approval.

-After heat straightening the misalignment measured to be approximately 3 to 5 mm.

- The stiffener length is measured to be 1500mm.
- The material is A709 Grade 485 Non-Seismic Performance Critical Member (SPCM).
- These components are located at Tower Heavy Dock.

Note* Since time of initial observation, ZPMC personnel have performed additional heat straightening of tower grillage stiffeners. All transverse and longitudinal stiffeners have received heat straightening.

AWS D1.5 2002 Section 3.7.3: "Members distorted by welding shall be straightened by mechanical means or by carefully supervised application of a limited amount of localized heat as approved by the Engineer."
