Contract #: 04-0120F4Cty: SF/ALA Rte: 80 PM: 13.2/13.9File #: 69.28**WELDING INSPECTION REPORT****Resident Engineer:** Siegenthaler, Peter**Address:** 333 Burma Road**City:** Oakland, CA 94607**Report No:** WIR-018373**Date Inspected:** 23-Nov-2010**Project Name:** SAS Superstructure**OSM Arrival Time:** 700**Prime Contractor:** American Bridge/Fluor Enterprises, a JV**OSM Departure Time:** 1900**Contractor:** Zhenhua Port Machinery Company, Ltd (ZPMC), Changxing Island **Location:** Shanghai, China

Bridge No: 34-0006**Component:** TOWER & OBG Components**Summary of Items Observed:**

WELDING INSPECTION REPORT

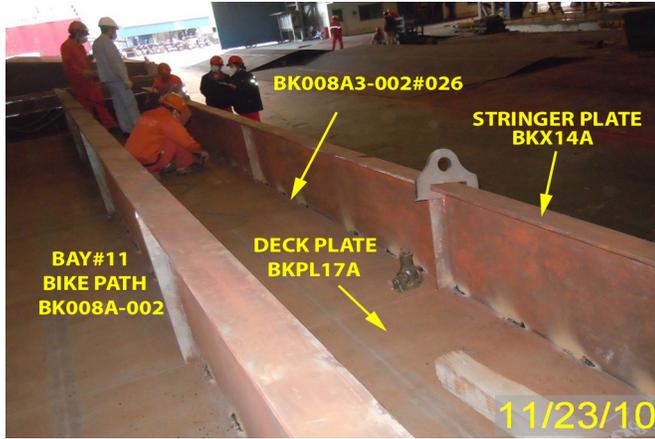
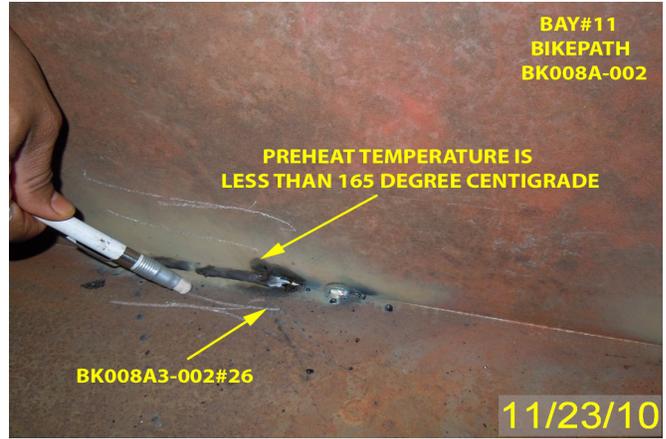
During Caltrans QA in process observations of the fabrication of Bike path: BK008A-002, this QA discovered the following issue(s):

ZPMC welding personnel did not appear to be following the NEW WELD PROCEDURE (Rager / McQuaid)

The weld is identified as BK008A3-002-026.

The tack welding process used was Shielded Metal Arc Welding (SMAW).

The area was being preheated using gas torch.

The weld is a fillet tack weld joining stringer plate (BKX14A) to deck plate (BKPL17A).

F. Preheat shall be applied in such a manner to provide a minimum temperature in the area of the weld of 165°C.
