**DEPARTMENT OF TRANSPORTATION**

Contract #: 04-0120F4Cty: SF/ALA Rte: 80 PM: 13.2/13.9File #: 69.28**WELDING INSPECTION REPORT****Resident Engineer:** Siegenthaler, Peter**Address:** 333 Burma Road**City:** Oakland, CA 94607**Report No:** WIR-018376**Date Inspected:** 25-Nov-2010**Project Name:** SAS Superstructure**OSM Arrival Time:** 700**Prime Contractor:** American Bridge/Fluor Enterprises, a JV**OSM Departure Time:** 1900**Contractor:** Zhenhua Port Machinery Company, Ltd (ZPMC), Changxing Island **Location:** Shanghai, China**CWI Name:** Mr. Xu Le Fung.**CWI Present:** Yes No**Inspected CWI report:** Yes No N/A**Rod Oven in Use:** Yes No N/A**Electrode to specification:** Yes No N/A**Weld Procedures Followed:** Yes No N/A**Qualified Welders:** Yes No N/A**Verified Joint Fit-up:** Yes No N/A**Approved Drawings:** Yes No N/A**Approved WPS:** Yes No N/A**Delayed / Cancelled:** Yes No N/A**Bridge No:** 34-0006**Component:** Tower and Orthotropic Box Girder (OBG)**Summary of Items Observed:**

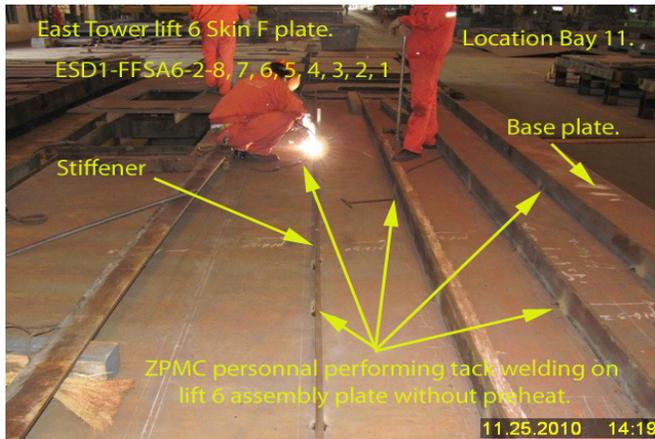
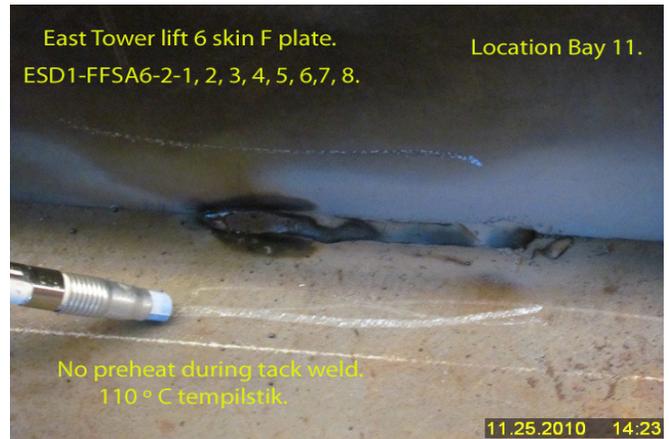
During Caltrans QA in process observations of the fabrication of East Tower Lift 6 Skin F, Assembly plate. ESD1-FFSA6-2, this QA discovered the following issue(s): ZPMC welding personnel did not appear to be following the NEW WELD PROCEDURE (Rager / McQuaid) The following requirements were not followed:

The weld is identified as: ESD1-FFSA6-2-1, 2, 3, 4, 5, 6, 7, 8. The welding process used was SMAW, The area was being no preheated. The weld is as Fillet joining stiffener plate to base plate, The weld is not SPCM ESD1-FFSA6-2 is located in Bay 11. For further information, please see the attached pictures. Incident Report to be generated to this date.
