**DEPARTMENT OF TRANSPORTATION**

Contract #: 04-0120F4Cty: SF/ALA Rte: 80 PM: 13.2/13.9File #: 69.28**WELDING INSPECTION REPORT****Resident Engineer:** Siegenthaler, Peter**Address:** 333 Burma Road**City:** Oakland, CA 94607**Report No:** WIR-019036**Date Inspected:** 20-Nov-2010**Project Name:** SAS Superstructure**OSM Arrival Time:** 700**Prime Contractor:** American Bridge/Fluor Enterprises, a JV**OSM Departure Time:** 1900**Contractor:** Zhenhua Port Machinery Company, Ltd (ZPMC), Changxing Island **Location:** Shanghai, China**CWI Name:** Li Yan Hua.**CWI Present:** Yes No**Inspected CWI report:** Yes No N/A**Rod Oven in Use:** Yes No N/A**Electrode to specification:** Yes No N/A**Weld Procedures Followed:** Yes No N/A**Qualified Welders:** Yes No N/A**Verified Joint Fit-up:** Yes No N/A**Approved Drawings:** Yes No N/A**Approved WPS:** Yes No N/A**Delayed / Cancelled:** Yes No N/A**Bridge No:** 34-0006**Component:** OBG components.**Summary of Items Observed:**

## WELDING INSPECTION REPORT

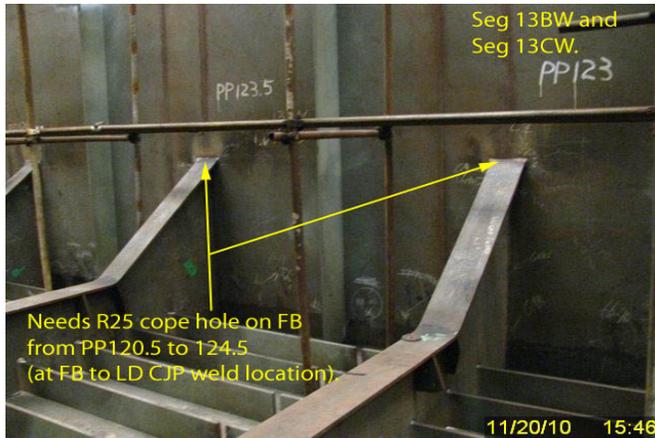
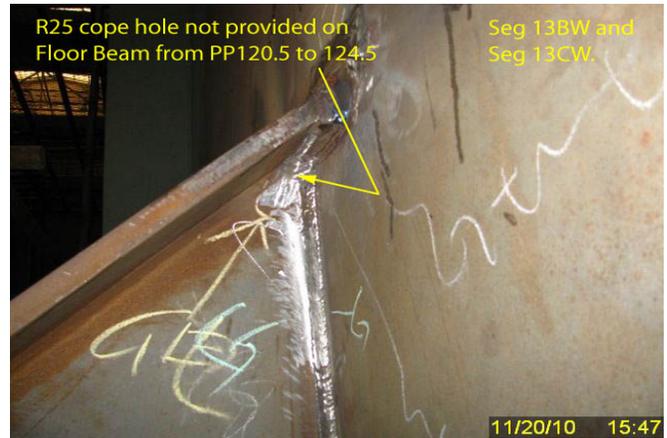
This QA Inspector observed that the R25 cope hole is not provided on the floor beams; from PP120.5 to 124.5. Welding and NDT (UT) of FB to LD CJP weld from PP120.5 to 124.5 is completed. This is informed this to ZPMC CWI Li Ming Yang and CT Lead QA. See attached photos for further details.
