DEPARTMENT OF TRANSPORTATION

Contract #: 04-0120F4Cty: SF/ALA Rte: 80 PM: 13.2/13.9File #: 69.28**WELDING INSPECTION REPORT****Resident Engineer:** Siegenthaler, Peter**Address:** 333 Burma Road**City:** Oakland, CA 94607**Report No:** WIR-019255**Date Inspected:** 24-Nov-2010**Project Name:** SAS Superstructure**OSM Arrival Time:** 700**Prime Contractor:** American Bridge/Fluor Enterprises, a JV**OSM Departure Time:** 1900**Contractor:** Zhenhua Port Machinery Company, Ltd (ZPMC), Changxing Island **Location:** Shanghai, China**CWI Name:** Qiu Wen.**CWI Present:** Yes No**Inspected CWI report:** Yes No N/A**Rod Oven in Use:** Yes No N/A**Electrode to specification:** Yes No N/A**Weld Procedures Followed:** Yes No N/A**Qualified Welders:** Yes No N/A**Verified Joint Fit-up:** Yes No N/A**Approved Drawings:** Yes No N/A**Approved WPS:** Yes No N/A**Delayed / Cancelled:** Yes No N/A**Bridge No:** 34-0006**Component:** OBG components.**Summary of Items Observed:**

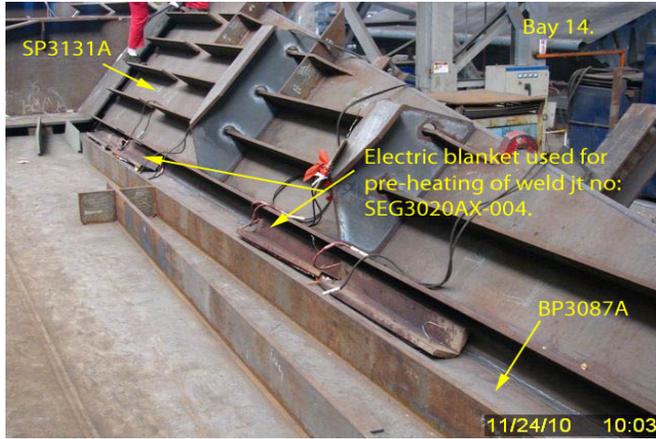
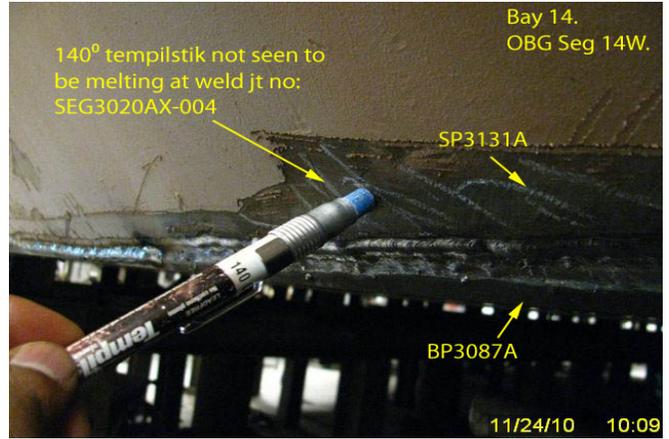
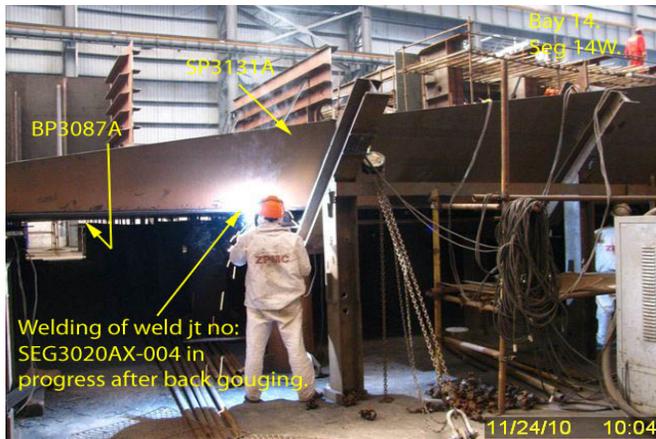
The Shielded Metal Arc Welding (SMAW) process on weld joint no: SEG3020AX-004 [Side Panel (SP) to Bottom Panel (BP), complete joint penetration (CJP) weld]. The welder is identified as 066413 and was observed welding in the 4G position. ZPMC Quality Control (QC) was identified as Qiu Wen. The welding variables recorded by QC appeared to comply with Welding Procedure Specification (WPS): B-P-2213-B-U3b.

- Welding of this joint was observed to be done after back gouging.
- However, ZPMC personnel did not appear to be following the New Weld Procedure (Rager / McQuaid).
- Minimum pre heating temperature of 140C was not maintained was welding was in progress.

- This QA Inspector informed about this to ZPMC QC Qiu Wen, that an Incident Report will be raised for this.
- See attached photos for further details.
