DEPARTMENT OF TRANSPORTATION

Contract #: 04-0120F4Cty: SF/ALA Rte: 80 PM: 13.2/13.9File #: 99.28**WELDING INSPECTION REPORT****Resident Engineer:** Siegenthaler, Peter**Address:** 333 Burma Road**City:** Oakland, CA 94607**Report No:** WIR-021470**Date Inspected:** 29-Nov-2010**Project Name:** SAS Superstructure**OSM Arrival Time:** 700**Prime Contractor:** American Bridge/Fluor Enterprises, a JV**OSM Departure Time:** 1900**Contractor:** Zhenhua Port Machinery Company, Ltd (ZPMC) Chanxing Island**Location:** Shanghai, China

Bridge No: 34-0006**Component:** OBG Segment**Summary of Items Observed:**

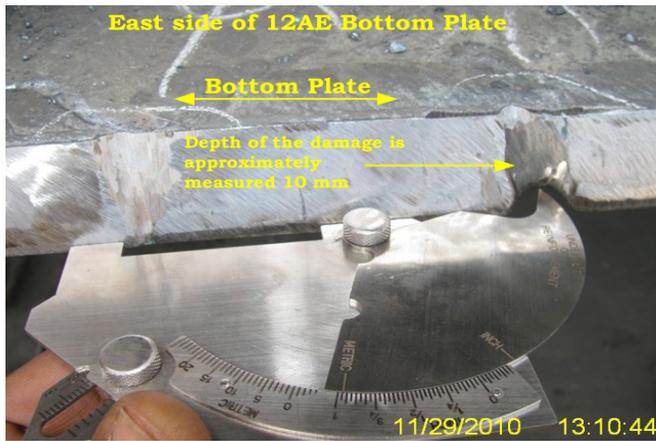
ZPMC personnel performing Edge preparation of bottom plate for bottom plate to bottom plate transverse splice weld joint located on east side of 12AE. During Visual Inspection of the above mention weld joint damage found on base metal of bottom plate. The depth of the damage is approximately measured 10 mm. The Information of the problem pass over the ZPMC CWI Mr. LIU HUA JIE for further rectification with approved CWR. See attached picture for further detail.
