DEPARTMENT OF TRANSPORTATION

Contract #: 04-0120F4Cty: SF/ALA Rte: 80 PM: 13.2/13.9File #: 99.28**WELDING INSPECTION REPORT****Resident Engineer:** Siegenthaler, Peter**Address:** 333 Burma Road**City:** Oakland, CA 94607**Report No:** WIR-018448**Date Inspected:** 03-Dec-2010**Project Name:** SAS Superstructure**OSM Arrival Time:** 700**Prime Contractor:** American Bridge/Fluor Enterprises, a JV**OSM Departure Time:** 1900**Contractor:** Zhenhua Port Machinery Company, Ltd (ZPMC)**Location:** Shanghai, China**CWI Name:** Li Yang and Zhu Zhong Hai**CWI Present:** Yes No**Inspected CWI report:** Yes No N/A**Rod Oven in Use:** Yes No N/A**Electrode to specification:** Yes No N/A**Weld Procedures Followed:** Yes No N/A**Qualified Welders:** Yes No N/A**Verified Joint Fit-up:** Yes No N/A**Approved Drawings:** Yes No N/A**Approved WPS:** Yes No N/A**Delayed / Cancelled:** Yes No N/A**Bridge No:** 34-0006**Component:** OBG Trial Assembly**Summary of Items Observed:**

WELDING INSPECTION REPORT

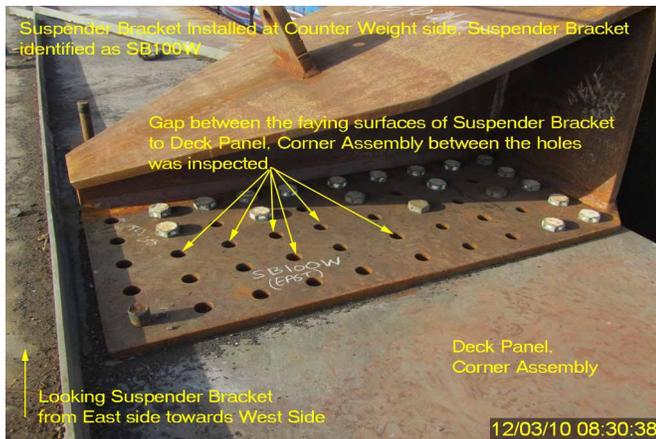
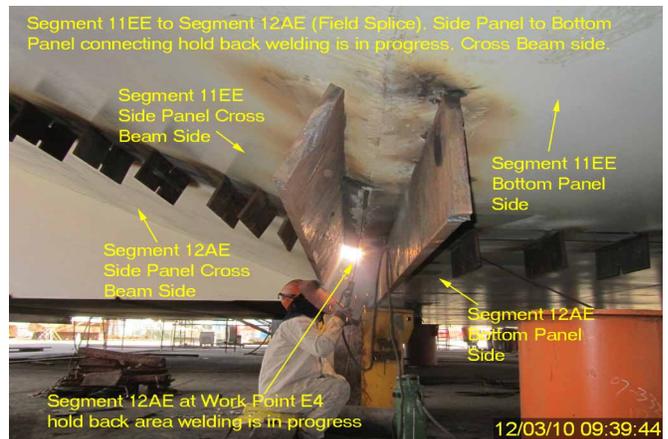
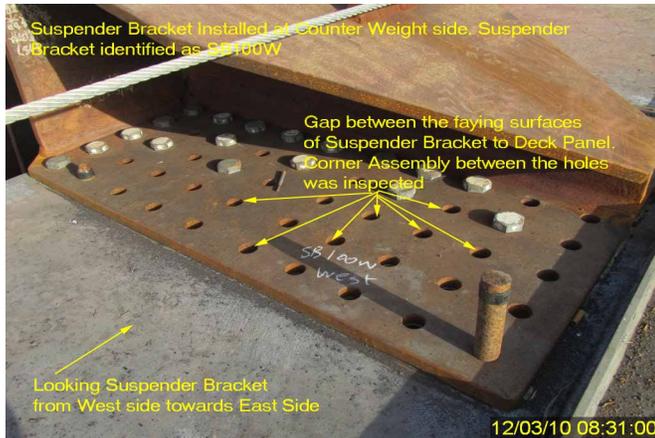
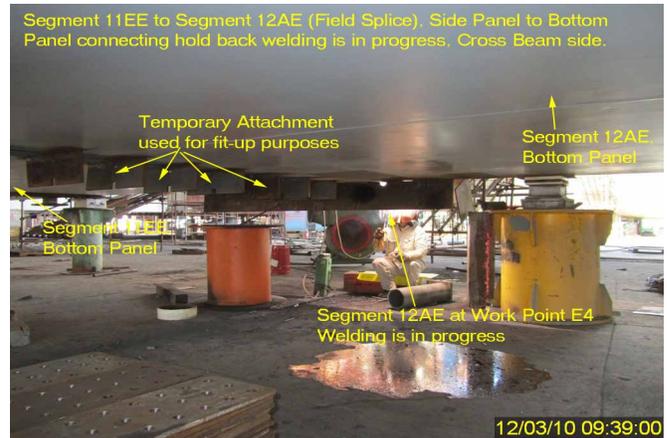
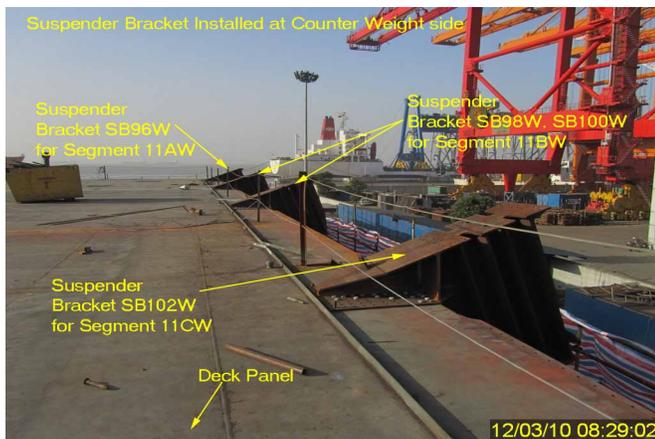
This Quality Assurance (QA) Inspector verified and measured the gap between the faying surfaces of Deck Panel Corner Assembly to Suspender Bracket (SB) flange at the pre-installation stage along with ZPMC QC Inspector Mr. Shen Jian Bo and observed the gap to be in general compliance with contact requirements. Inspection was performed against the Notification No. 00018 Dated December 03, 2010.

This QA Inspector observed the in-process welding by Shielded Metal Arc Welding (SMAW) process on a Complete Joint Penetration (CJP) groove weld. The weld joint was designated as Seg074A-011. The welder identification was 044515 and observed welding in the 4G (Overhead) position using approved Welding Procedure Specification WPS-B-P-2214-B-U2-FCM-1. The piece mark was identified as Bottom Panel to Side Panel at work point E4.

This QA Inspector observed the in-process welding by Shielded Metal Arc Welding (SMAW) process on a Complete Joint Penetration (CJP) groove weld. The weld joint was designated as Seg3001A-015. The welder identification was 044515 and observed welding in the 4G (Overhead) position using approved Welding Procedure Specification WPS-B-P-2214-B-U2-FCM-1. The piece mark was identified as Bottom Panel to Side Panel at work point E4.
