**DEPARTMENT OF TRANSPORTATION**

Contract #: 04-0120F4Cty: SF/ALA Rte: 80 PM: 13.2/13.9File #: 69.28**WELDING INSPECTION REPORT****Resident Engineer:** Siegenthaler, Peter**Address:** 333 Burma Road**City:** Oakland, CA 94607**Report No:** WIR-018815**Date Inspected:** 15-Dec-2010**Project Name:** SAS Superstructure**OSM Arrival Time:** 700**Prime Contractor:** American Bridge/Fluor Enterprises, a JV**OSM Departure Time:** 1900**Contractor:** Zhenhua Port Machinery Company, Ltd (ZPMC), Changxing Island **Location:** Shanghai, China

On this day Caltrans OSM Quality Assurance (QA) Inspector Subhasis Bera was present during the times noted above for observations relative to the fabrication of the SAS Superstructure being performed by Zhen Hua Port Machinery Company (ZPMC) at Chang Xing Island in Shanghai, China. QA Inspector observed and/or found the following:

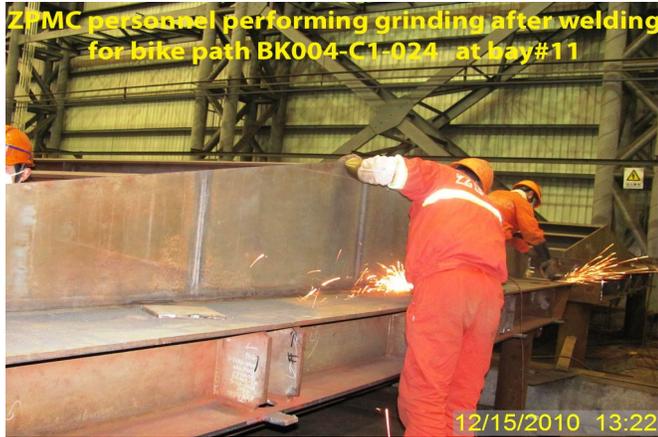
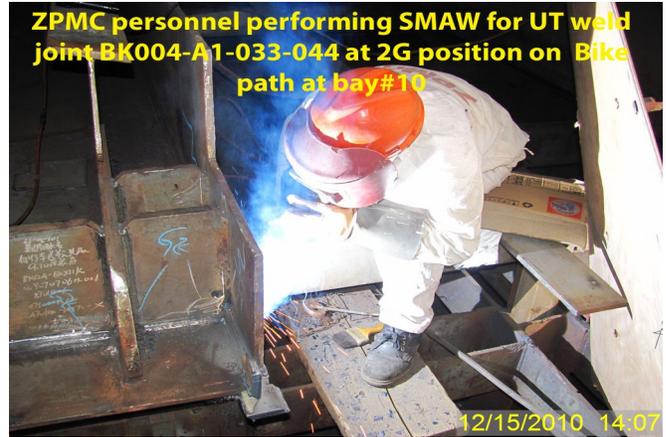
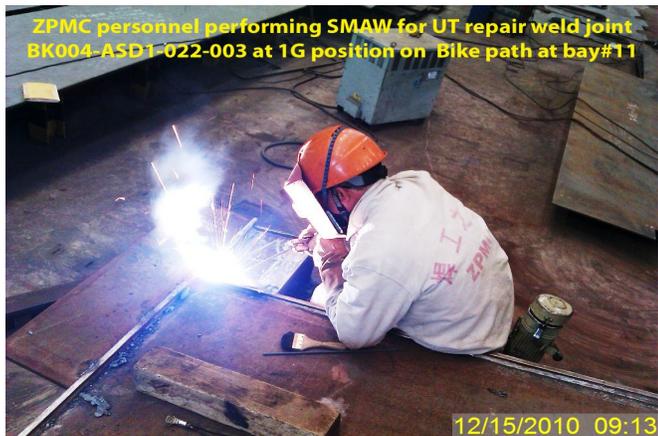
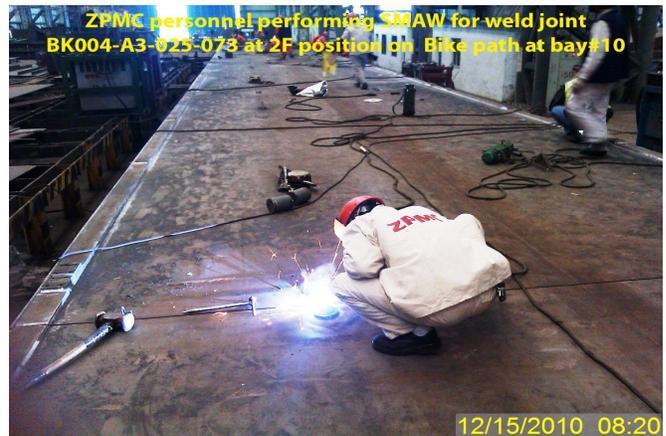
Unless otherwise noted, all work observed on this date appeared to generally comply with applicable contract documents.
