DEPARTMENT OF TRANSPORTATION

Contract #: 04-0120F4Cty: SF/ALA Rte: 80 PM: 13.2/13.9File #: 99.28**WELDING INSPECTION REPORT****Resident Engineer:** Siegenthaler, Peter**Address:** 333 Burma Road**City:** Oakland, CA 94607**Report No:** WIR-019313**Date Inspected:** 10-Jan-2011**Project Name:** SAS Superstructure**OSM Arrival Time:** 700**Prime Contractor:** American Bridge/Fluor Enterprises, a JV**OSM Departure Time:** 1900**Contractor:** Zhenhua Port Machinery Company, Ltd (ZPMC) Chanxing Island**Location:** Shanghai, China

CWI Name:	Mr. Qui Wen	CWI Present:	Yes	No
Inspected CWI report:	Yes No N/A	Rod Oven in Use:	Yes No N/A	
Electrode to specification:	Yes No N/A	Weld Procedures Followed:	Yes No N/A	
Qualified Welders:	Yes No N/A	Verified Joint Fit-up:	Yes No N/A	
Approved Drawings:	Yes No N/A	Approved WPS:	Yes No N/A	
		Delayed / Cancelled:	Yes No N/A	
Bridge No:	34-0006	Component:	OBG Segment

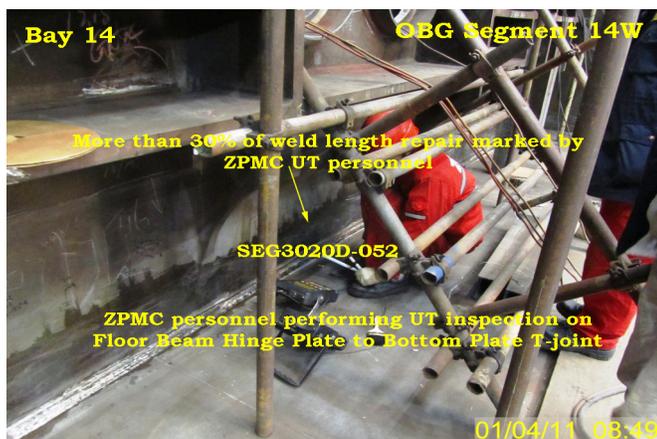
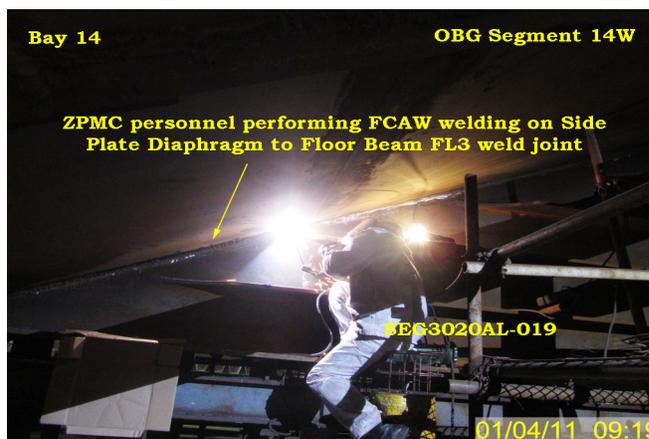
Unless otherwise noted, all work observed on this date appeared to be in general compliance with the applicable contract documents.
