DEPARTMENT OF TRANSPORTATION

Contract #: 04-0120F4Cty: SF/ALA Rte: 80 PM: 13.2/13.9File #: 69.28**WELDING INSPECTION REPORT****Resident Engineer:** Siegenthaler, Peter**Address:** 333 Burma Road**City:** Oakland, CA 94607**Report No:** WIR-019401**Date Inspected:** 06-Jan-2011**Project Name:** SAS Superstructure**OSM Arrival Time:** 700**Prime Contractor:** American Bridge/Fluor Enterprises, a JV**OSM Departure Time:** 1900**Contractor:** Zhenhua Port Machinery Company, Ltd (ZPMC), Changxing Island **Location:** Shanghai, China**CWI Name:** Mr. Qiu wei**CWI Present:** Yes No**Inspected CWI report:** Yes No N/A**Rod Oven in Use:** Yes No N/A**Electrode to specification:** Yes No N/A**Weld Procedures Followed:** Yes No N/A**Qualified Welders:** Yes No N/A**Verified Joint Fit-up:** Yes No N/A**Approved Drawings:** Yes No N/A**Approved WPS:** Yes No N/A**Delayed / Cancelled:** Yes No N/A**Bridge No:** 34-0006**Component:** Orthotropic Box Girder (OBG)**Summary of Items Observed:**

OBG Assembly Bay- 14.

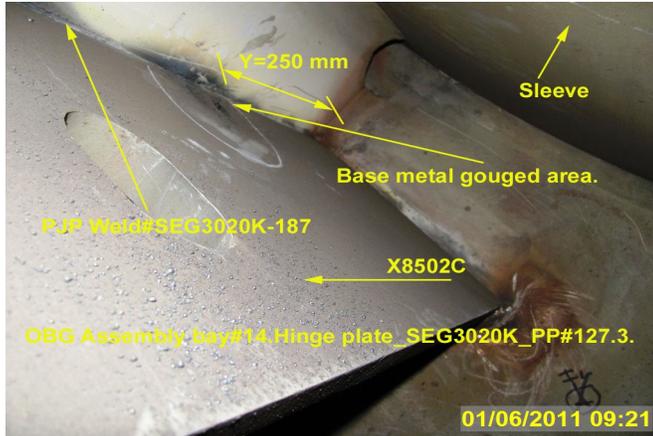
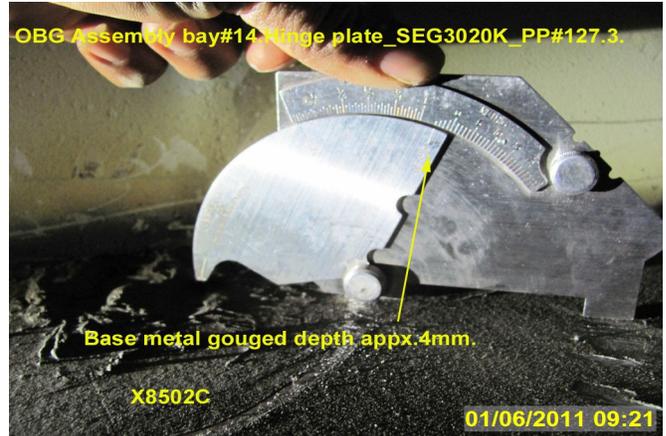
During random Visual Testing of OBG 14 West hinge plate SEG3020K at Panel Point 127.3(Counter weight side), this QA observed base metal gouged on Piece Mark (PCMK) identified as X8502C. The "Y" location is approximately 250 mm from south cope hole. This QA marked the affected area and measured the depth approximately 4mm and informed ZPMC Quality Control (QC) Certified Welding Inspector identified as Mr. An Qing xiang of this issue. Mr. An Qing xiang informed this QA that the gouged area would be corrected in a manner compliant with the contract documents. This QA also informed the above issue to shop Lead QA inspector (verbally). Refer the attached photos for reference.
