Contract #: 04-0120F4Cty: SF/ALA Rte: 80 PM: 13.2/13.9File #: 69.28**WELDING INSPECTION REPORT****Resident Engineer:** Siegenthaler, Peter**Address:** 333 Burma Road**City:** Oakland, CA 94607**Report No:** WIR-019531**Date Inspected:** 26-Jan-2011**Project Name:** SAS Superstructure**OSM Arrival Time:** 700**Prime Contractor:** American Bridge/Fluor Enterprises, a JV**OSM Departure Time:** 1900**Contractor:** Zhenhua Port Machinery Company, Ltd (ZPMC), Changxing Island **Location:** Shanghai, China**CWI Name:** Qiu Wen**CWI Present:** Yes No**Inspected CWI report:** Yes No N/A**Rod Oven in Use:** Yes No N/A**Electrode to specification:** Yes No N/A**Weld Procedures Followed:** Yes No N/A**Qualified Welders:** Yes No N/A**Verified Joint Fit-up:** Yes No N/A**Approved Drawings:** Yes No N/A**Approved WPS:** Yes No N/A**Delayed / Cancelled:** Yes No N/A**Bridge No:** 34-0006**Component:** OBG**Summary of Items Observed:**

BAY 14, OBG 14E (NWIT # 08291)

OBG Seg 14W:

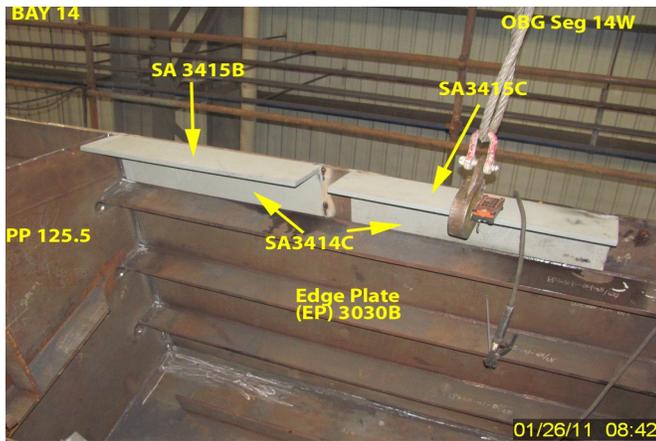
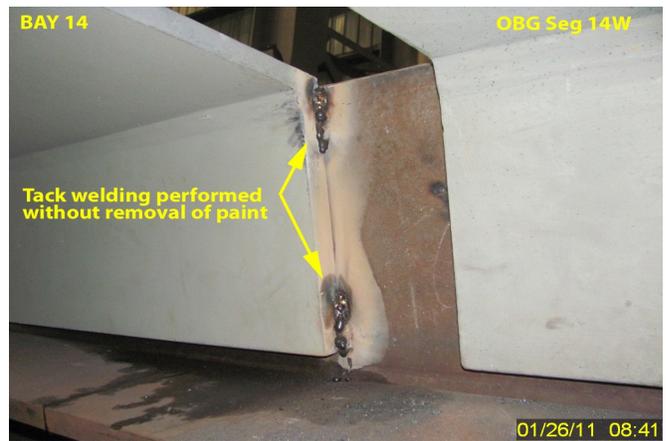
During random in process inspection this QA inspector observed that ZPMC personnel performed tack welding without removal of paint from the contact surface. The parts are identified as joining Sub Assembly (SA) 3415B, SA3415C and SA3414C to Edge Plate (EP) 3030B in between Panel Point (PP) 125~125.5. The welder is

identified as 066674. This issue has been discussed with AB/F QA Mr. Kim and CT lead QA. Mr. Kim informed this QA that this issue would be solved in manner compliant with contract documents. Later on this QA observed that ZPMC removed those tack welds, ground out weld and remove the paint properly and installed the part again. Attached photograph provide additional detail.
