**DEPARTMENT OF TRANSPORTATION**

Contract #: 04-0120F4Cty: SF/ALA Rte: 80 PM: 13.2/13.9File #: 69.28**WELDING INSPECTION REPORT****Resident Engineer:** Siegenthaler, Peter**Address:** 333 Burma Road**City:** Oakland, CA 94607**Report No:** WIR-020089**Date Inspected:** 26-Jan-2011**Project Name:** SAS Superstructure**OSM Arrival Time:** 700**Prime Contractor:** American Bridge/Fluor Enterprises, a JV**OSM Departure Time:** 1900**Contractor:** Zhenhua Port Machinery Company, Ltd (ZPMC), Changxing Island **Location:** Shanghai, China**CWI Name:** Xu tao**CWI Present:** Yes No**Inspected CWI report:** Yes No N/A**Rod Oven in Use:** Yes No N/A**Electrode to specification:** Yes No N/A**Weld Procedures Followed:** Yes No N/A**Qualified Welders:** Yes No N/A**Verified Joint Fit-up:** Yes No N/A**Approved Drawings:** Yes No N/A**Approved WPS:** Yes No N/A**Delayed / Cancelled:** Yes No N/A**Bridge No:** 34-0006**Component:** OBG Components**Summary of Items Observed:**

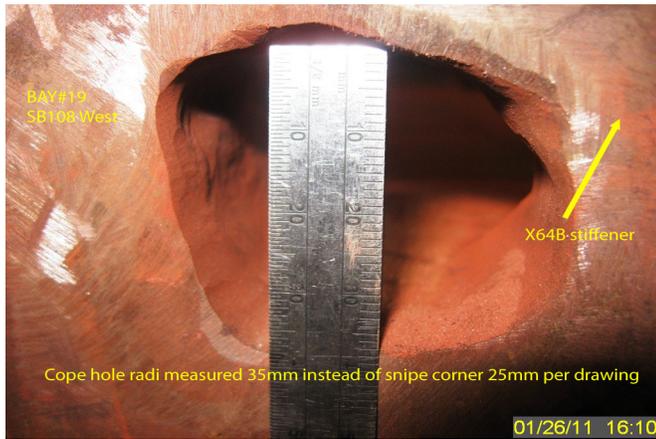
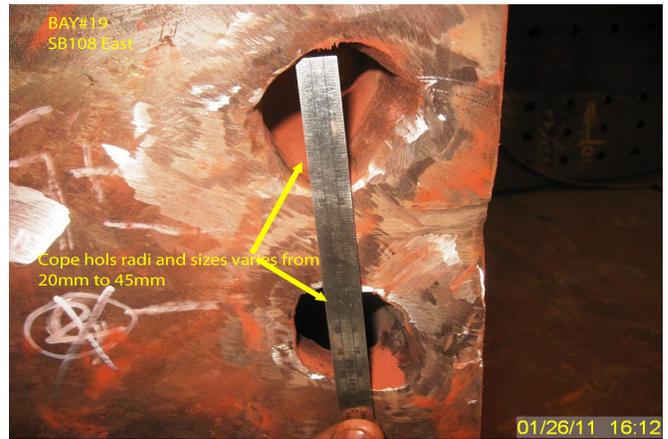
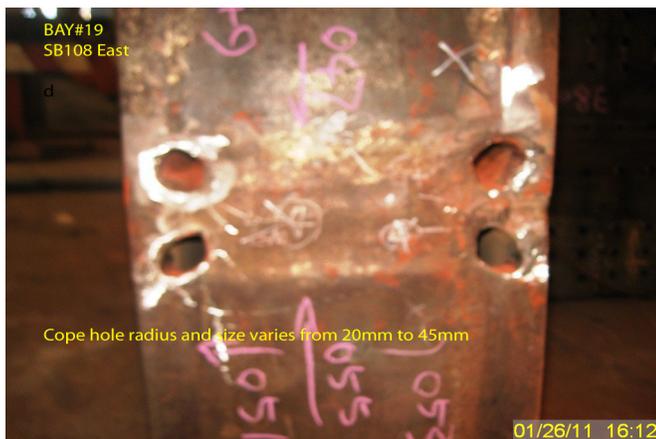
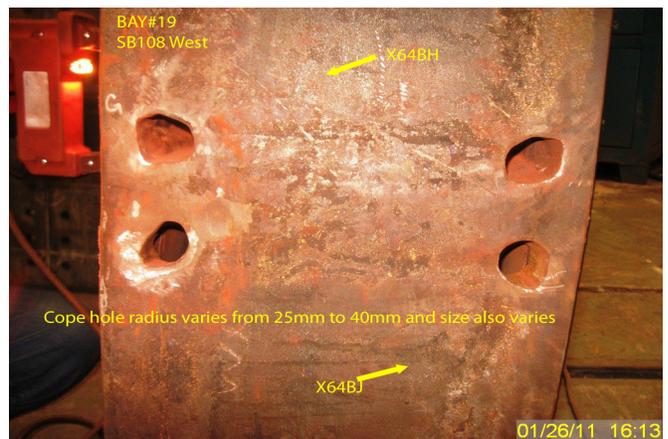
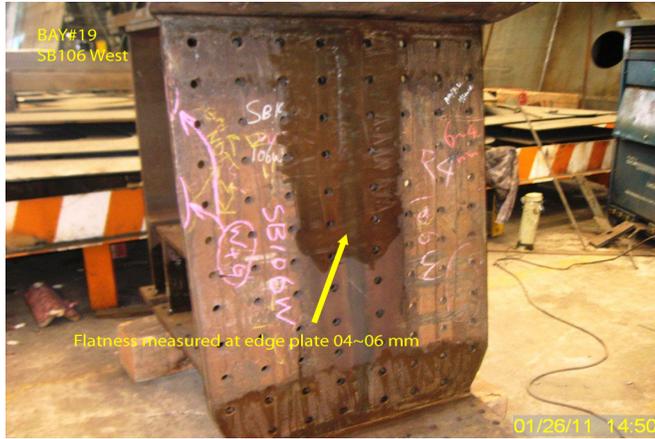
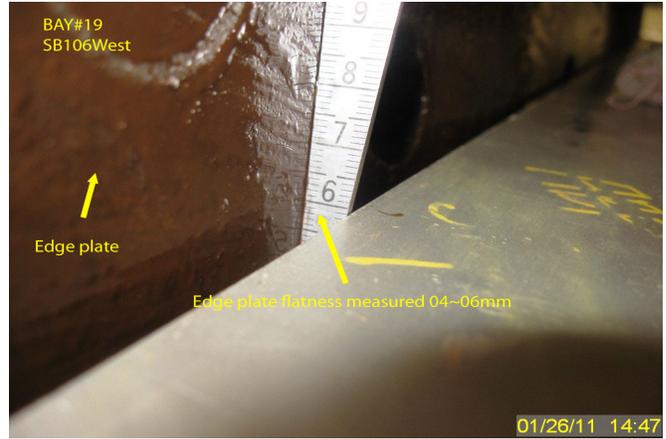
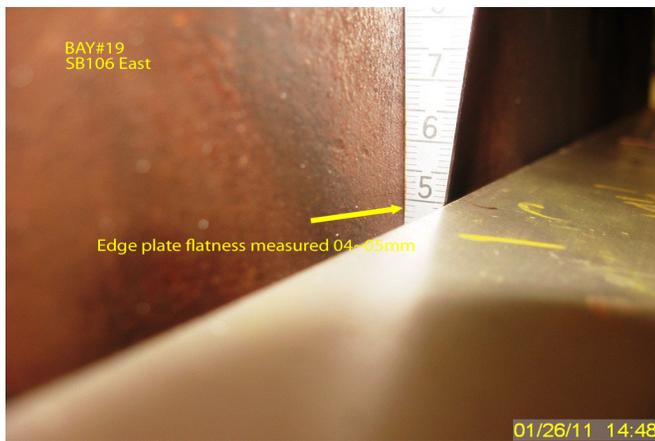
This is observed and measured that cope holes of SB108 East and west is not appeared to comply with approved

Drawing (Snipe corner 25mm).

SB108 East - 20mm to 45mm radius.

SB108 West- 25mm to 45mm radius.

The shape also varies one another. Please see the attached photos.
