DEPARTMENT OF TRANSPORTATION

Contract #: 04-0120F4Cty: SF/ALA Rte: 80 PM: 13.2/13.9File #: 69.28**WELDING INSPECTION REPORT****Resident Engineer:** Siegenthaler, Peter**Address:** 333 Burma Road**City:** Oakland, CA 94607**Report No:** WIR-021276**Date Inspected:** 29-Jan-2011**Project Name:** SAS Superstructure**OSM Arrival Time:** 1500**Prime Contractor:** American Bridge/Fluor Enterprises, a JV**OSM Departure Time:** 300**Contractor:** Zhenhua Port Machinery Company, Ltd (ZPMC), Changxing Island **Location:** Shanghai, China**CWI Name:** Yu Jiao**CWI Present:** Yes No**Inspected CWI report:** Yes No N/A**Rod Oven in Use:** Yes No N/A**Electrode to specification:** Yes No N/A**Weld Procedures Followed:** Yes No N/A**Qualified Welders:** Yes No N/A**Verified Joint Fit-up:** Yes No N/A**Approved Drawings:** Yes No N/A**Approved WPS:** Yes No N/A**Delayed / Cancelled:** Yes No N/A**Bridge No:** 34-0006**Component:** OBG Segment Assembly**Summary of Items Observed:**

OBG Segment 14E / Bay 14

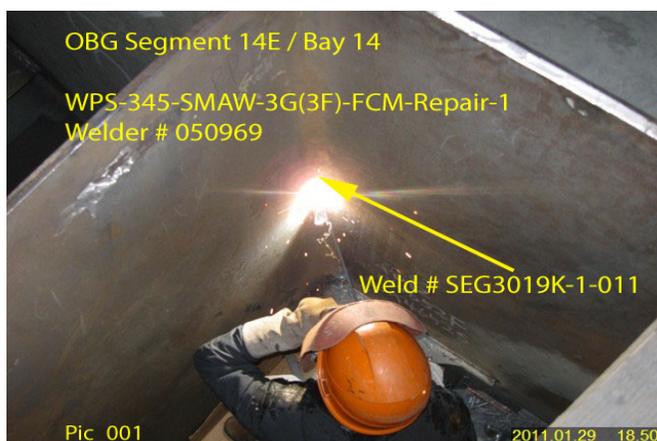
Shielded Metal Arc Welding (SMAW) in the 3G position of SA3324A to LD repair weld # SEG3019K-1-011, as per B-CWR # 2726. The welder is identified as 050969. ABF Quality Assurance (QA) is identified as Yu Jiao. The welding variables recorded by QC appeared to comply with WPS-345-SMAW-3G(3F)-FCM-Repair-1. See attached photograph Pic_001.
