Contract #: 04-0120F4Cty: SF/ALA Rte: 80 PM: 13.2/13.9File #: 69.28**WELDING INSPECTION REPORT****Resident Engineer:** Siegenthaler, Peter**Address:** 333 Burma Road**City:** Oakland, CA 94607**Report No:** WIR-022084**Date Inspected:** 09-Jan-2011**Project Name:** SAS Superstructure**OSM Arrival Time:** 700**Prime Contractor:** American Bridge/Fluor Enterprises, a JV**OSM Departure Time:** 1900**Contractor:** Zhenhua Port Machinery Company, Ltd (ZPMC), Changxing Island **Location:** Shanghai, China**CWI Name:** An Qing Xiang**CWI Present:** Yes No**Inspected CWI report:** Yes No N/A**Rod Oven in Use:** Yes No N/A**Electrode to specification:** Yes No N/A**Weld Procedures Followed:** Yes No N/A**Qualified Welders:** Yes No N/A**Verified Joint Fit-up:** Yes No N/A**Approved Drawings:** Yes No N/A**Approved WPS:** Yes No N/A**Delayed / Cancelled:** Yes No N/A**Bridge No:** 34-0006**Component:** OBG**Summary of Items Observed:**

BAY 14, OBG 13CW (NWIT # 08104)

OBG Seg 14W

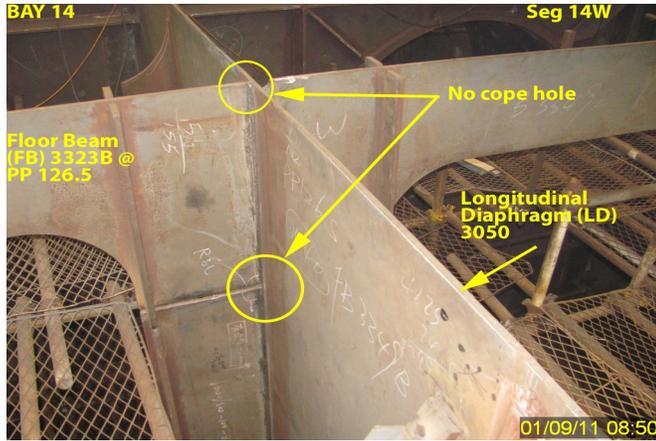
During random in process inspection this QA inspector observed there was no cope holes made at two locations on the web plate of Floor Beam (FB) 3323B at Panel Point (PP) 126.5. As per shop drawing it shows cope holes supposed to be there. This issue has been discussed with ZPMC CWI Mr. An Qing Xiang and CT Lead QA. Mr. An Qing Xiang informed this QA that this issue would be corrected in manner compliant with contract documents. Attached photograph provide additional details.
