DEPARTMENT OF TRANSPORTATION

Quality Assurance and Source Inspection

Contract #: 04-0120F4Cty: SF/ALA Rte: 80 PM: 13.2/13.9File #: 69.28**WELDING INSPECTION REPORT****Resident Engineer:** Siegenthaler, Peter**Address:** 333 Burma Road**City:** Oakland, CA 94607**Report No:** WIR-020452**Date Inspected:** 09-Feb-2011**Project Name:** SAS Superstructure**OSM Arrival Time:** 700**Prime Contractor:** American Bridge/Fluor Enterprises, a JV**OSM Departure Time:** 1900**Contractor:** Zhenhua Port Machinery Company, Ltd (ZPMC), Changxing Island **Location:** Shanghai, China**CWI Name:** Li Yan Hua**CWI Present:** Yes No**Inspected CWI report:** Yes No N/A**Rod Oven in Use:** Yes No N/A**Electrode to specification:** Yes No N/A**Weld Procedures Followed:** Yes No N/A**Qualified Welders:** Yes No N/A**Verified Joint Fit-up:** Yes No N/A**Approved Drawings:** Yes No N/A**Approved WPS:** Yes No N/A**Delayed / Cancelled:** Yes No N/A**Bridge No:** 34-0006**Component:** OBG**Summary of Items Observed:**

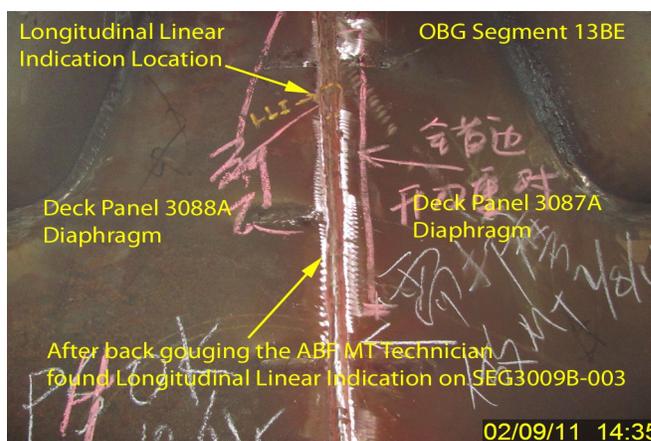
Segment 13BE, this Quality Assurance Inspector (QA) observed the following issues;

Two Linear Longitudinal Indications were found measuring approximately 10mm and 15mm lengths respectively. After back gouging, these indications were discovered visually and confirmed by Magnetic particle Testing (MT) by ABF MT personnel. The indications are clearly marked on the material near the weld for further repair. The weld number is identified as SEG3009B-003. The panel point is identified as a PP122. This weld is a CJP weld joining the Deck Panel Diaphragm to Deck Panel Diaphragm. The above mentioned discrepancy was informed to ABF QA, ZPMC QA and the Lead Inspector for further action. Please see the attached picture.
