DEPARTMENT OF TRANSPORTATION

Quality Assurance and Source Inspection

Contract #: 04-0120F4Cty: SF/ALA Rte: 80 PM: 13.2/13.9File #: 99.28**WELDING INSPECTION REPORT****Resident Engineer:** Siegenthaler, Peter**Address:** 333 Burma Road**City:** Oakland, CA 94607**Report No:** WIR-020542**Date Inspected:** 13-Feb-2011**Project Name:** SAS Superstructure**OSM Arrival Time:** 700**Prime Contractor:** American Bridge/Fluor Enterprises, a JV**OSM Departure Time:** 1900**Contractor:** Zhenhua Port Machinery Company, Ltd (ZPMC)**Location:** Shanghai, China

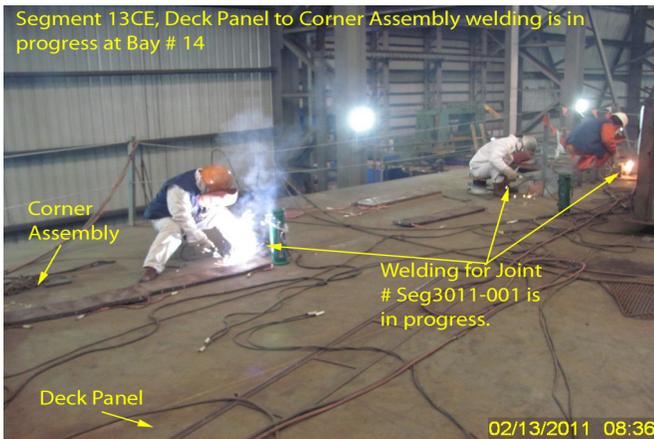
Bay # 14: Segment 13CE

This QA Inspector observed the in-process welding by Shielded Metal Arc Welding (SMAW) process on a Complete Joint Penetration (CJP) groove weld. The Weld joint was designated as Seg3011-001. The welder identification was 067572 and observed welding in the 1G (Flat) position using approved Welding Procedure Specification WPS-B-P-2211-B-U2a-FCM-1. The piece mark was identified as the weld connecting the Deck Panel (DP3099A) to Corner Assembly (CA3014A).

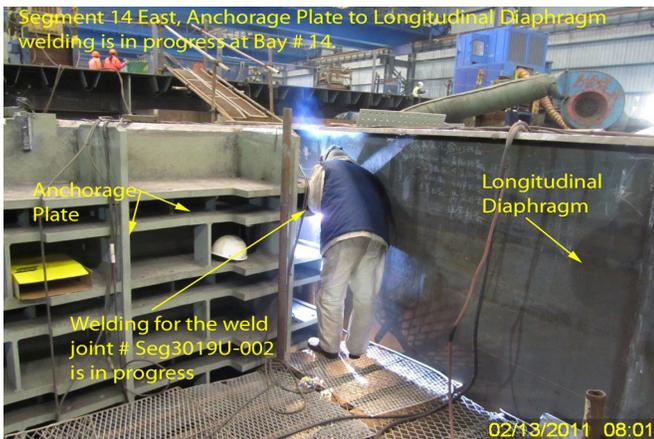
Bay # 14: Segment 14 East

This QA Inspector observed the in-process welding by Flux Cored Arc Welding (FCAW) process on a Complete Joint Penetration (CJP) groove weld. The Weld joint was designated as Seg3019U-002. The welder identification was 067079 and observed welding in the 3G (Vertical) position using approved Welding Procedure Specification WPS-B-T-2233-ESAB. The piece mark was identified as the weld connecting the Anchorage Plate AP3031A to the Longitudinal Diaphragm at work point E3.

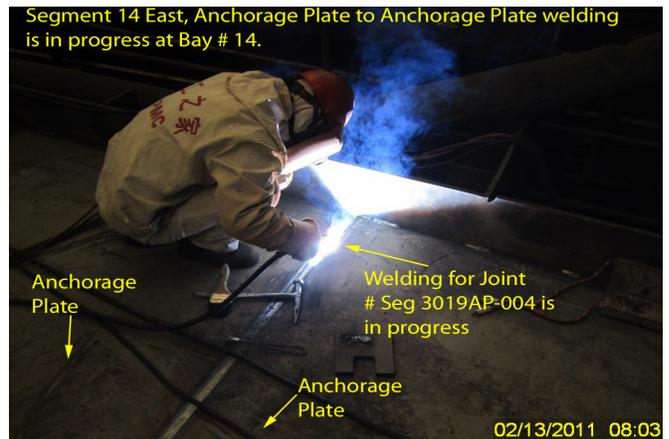
Bay # 14: Segment 14 East

This QA Inspector observed the in-process welding by Flux Cored Arc Welding (FCAW) process on a Complete Joint Penetration (CJP) groove weld. The Weld joint was designated as Seg3019AP-004. The welder identification was 066763 and observed welding in the 1G (Flat) position using approved Welding Procedure Specification WPS-B-T-2231-ESAB. The piece mark was identified as the weld connecting the Anchorage Plate (AP3004) to Anchorage Plate (AP3005).

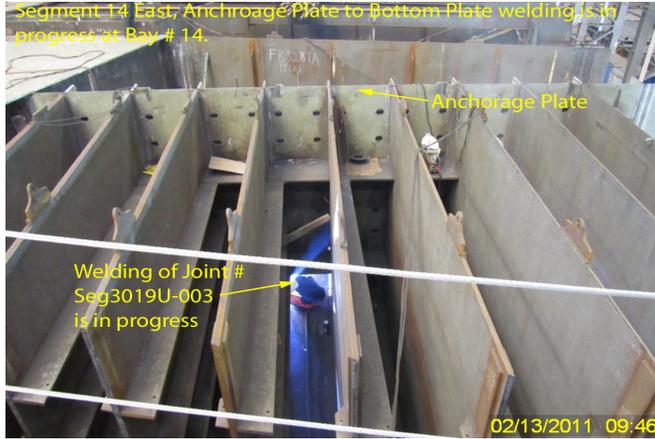
Bay # 14: Segment 14 East

This QA Inspector observed the in-process welding by Flux Cored Arc Welding (FCAW) process on a Complete Joint Penetration (CJP) groove weld. The Weld joint was designated as Seg3019U-003. The welder identification was 066236 and observed welding in the 2G (Horizontal) position using approved Welding Procedure Specification WPS-B-T-2232-ESAB. The piece mark was identified as the weld connecting the Anchorage Plate to Bottom Panel.
