DEPARTMENT OF TRANSPORTATION

Office of Structural Materials

Contract #: 04-0120F4Cty: SF/ALA Rte: 80 PM: 13.2/13.9File #: 69.28**WELDING INSPECTION REPORT****Resident Engineer:** Siegenthaler, Peter**Address:** 333 Burma Road**City:** Oakland, CA 94607**Report No:** WIR-020804**Date Inspected:** 20-Feb-2011**Project Name:** SAS Superstructure**OSM Arrival Time:** 700**Prime Contractor:** American Bridge/Fluor Enterprises, a JV**OSM Departure Time:** 1900**Contractor:** Zhenhua Port Machinery Company, Ltd (ZPMC), Changxing Island **Location:** Shanghai, China**CWI Name:** Zhou Zhong Hai**CWI Present:** Yes No**Inspected CWI report:** Yes No N/A**Rod Oven in Use:** Yes No N/A**Electrode to specification:** Yes No N/A**Weld Procedures Followed:** Yes No N/A**Qualified Welders:** Yes No N/A**Verified Joint Fit-up:** Yes No N/A**Approved Drawings:** Yes No N/A**Approved WPS:** Yes No N/A**Delayed / Cancelled:** Yes No N/A**Bridge No:** 34-0006**Component:** OBG Segments**Summary of Items Observed:**

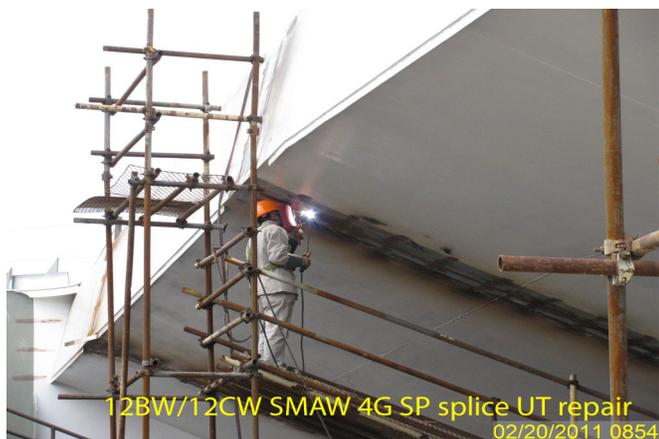
This QA Inspector observed ABF personnel performing Ultrasonic Testing on the Side Plate transverse CJP splice, cross beam side.
