DEPARTMENT OF TRANSPORTATION

Contract #: 04-0120F4Cty: SF/ALA Rte: 80 PM: 13.2/13.9File #: 69.28**WELDING INSPECTION REPORT****Resident Engineer:** Siegenthaler, Peter**Address:** 333 Burma Road**City:** Oakland, CA 94607**Report No:** WIR-020868**Date Inspected:** 12-Feb-2011**Project Name:** SAS Superstructure**OSM Arrival Time:** 1500**Prime Contractor:** American Bridge/Fluor Enterprises, a JV**OSM Departure Time:** 300**Contractor:** Zhenhua Port Machinery Company, Ltd (ZPMC), Changxing Island **Location:** Shanghai, China**CWI Name:** Mr. Yu Iao (ABF)**CWI Present:** Yes No**Inspected CWI report:** Yes No N/A**Rod Oven in Use:** Yes No N/A**Electrode to specification:** Yes No N/A**Weld Procedures Followed:** Yes No N/A**Qualified Welders:** Yes No N/A**Verified Joint Fit-up:** Yes No N/A**Approved Drawings:** Yes No N/A**Approved WPS:** Yes No N/A**Delayed / Cancelled:** Yes No N/A**Bridge No:** 34-0006**Component:** BAY 14 OBG**Summary of Items Observed:**

OBG BAY 14

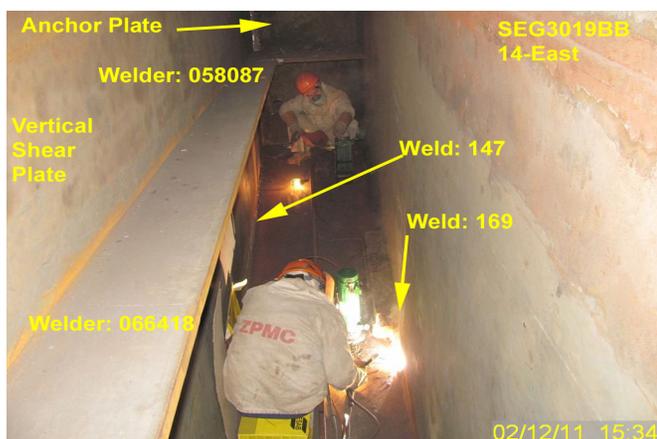
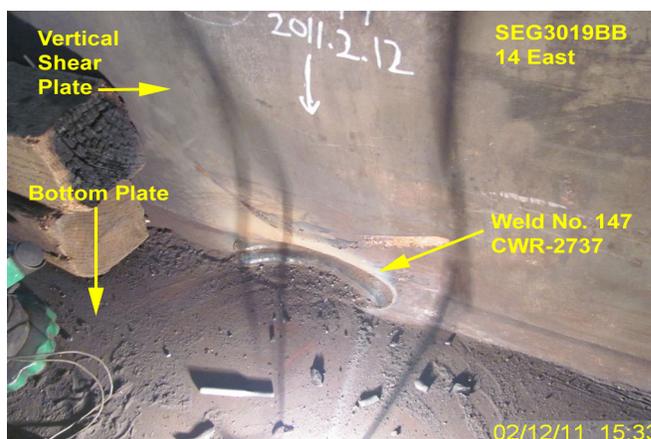
SMAW welding of complete joint penetration weld joint(s) located on lift 14 East Line SEG30019BB Vertical Shear Plate to Bottom Panel weld number(s) 147. Welder is identified as welder no. 058087. The welding variables recorded by ZPMC QC identified as Zhan Hai Feng appeared to comply with applicable WPS(s) WPS-345-SMAW-2G (2F)-FCM-Repair-1 and CWR-2737

SMAW welding of complete joint penetration weld joint(s) located on lift 14 East Line SEG30019BB Vertical Shear Plate to Bottom Panel weld number(s) 191. Welder is identified as welder no. 058087. The welding variables recorded by ZPMC QC identified as Zhan Hai Feng appeared to comply with applicable WPS(s) WPS-345-SMAW-2G (2F)-FCM-Repair-1 and CWR-2737

Unless otherwise noted, all work observed on this date appeared to generally comply with applicable contract documents.
