DEPARTMENT OF TRANSPORTATION

Contract #: 04-0120F4Cty: SF/ALA Rte: 80 PM: 13.2/13.9File #: 69.28**WELDING INSPECTION REPORT****Resident Engineer:** Siegenthaler, Peter**Address:** 333 Burma Road**City:** Oakland, CA 94607**Report No:** WIR-020982**Date Inspected:** 22-Feb-2011**Project Name:** SAS Superstructure**OSM Arrival Time:** 1500**Prime Contractor:** American Bridge/Fluor Enterprises, a JV**OSM Departure Time:** 300**Contractor:** Zhenhua Port Machinery Company, Ltd (ZPMC), Changxing Island **Location:** Shanghai, China**CWI Name:** Mr. Lv Li Qing**CWI Present:** Yes No**Inspected CWI report:** Yes No N/A**Rod Oven in Use:** Yes No N/A**Electrode to specification:** Yes No N/A**Weld Procedures Followed:** Yes No N/A**Qualified Welders:** Yes No N/A**Verified Joint Fit-up:** Yes No N/A**Approved Drawings:** Yes No N/A**Approved WPS:** Yes No N/A**Delayed / Cancelled:** Yes No N/A**Bridge No:** 34-0006**Component:** BAY14 OBG**Summary of Items Observed:**

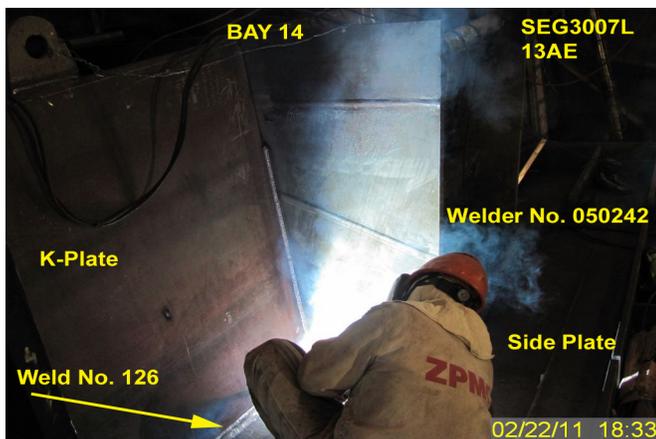
SMAW welding of complete joint penetration weld joint(s) located on lift 14 East Line SEG3019E Floor Beam Stiffener to Longitudinal Diaphragm weld number(s) 155. Welder is identified as welder no. 215553. The welding variables recorded by ZPMC QC identified as Zhan Hai Feng appeared to comply with applicable WPS(s) WPS-345-SMAW-2G (2F)-FCM-Repair-1 and B-WR-20273.

SMAW welding of complete joint penetration weld joint(s) located on lift 14 East Line SEG3019E Floor Beam Stiffener to Longitudinal Diaphragm weld number(s) 146. Welder is identified as welder no. 067656. The welding variables recorded by ZPMC QC identified as Zhan Hai Feng appeared to comply with applicable WPS(s) WPS-345-SMAW-2G (2F)-FCM-Repair-1 and B-WR-20273.

FCAW welding of complete joint penetration weld joint(s) located on lift 13A East Line SEG3007L K-Plate to Side Plate weld number(s) 126. Welder is identified as welder no. 050242. The welding variables recorded by ZPMC QC identified as Zhan Hai Feng appeared to comply with applicable WPS(s) WPS-B-T-2212-ESAB.
