DEPARTMENT OF TRANSPORTATION

Contract #: 04-0120F4Cty: SF/ALA Rte: 80 PM: 13.2/13.9File #: 99.28**WELDING INSPECTION REPORT****Resident Engineer:** Siegenthaler, Peter**Address:** 333 Burma Road**City:** Oakland, CA 94607**Report No:** WIR-021034**Date Inspected:** 25-Feb-2011**Project Name:** SAS Superstructure**OSM Arrival Time:** 700**Prime Contractor:** American Bridge/Fluor Enterprises, a JV**OSM Departure Time:** 1900**Contractor:** Zhenhua Port Machinery Company, Ltd (ZPMC) Chanxing Island**Location:** Shanghai, China

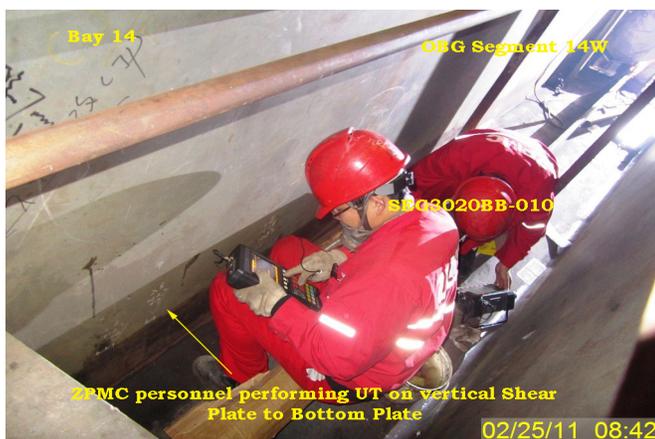
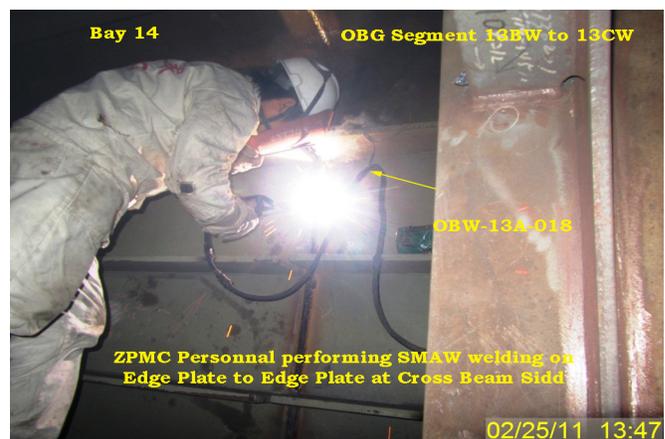
This QA inspector observed ZPMC personnel performed Ultrasonic Testing on Vertical Shear Plate to bottom plate 'T' joint weld at panel point 125 to 126 of OBG Segment 14W. The weld number is identified as SEG3020BB-037 and SEG3020BB-010. See the attached pictures.
