Quality Assurance and Source Inspection

Contract #: 04-0120F4Cty: SF/ALA Rte: 80 PM: 13.2/13.9File #: 69.28**WELDING INSPECTION REPORT****Resident Engineer:** Siegenthaler, Peter**Address:** 333 Burma Road**City:** Oakland, CA 94607**Report No:** WIR-021585**Date Inspected:** 13-Feb-2011**Project Name:** SAS Superstructure**OSM Arrival Time:** 700**Prime Contractor:** American Bridge/Fluor Enterprises, a JV**OSM Departure Time:** 1900**Contractor:** Zhenhua Port Machinery Company, Ltd (ZPMC), Changxing Island **Location:** Shanghai, China**CWI Name:** Mr. Xu Le Feng.**CWI Present:** Yes No**Inspected CWI report:** Yes No N/A**Rod Oven in Use:** Yes No N/A**Electrode to specification:** Yes No N/A**Weld Procedures Followed:** Yes No N/A**Qualified Welders:** Yes No N/A**Verified Joint Fit-up:** Yes No N/A**Approved Drawings:** Yes No N/A**Approved WPS:** Yes No N/A**Delayed / Cancelled:** Yes No N/A**Bridge No:** 34-0006**Component:** Orthotropic Box Girder (OBG)**Summary of Items Observed:**

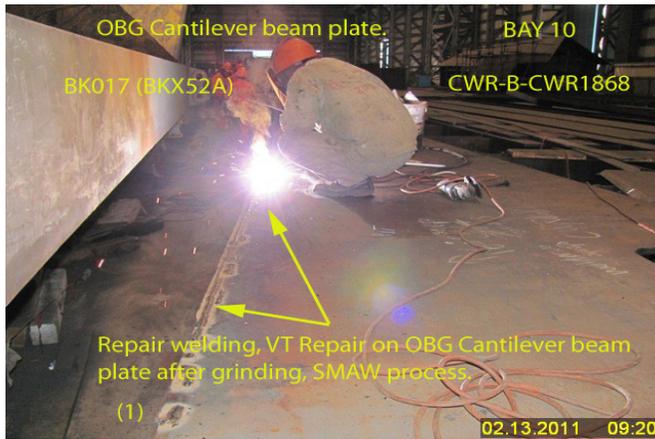
This QA Inspector observed ZPMC qualified welding personnel identified as 040270, Perform Shielded Metal Arc Welding (SMAW) on OBG Cantilever beam plate. Plate identified as BK17 (BKX52A). ZPMC QC Identified as Yu Zhi Lai with Critical welding repair report CWR-B-CWR1868. The welding parameters as measured using QC's calibrated instrument appeared to be in general compliance with WPS-345-SMAW-1G (1F) Repair. For more information see attached picture number 1.

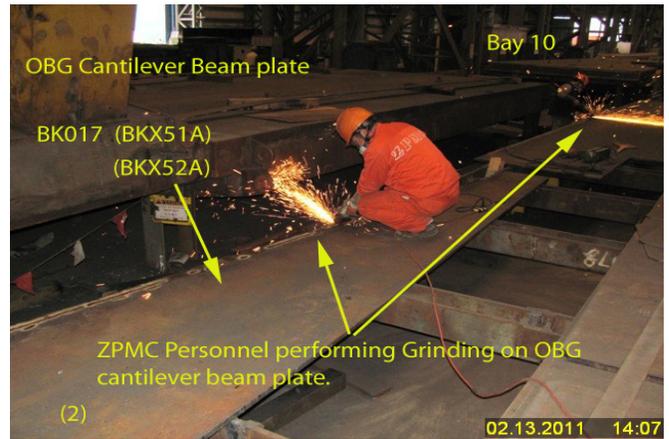
This QA Inspector observed ZPMC personnel identified in Bay 10, Performing Grinding on plate of OBG Cantilever beam plate. The Plate was completed by weld build up. The grinding on OBG cantilever beam Plate, after welding. Plate identified as BK017 (BKX51A). For more information see attached picture number 2.
