Contract #: 04-0120F4Cty: SF/ALA Rte: 80 PM: 13.2/13.9File #: 69.28**WELDING INSPECTION REPORT****Resident Engineer:** Siegenthaler, Peter**Address:** 333 Burma Road**City:** Oakland, CA 94607**Report No:** WIR-021306**Date Inspected:** 02-Mar-2011**Project Name:** SAS Superstructure**OSM Arrival Time:** 1900**Prime Contractor:** American Bridge/Fluor Enterprises, a JV**OSM Departure Time:** 700**Contractor:** Zhenhua Port Machinery Company, Ltd (ZPMC), Changxing Island **Location:** Shanghai, China**CWI Name:** Bao Qian**CWI Present:** Yes No**Inspected CWI report:** Yes No N/A**Rod Oven in Use:** Yes No N/A**Electrode to specification:** Yes No N/A**Weld Procedures Followed:** Yes No N/A**Qualified Welders:** Yes No N/A**Verified Joint Fit-up:** Yes No N/A**Approved Drawings:** Yes No N/A**Approved WPS:** Yes No N/A**Delayed / Cancelled:** Yes No N/A**Bridge No:** 34-0006**Component:** OBG**Summary of Items Observed:**

OBG Bay 14

Segments 13 East and 13 West

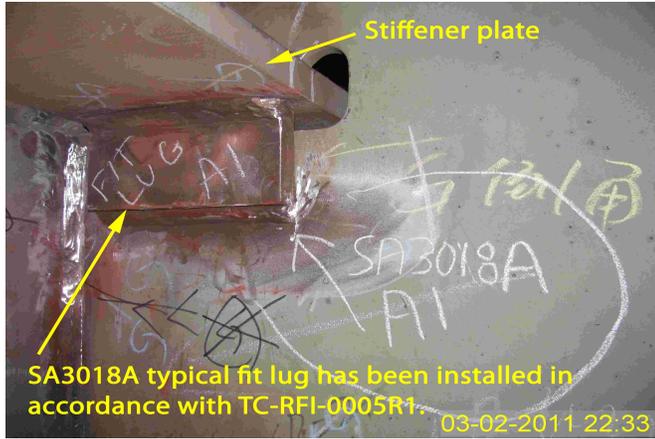
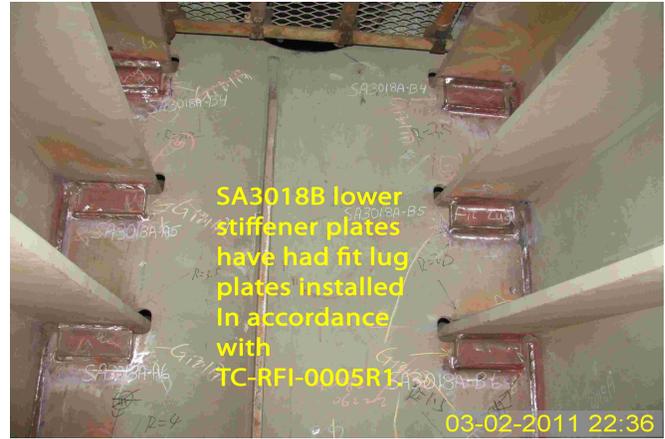
This QA Inspector performed random document review of "Team China request for information (TC-RFI)" document #TC-RFI-0005R1. This RFI addresses OBG 13E and 13W diaphragm fit lugs near panel point 119 on segments 13 East and 13 West. This QA Inspector performed random visual inspections of the welds listed in the RFI and observed ZPMC appears to have completed installation of fit lugs on the East segment assemblies and have not completed welding or installation of fit lugs on the West segment assemblies. The following sub assemblies were included in this inspection: West line: SA3167A, B, SA3177A, B, SA3178A, B, SA3179A, B, SA3180A, B, SA3181A, B, SA3158A, B; East line: SA3014A, B, SA3092A, B, SA3015A, B, SA3016A, B, SA3017A, B, and SA3018A, B. This QA Inspector took random photographs of the welds and copies of the photographs have been placed in "TC-RFI Documentation" folder located on Team China common Z drive along with a summary of the locations where fit lugs have been installed.
