DEPARTMENT OF TRANSPORTATION

Contract #: 04-0120F4Cty: SF/ALA Rte: 80 PM: 13.2/13.9File #: 99.28**WELDING INSPECTION REPORT****Resident Engineer:** Siegenthaler, Peter**Address:** 333 Burma Road**City:** Oakland, CA 94607**Report No:** WIR-021438**Date Inspected:** 04-Mar-2011**Project Name:** SAS Superstructure**OSM Arrival Time:** 700**Prime Contractor:** American Bridge/Fluor Enterprises, a JV**OSM Departure Time:** 1900**Contractor:** Zhenhua Port Machinery Company, Ltd (ZPMC) Chanxing Island**Location:** Shanghai, China

WELDING INSPECTION REPORT

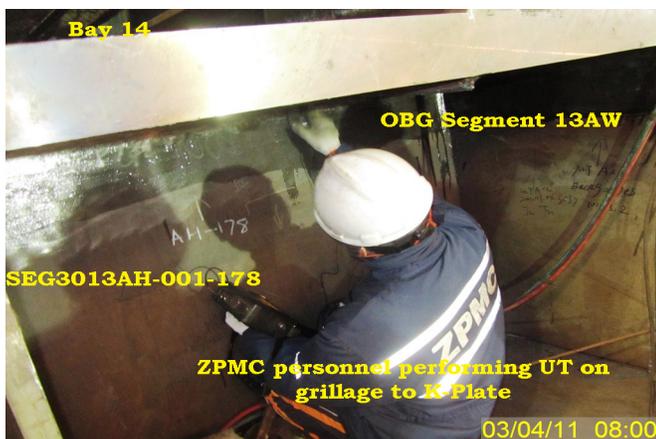
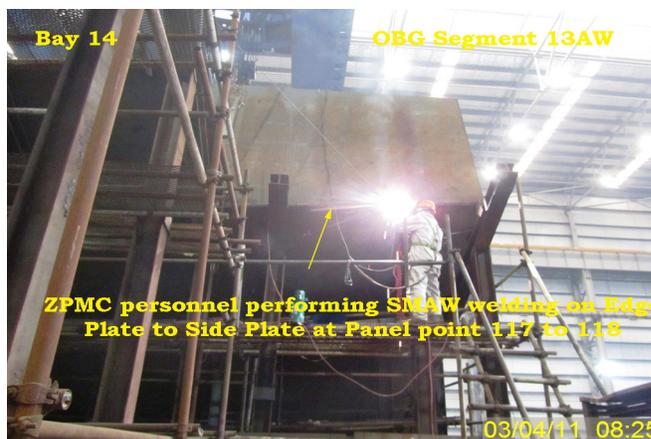
This QA inspector observed ZPMC personnel performed Ultrasonic Testing on Floor Beam to Grillage 'T' joint weld at panel point 119, 119+1500 and PP119-1500 Bike Path Side of OBG Segment 13AW. The weld number is identified as SEG3013AH-178. See the attached pictures.
