**DEPARTMENT OF TRANSPORTATION**

Contract #: 04-0120F4Cty: SF/ALA Rte: 80 PM: 13.2/13.9File #: 69.28**WELDING INSPECTION REPORT****Resident Engineer:** Siegenthaler, Peter**Address:** 333 Burma Road**City:** Oakland, CA 94607**Report No:** WIR-021445**Date Inspected:** 01-Mar-2011**Project Name:** SAS Superstructure**OSM Arrival Time:** 700**Prime Contractor:** American Bridge/Fluor Enterprises, a JV**OSM Departure Time:** 1900**Contractor:** Zhenhua Port Machinery Company, Ltd (ZPMC), Changxing Island **Location:** Shanghai, China**CWI Name:** Lv Li Qing Xi/Geng Wei**CWI Present:** Yes No**Inspected CWI report:** Yes No N/A**Rod Oven in Use:** Yes No N/A**Electrode to specification:** Yes No N/A**Weld Procedures Followed:** Yes No N/A**Qualified Welders:** Yes No N/A**Verified Joint Fit-up:** Yes No N/A**Approved Drawings:** Yes No N/A**Approved WPS:** Yes No N/A**Delayed / Cancelled:** Yes No N/A**Bridge No:** 34-0006**Component:** OBG**Summary of Items Observed:**

## WELDING INSPECTION REPORT

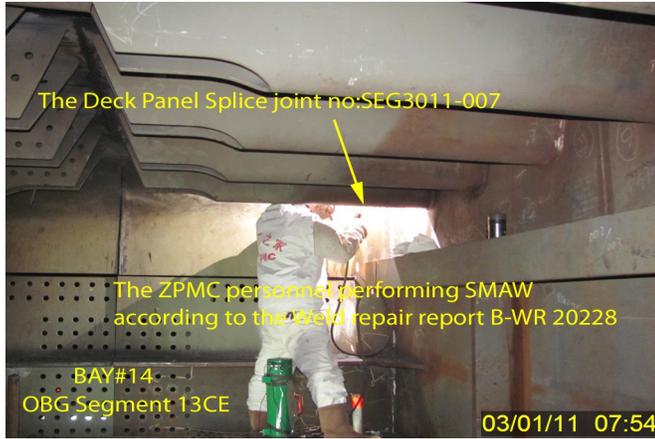
SMAW welding of weld joint no: SEG3011-007 located on OBG Segment 13CE Deck panel splice weld. Welder is identified as #066258. ZPMC QC is identified as Mr. Zhong Yang Hong. Welding was performed according to the weld repair report B-WR20228. The welding variables recorded by QC appeared to comply with the WPS-345-SMAW-4G(4F)-FCM-Repair-1. Please see the attached picture.
