DEPARTMENT OF TRANSPORTATION

Contract #: 04-0120F4Cty: SF/ALA Rte: 80 PM: 13.2/13.9File #: 69.28**WELDING INSPECTION REPORT****Resident Engineer:** Siegenthaler, Peter**Address:** 333 Burma Road**City:** Oakland, CA 94607**Report No:** WIR-021615**Date Inspected:** 05-Mar-2011**Project Name:** SAS Superstructure**OSM Arrival Time:** 700**Prime Contractor:** American Bridge/Fluor Enterprises, a JV**OSM Departure Time:** 1900**Contractor:** Zhenhua Port Machinery Company, Ltd (ZPMC), Changxing Island **Location:** Shanghai, China**CWI Name:** Geng Wei**CWI Present:** Yes No**Inspected CWI report:** Yes No N/A**Rod Oven in Use:** Yes No N/A**Electrode to specification:** Yes No N/A**Weld Procedures Followed:** Yes No N/A**Qualified Welders:** Yes No N/A**Verified Joint Fit-up:** Yes No N/A**Approved Drawings:** Yes No N/A**Approved WPS:** Yes No N/A**Delayed / Cancelled:** Yes No N/A**Bridge No:** 34-0006**Component:** OBG Components**Summary of Items Observed:**

WELDING INSPECTION REPORT

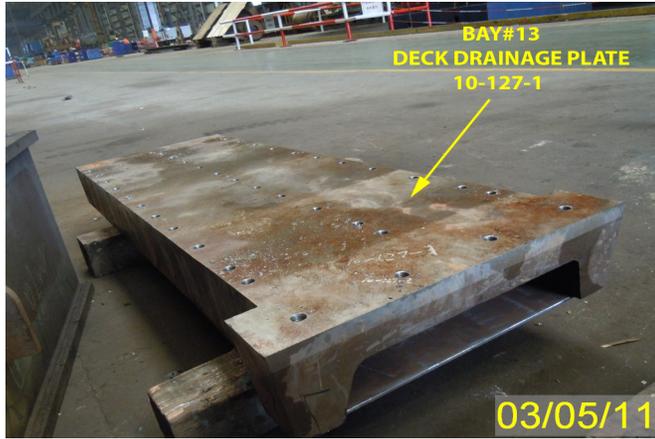
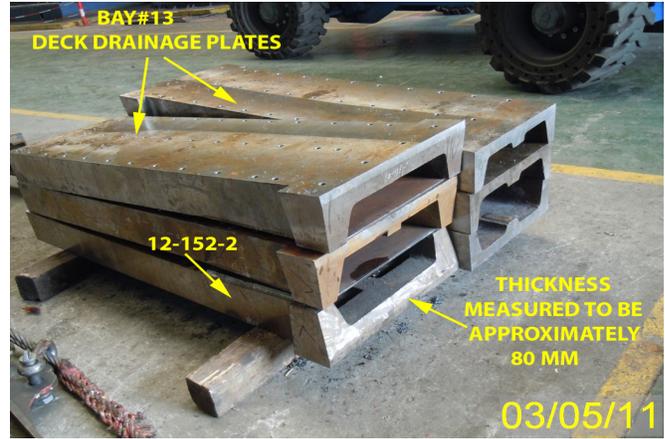
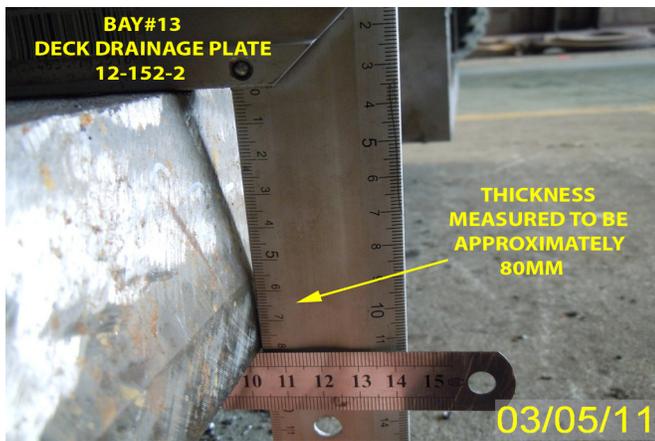
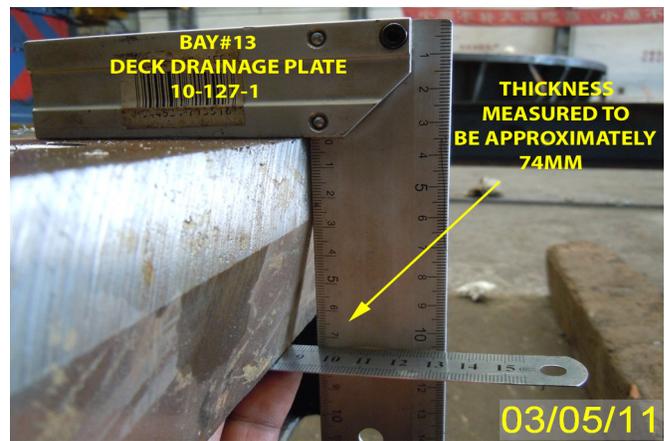
During dimensional inspection verification on deck drainage plates, this Caltrans Quality Assurance (QA) Inspector observed the following issue:

- The material thickness of 18 deck drainage plates did not comply with the approved drawings.
- According to Section B-B on approved shop drawing #DRG-1, the maximum allowed thickness is 50 mm.
- The thicknesses varied from 66mm and 80mm as measured by this QA.
- The following drainage plates are affected by this condition: 10-127-1, 10-125-3, 10-116-2, 10-116-1, 10-97-3, 10-125-4, 10-127-2, 10-93-3, 10-136-4, 12-152-3, 10-93-4, 10-136-1, 12-167-7, 12-152-2 and 10-93-1.

NOTE: 3 of the plates were inaccessible for identification. The numbers given above are stenciled on the bottom surface nearest the thickest end of the material.

- These components are located in Bay-13.
