Contract #: 04-0120F4Cty: SF/ALA Rte: 80 PM: 13.2/13.9File #: 69.28**WELDING INSPECTION REPORT****Resident Engineer:** Siegenthaler, Peter**Address:** 333 Burma Road**City:** Oakland, CA 94607**Report No:** WIR-021669**Date Inspected:** 08-Mar-2011**Project Name:** SAS Superstructure**OSM Arrival Time:** 1900**Prime Contractor:** American Bridge/Fluor Enterprises, a JV**OSM Departure Time:** 700**Contractor:** Zhenhua Port Machinery Company, Ltd (ZPMC), Changxing Island **Location:** Shanghai, China**CWI Name:** See Below**CWI Present:** Yes No**Inspected CWI report:** Yes No N/A**Rod Oven in Use:** Yes No N/A**Electrode to specification:** Yes No N/A**Weld Procedures Followed:** Yes No N/A**Qualified Welders:** Yes No N/A**Verified Joint Fit-up:** Yes No N/A**Approved Drawings:** Yes No N/A**Approved WPS:** Yes No N/A**Delayed / Cancelled:** Yes No N/A**Bridge No:** 34-0006**Component:** OBG**Summary of Items Observed:**

OBG Bay 14

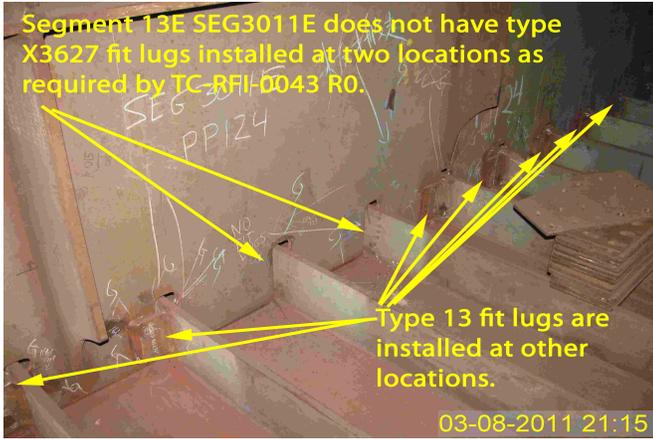
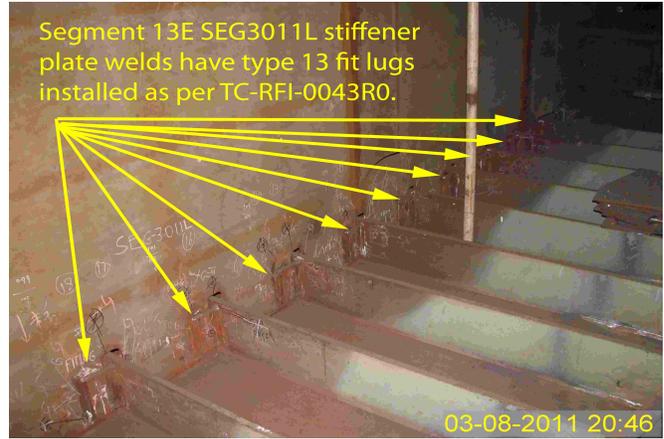
East: type X3627 lugs are not installed at panel points PP123 and PP124, and Type 13 Fit Lugs are installed at the locations noted above.

West: No fit lugs installed at any of the locations noted above.
