DEPARTMENT OF TRANSPORTATION

Contract #: 04-0120F4Cty: SF/ALA Rte: 80 PM: 13.2/13.9File #: 69.28**WELDING INSPECTION REPORT****Resident Engineer:** Siegenthaler, Peter**Address:** 333 Burma Road**City:** Oakland, CA 94607**Report No:** WIR-021780**Date Inspected:** 15-Mar-2011**Project Name:** SAS Superstructure**OSM Arrival Time:** 700**Prime Contractor:** American Bridge/Fluor Enterprises, a JV**OSM Departure Time:** 1900**Contractor:** Zhenhua Port Machinery Company, Ltd (ZPMC), Changxing Island **Location:** Shanghai, China**CWI Name:** Li Yang and Zhu Zhong Hai**CWI Present:** Yes No**Inspected CWI report:** Yes No N/A**Rod Oven in Use:** Yes No N/A**Electrode to specification:** Yes No N/A**Weld Procedures Followed:** Yes No N/A**Qualified Welders:** Yes No N/A**Verified Joint Fit-up:** Yes No N/A**Approved Drawings:** Yes No N/A**Approved WPS:** Yes No N/A**Delayed / Cancelled:** Yes No N/A**Bridge No:** 34-0006**Component:** OBG Trial Assembly**Summary of Items Observed:**

Orthotropic Box Girder (OBG) at Trial Assembly Areas

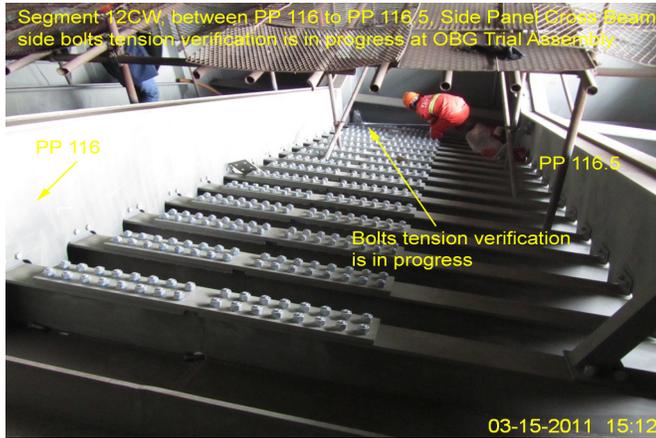
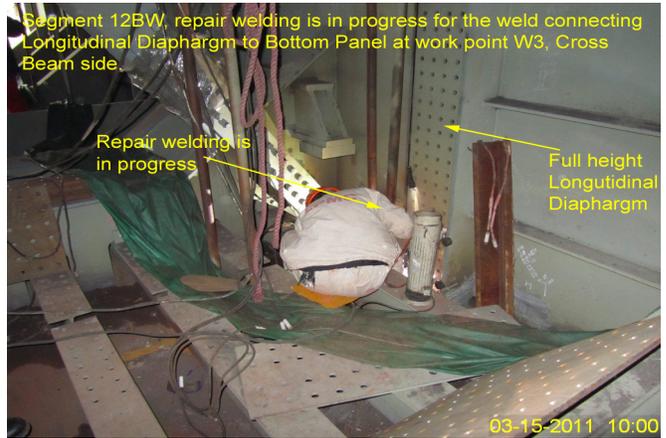
This QA Inspector witnessed final bolt tension verification on bolts connecting T-Rib to T-Rib for Transverse Splice at Side Panel Cross Beam Side (from work point W6 towards W4), Bottom Panel (from work point W4 towards W3) and Counter Weight side (from work point W3 to W1) between Panel Point (PP) 116 to PP 116.5 for Segment 12CW. Inspected the bolt tensioning on a random basis and found the tension to be in general compliance. Inspection was performed against the Notification No. 00626 Dated March 15, 2011.

The bolt sizes used were M22 x 65 RC Lot # DHGM220112 and the final torque value established was 343 N-m.

The bolt sizes used were M22 x 70 RC Lot # DHGM220041 and the final torque value established was 460 N-m.

The bolt sizes used were M22 x 75 RC Lot # DHGM220034 and the final torque value established was 453 N-m.

The bolt sizes used were M22 x 80 RC Lot # DHGM220118 and the final torque value established was 467 N-m.

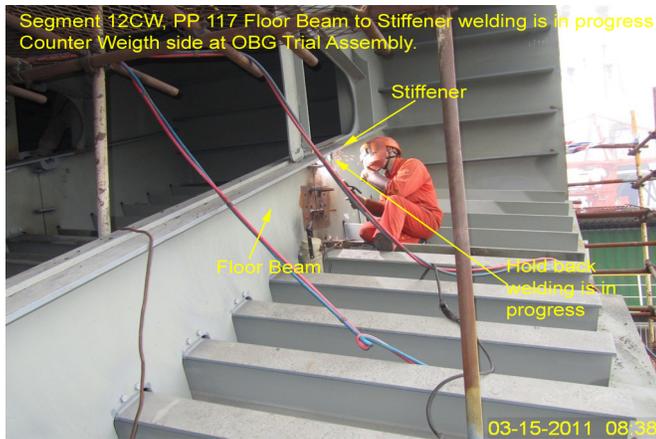
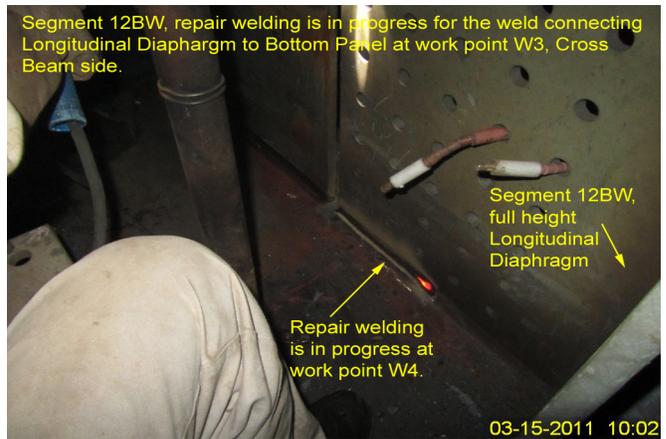
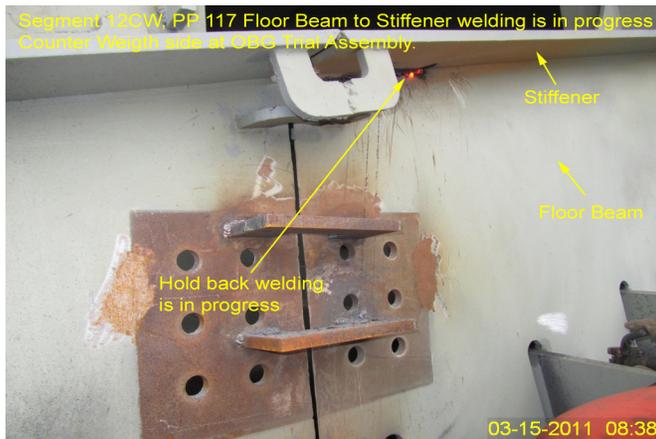
This QA Inspector observed the repair welding by Shielded Metal Arc Welding (SMAW) process on a Complete Joint Penetration (CJP) groove weld. The weld joint was designated as Seg3006S-035. The welder identification was 046709 and was observed welding in the 2G (Horizontal) position using approved Welding Procedure Specification WPS-345-SMAW-2G(2F)-Repair-FCM-1. The piece mark was identified as full height Longitudinal Diaphragm web to Bottom Panel hold back weld at work point W3. ZPMC performed repair welding in accordance with Welding Repair Report BWR-20338.

This QA Inspector observed the repair welding by Shielded Metal Arc Welding (SMAW) process on a Complete Joint Penetration (CJP) groove weld. The weld joint was designated as Seg3006T-035. The welder identification was 046709 and was observed welding in the 2G (Horizontal) position using approved Welding Procedure Specification WPS-345-SMAW-2G(2F)-Repair-FCM-1. The piece mark was identified as full height Longitudinal Diaphragm web to Bottom Panel hold back weld at work point W3. ZPMC performed repair welding in accordance with Welding Repair Report BWR-20338.
