**DEPARTMENT OF TRANSPORTATION**

Contract #: 04-0120F4Cty: SF/ALA Rte: 80 PM: 13.2/13.9File #: 69.28**WELDING INSPECTION REPORT****Resident Engineer:** Siegenthaler, Peter**Address:** 333 Burma Road**City:** Oakland, CA 94607**Report No:** WIR-021821**Date Inspected:** 14-Mar-2011**Project Name:** SAS Superstructure**OSM Arrival Time:** 700**Prime Contractor:** American Bridge/Fluor Enterprises, a JV**OSM Departure Time:** 1900**Contractor:** Zhenhua Port Machinery Company, Ltd (ZPMC), Changxing Island **Location:** Shanghai, China**CWI Name:** An Qing Xiang**CWI Present:** Yes No**Inspected CWI report:** Yes No N/A**Rod Oven in Use:** Yes No N/A**Electrode to specification:** Yes No N/A**Weld Procedures Followed:** Yes No N/A**Qualified Welders:** Yes No N/A**Verified Joint Fit-up:** Yes No N/A**Approved Drawings:** Yes No N/A**Approved WPS:** Yes No N/A**Delayed / Cancelled:** Yes No N/A**Bridge No:** 34-0006**Component:** OBG**Summary of Items Observed:**

**BAY 14, OBG 14W**

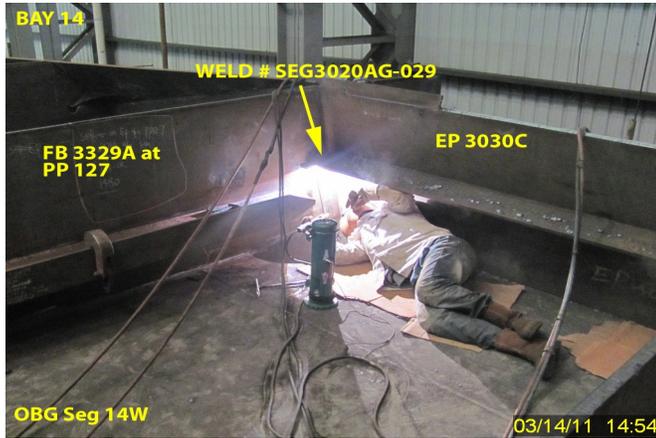
The Shielded Metal Arc Welding (SMAW) process on weld joint no: SEG3020AG-029 (Stiffener on Edge Plate (EP) 3030C to Floor Beam (FB) 3329A, CJP weld at Panel Point PP127). The welder is identified as 067764 and was observed welding in the 4G position. ZPMC QC was identified as Mr. Zhu Lin. The welding variables recorded by QC appeared to comply with WPS: B-P-2214-Tc-U4b-FCM-1. See attached photograph for additional

details.
