DEPARTMENT OF TRANSPORTATION

Quality Assurance and Source Inspection

Contract #: 04-0120F4Cty: SF/ALA Rte: 80 PM: 13.2/13.9File #: 69.28**WELDING INSPECTION REPORT****Resident Engineer:** Siegenthaler, Peter**Address:** 333 Burma Road**City:** Oakland, CA 94607**Report No:** WIR-021858**Date Inspected:** 18-Mar-2011**Project Name:** SAS Superstructure**OSM Arrival Time:** 700**Prime Contractor:** American Bridge/Fluor Enterprises, a JV**OSM Departure Time:** 1900**Contractor:** Zhenhua Port Machinery Company, Ltd (ZPMC), Changxing Island **Location:** Shanghai, China**CWI Name:** Li Yang and Zhu Zhong Hai**CWI Present:** Yes No**Inspected CWI report:** Yes No N/A**Rod Oven in Use:** Yes No N/A**Electrode to specification:** Yes No N/A**Weld Procedures Followed:** Yes No N/A**Qualified Welders:** Yes No N/A**Verified Joint Fit-up:** Yes No N/A**Approved Drawings:** Yes No N/A**Approved WPS:** Yes No N/A**Delayed / Cancelled:** Yes No N/A**Bridge No:** 34-0006**Component:** OBG Trial Assembly**Summary of Items Observed:**

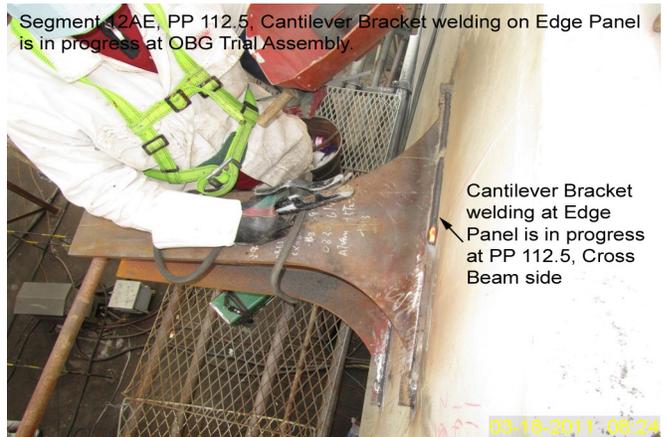
This QA Inspector observed the in-process welding by Shielded Metal Arc Welding (SMAW) process on a Fillet weld. The weld joint was designated as OBE12C-018/019. The welder identification was 044504 and was observed welding in the 3F (Vertical) position using approved Welding Procedure Specification WPS-B-P-2213-FCM-1. The piece mark was identified as Cantilever Brackets welded at Edge Panel at PP 114.5, Cross Beam side.
