DEPARTMENT OF TRANSPORTATION

Contract #: 04-0120F4Cty: SF/ALA Rte: 80 PM: 13.2/13.9File #: 69.28**WELDING INSPECTION REPORT****Resident Engineer:** Siegenthaler, Peter**Address:** 333 Burma Road**City:** Oakland, CA 94607**Report No:** WIR-021867**Date Inspected:** 11-Mar-2011**Project Name:** SAS Superstructure**OSM Arrival Time:** 700**Prime Contractor:** American Bridge/Fluor Enterprises, a JV**OSM Departure Time:** 1900**Contractor:** Zhenhua Port Machinery Company, Ltd (ZPMC), Changxing Island **Location:** Shanghai, China**CWI Name:** Geng Wei**CWI Present:** Yes No**Inspected CWI report:** Yes No N/A**Rod Oven in Use:** Yes No N/A**Electrode to specification:** Yes No N/A**Weld Procedures Followed:** Yes No N/A**Qualified Welders:** Yes No N/A**Verified Joint Fit-up:** Yes No N/A**Approved Drawings:** Yes No N/A**Approved WPS:** Yes No N/A**Delayed / Cancelled:** Yes No N/A**Bridge No:** 34-0006**Component:** OBG Components**Summary of Items Observed:**

BIKE PATH CANTILEVER BEAM

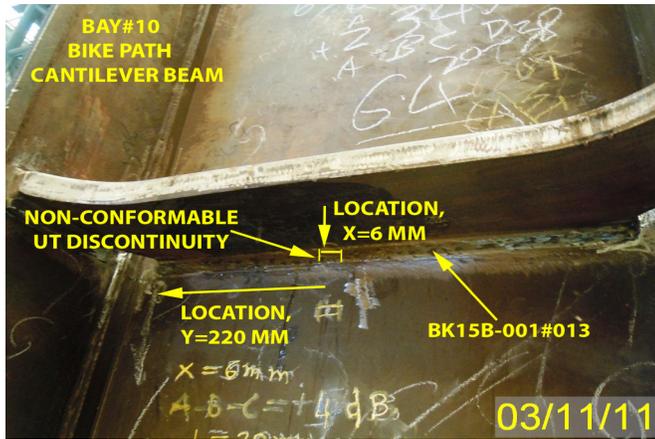
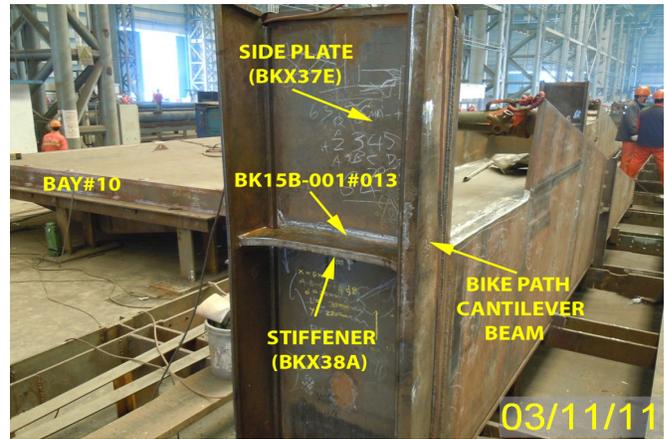
During random 10% verification Ultrasonic Testing (UT) of bike path cantilever beam, this Quality Assurance Inspector (QA) discovered the following issue:

- One (1) Class "A" non conforming longitudinal indication in a weld.
- UT discontinuity rating was +4 db; Class "A" non-conformable indication.
- Depth of the discontinuity from face "B" is approximately 20 mm.
- Length of the discontinuity is approximately 25 mm.
- Y location is approximately 220 mm from left side of the joint.
- Weld is a double groove, complete joint penetration (CJP) T- joint, joining the side plate (BKX37E) to the stiffener (BKX38A).
- The weld is identified as BK15B-001#13.
- Scanning was performed from face "A" and "B" to cover the full volumetric scan of the weld.
- The material thickness is 30 mm.
- This member is identified as Non-Seismic Performance Critical Member (SPCM).
- Component located at fabrication Bay#10.

The Notice of Witness Inspection Number (NWIT) is 08509. The indication is located inside the area that has been previously tested and accepted by ZPMC Quality Control (QC) personnel. ZPMC's QC personnel performed 100% UT inspection of this weld.
