DEPARTMENT OF TRANSPORTATION

Office of Structural Materials

Contract #: 04-0120F4Cty: SF/ALA Rte: 80 PM: 13.2/13.9File #: 69.28**WELDING INSPECTION REPORT****Resident Engineer:** Siegenthaler, Peter**Address:** 333 Burma Road**City:** Oakland, CA 94607**Report No:** WIR-022001**Date Inspected:** 17-Mar-2011**Project Name:** SAS Superstructure**OSM Arrival Time:** 700**Prime Contractor:** American Bridge/Fluor Enterprises, a JV**OSM Departure Time:** 1900**Contractor:** Zhenhua Port Machinery Company, Ltd (ZPMC), Changxing Island **Location:** Shanghai, China**CWI Name:** Mr. An Qing Xian.**CWI Present:** Yes No**Inspected CWI report:** Yes No N/A**Rod Oven in Use:** Yes No N/A**Electrode to specification:** Yes No N/A**Weld Procedures Followed:** Yes No N/A**Qualified Welders:** Yes No N/A**Verified Joint Fit-up:** Yes No N/A**Approved Drawings:** Yes No N/A**Approved WPS:** Yes No N/A**Delayed / Cancelled:** Yes No N/A**Bridge No:** 34-0006**Component:** Orthotropic Box Girder (OBG)**Summary of Items Observed:**

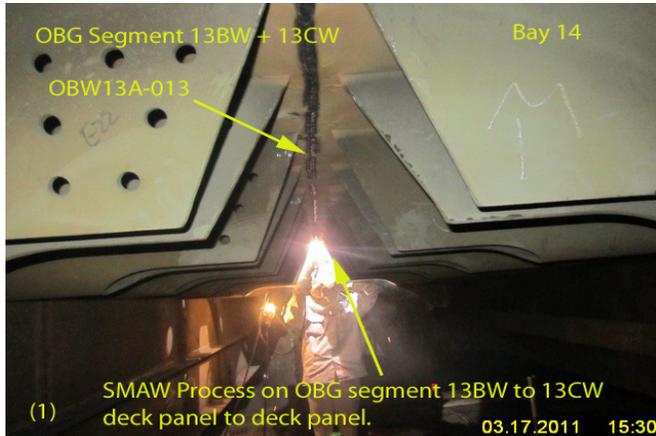
SMAW welding of weld joint OBW13A-013 located on Deck Panel to Deck Panel of OBG Segment 13CW to OBG Segment 13BW. ZPMC Welder is identified as 064461. ZPMC Quality Control (QC) is identified as Mr. Wang Xing Pin. The welding variables recorded by QC appeared to comply with the Applicable WPS-B-P-2214-Tc-U4b-FCM-1. For more information see below attached picture number 1.
