DEPARTMENT OF TRANSPORTATION

Quality Assurance and Source Inspection

Contract #: 04-0120F4Cty: SF/ALA Rte: 80 PM: 13.2/13.9File #: 69.28**WELDING INSPECTION REPORT****Resident Engineer:** Siegenthaler, Peter**Address:** 333 Burma Road**City:** Oakland, CA 94607**Report No:** WIR-022186**Date Inspected:** 30-Mar-2011**Project Name:** SAS Superstructure**OSM Arrival Time:** 700**Prime Contractor:** American Bridge/Fluor Enterprises, a JV**OSM Departure Time:** 1900**Contractor:** Zhenhua Port Machinery Company, Ltd (ZPMC), Changxing Island **Location:** Shanghai, China**CWI Name:** Zhu Zhong Hai**CWI Present:** Yes No**Inspected CWI report:** Yes No N/A**Rod Oven in Use:** Yes No N/A**Electrode to specification:** Yes No N/A**Weld Procedures Followed:** Yes No N/A**Qualified Welders:** Yes No N/A**Verified Joint Fit-up:** Yes No N/A**Approved Drawings:** Yes No N/A**Approved WPS:** Yes No N/A**Delayed / Cancelled:** Yes No N/A**Bridge No:** 34-0006**Component:** OBG Segments**Summary of Items Observed:**

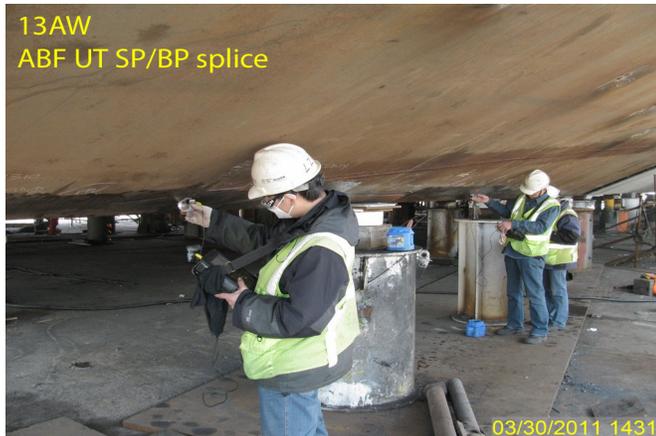
This QA Inspector observed ABF personnel performing Ultrasonic Testing on the Side Plate to Bottom Plate longitudinal splice, counter weight side.

13AW
ABF UT SP/BP splice

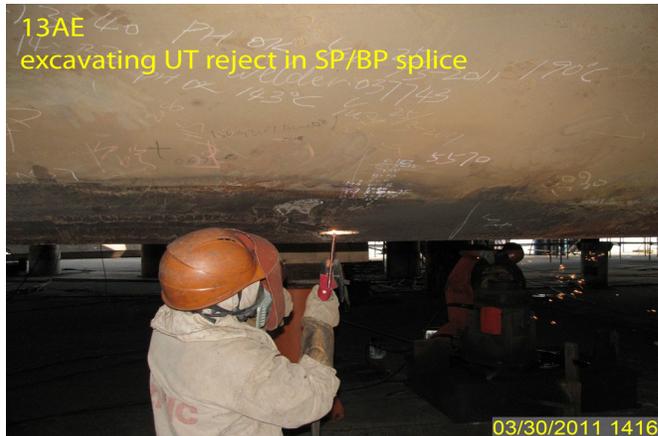
This QA Inspector observed excavating UT rejects by arc gouge in the Side Plate to Bottom Plate longitudinal splice, cross beam side.

13AE
excavating UT reject in SP/BP splice

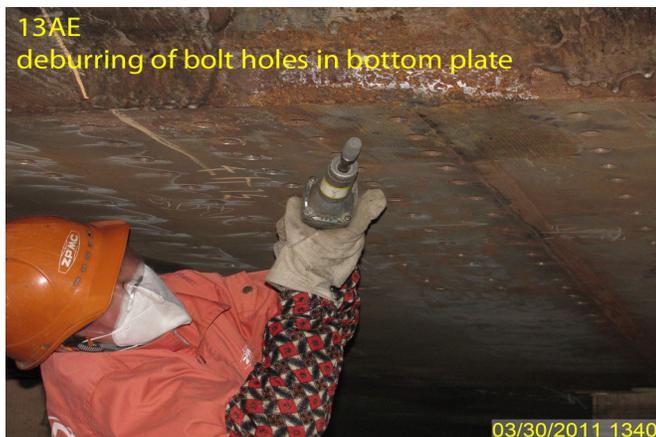
This QA Inspector observed deburring of bolt holes in Bottom Plate.

13AE
deburring of bolt holes in bottom plate
