**DEPARTMENT OF TRANSPORTATION**

Contract #: 04-0120F4Cty: SF/ALA Rte: 80 PM: 13.2/13.9File #: 99.28**WELDING INSPECTION REPORT****Resident Engineer:** Siegenthaler, Peter**Address:** 333 Burma Road**City:** Oakland, CA 94607**Report No:** WIR-022553**Date Inspected:** 05-Apr-2011**Project Name:** SAS Superstructure**OSM Arrival Time:** 700**Prime Contractor:** American Bridge/Fluor Enterprises, a JV**OSM Departure Time:** 1900**Contractor:** Zhenhua Port Machinery Company, Ltd (ZPMC) Chanxing Island**Location:** Shanghai, China

**Bridge No:** 34-0006**Component:** OBG Segment**Summary of Items Observed:**

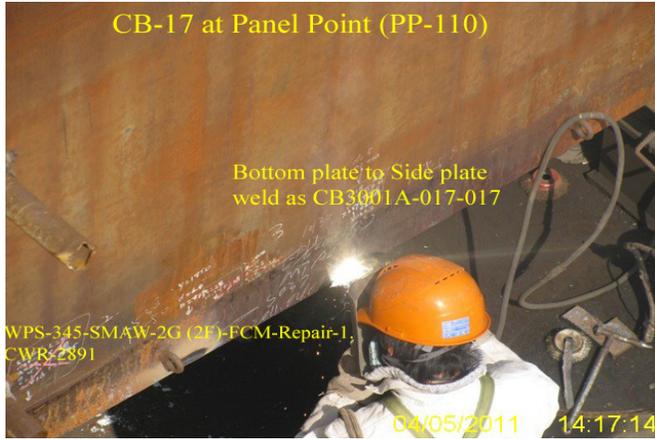
ZPMC welding personnel performing Shielded Metal Arc Welding of Repair weld for the bottom plate to side plate weld joint located on CB-17 at Panel Point (PP-110). The weld is designated as CB3001A-017-017. The welder is identified as 066459. ZPMC QC Mr. LI YANG was onsite monitoring the welding variables. The inprocess Shielded Metal Arc Welding appears to be progressing in compliance with WPS-345-SMAW-2G (2F)-FCM-Repair-1. The weld repair report number is named as CWR-2891. Further weld detail mention in attached picture.

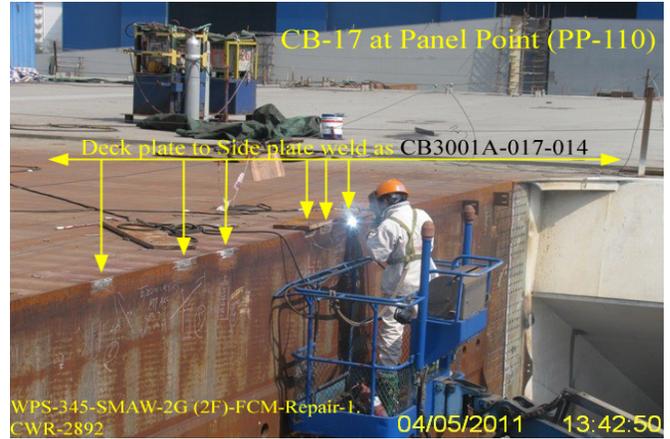
ZPMC welding personnel performing Shielded Metal Arc Welding of Repair weld for the deck plate to side plate weld joint located on CB-17 at Panel Point (PP-110). The weld is designated as CB3001A-017-014. The welder is identified as 066459. ZPMC QC Mr. LI YANG was onsite monitoring the welding variables. The inprocess Shielded Metal Arc Welding appears to be progressing in compliance with WPS-345-SMAW-2G (2F)-FCM-Repair-1. The weld repair report number is named as CWR-2892. Further weld detail mention in attached picture.
