**DEPARTMENT OF TRANSPORTATION**

Contract #: 04-0120F4Cty: SF/ALA Rte: 80 PM: 13.2/13.9File #: 69.28**WELDING INSPECTION REPORT****Resident Engineer:** Siegenthaler, Peter**Address:** 333 Burma Road**City:** Oakland, CA 94607**Report No:** WIR-022661**Date Inspected:** 17-Apr-2011**Project Name:** SAS Superstructure**OSM Arrival Time:** 700**Prime Contractor:** American Bridge/Fluor Enterprises, a JV**OSM Departure Time:** 1900**Contractor:** Zhenhua Port Machinery Company, Ltd (ZPMC), Changxing Island **Location:** Shanghai, China**CWI Name:** An Qing Xiang**CWI Present:** Yes No**Inspected CWI report:** Yes No N/A**Rod Oven in Use:** Yes No N/A**Electrode to specification:** Yes No N/A**Weld Procedures Followed:** Yes No N/A**Qualified Welders:** Yes No N/A**Verified Joint Fit-up:** Yes No N/A**Approved Drawings:** Yes No N/A**Approved WPS:** Yes No N/A**Delayed / Cancelled:** Yes No N/A**Bridge No:** 34-0006**Component:** OBG**Summary of Items Observed:**

## WELDING INSPECTION REPORT

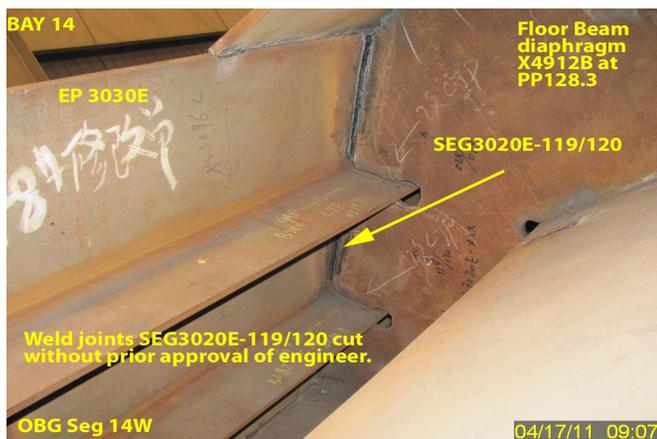
During random in process visual inspection this QA Inspector observed the weld joints SEG3020E-119, 120 [joining Edge Panel (EP) 3030E to FB diaphragm X4912B] were cut at panel point PP128.3 without prior approval of engineer. This issue has been discussed with ZPMC CWI Mr. An Qing Xiang and CT Lead QA Inspector. ZPMC CWI Mr. An Qing Xiang informed this QA Inspector that ZPMC will prepare Welding Repair Report (WRR) for these weld joints. Attached photograph provide additional details.
