**DEPARTMENT OF TRANSPORTATION**

Contract #: 04-0120F4Cty: SF/ALA Rte: 80 PM: 13.2/13.9File #: 69.28**WELDING INSPECTION REPORT****Resident Engineer:** Siegenthaler, Peter**Address:** 333 Burma Road**City:** Oakland, CA 94607**Report No:** WIR-023254**Date Inspected:** 28-Apr-2011**Project Name:** SAS Superstructure**OSM Arrival Time:** 700**Prime Contractor:** American Bridge/Fluor Enterprises, a JV**OSM Departure Time:** 1900**Contractor:** Zhenhua Port Machinery Company, Ltd (ZPMC), Changxing Island **Location:** Shanghai, China**CWI Name:** Liu Hua Jie.**CWI Present:** Yes No**Inspected CWI report:** Yes No N/A**Rod Oven in Use:** Yes No N/A**Electrode to specification:** Yes No N/A**Weld Procedures Followed:** Yes No N/A**Qualified Welders:** Yes No N/A**Verified Joint Fit-up:** Yes No N/A**Approved Drawings:** Yes No N/A**Approved WPS:** Yes No N/A**Delayed / Cancelled:** Yes No N/A**Bridge No:** 34-0006**Component:** OBG components.**Summary of Items Observed:**

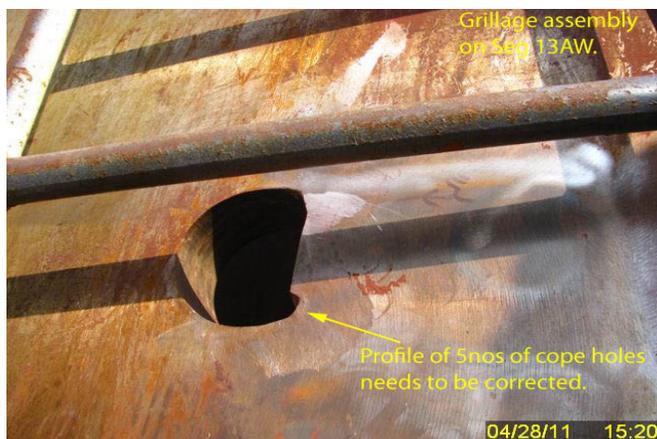
This QA Inspector observed that the profile of 5 cope holes on these Grillage weld locations require corrective action. This QA Inspector informed ZPMC CWI, Mr. An Qing Xiang regarding this issue. The CT SMR Engineer was also informed of this non-conforming issue. See attached photo for details.
