DEPARTMENT OF TRANSPORTATION

Contract #: 04-0120F4Cty: SF/ALA Rte: 80 PM: 13.2/13.9File #: 69.28**WELDING INSPECTION REPORT****Resident Engineer:** Siegenthaler, Peter**Address:** 333 Burma Road**City:** Oakland, CA 94607**Report No:** WIR-024974**Date Inspected:** 28-Apr-2011**Project Name:** SAS Superstructure**OSM Arrival Time:** 700**Prime Contractor:** American Bridge/Fluor Enterprises, a JV**OSM Departure Time:** 1900**Contractor:** Zhenhua Port Machinery Company, Ltd (ZPMC), Changxing Island **Location:** Shanghai, China**CWI Name:** Xu Le Feng**CWI Present:** Yes No**Inspected CWI report:** Yes No N/A**Rod Oven in Use:** Yes No N/A**Electrode to specification:** Yes No N/A**Weld Procedures Followed:** Yes No N/A**Qualified Welders:** Yes No N/A**Verified Joint Fit-up:** Yes No N/A**Approved Drawings:** Yes No N/A**Approved WPS:** Yes No N/A**Delayed / Cancelled:** Yes No N/A**Bridge No:** 34-0006**Component:** OBG & TOWER Components**Summary of Items Observed:**

POST BLAST INSPECTION INTERNAL AND EXTERNAL OF TOWER HEAD, SOUTH SHAFT LIFT-6

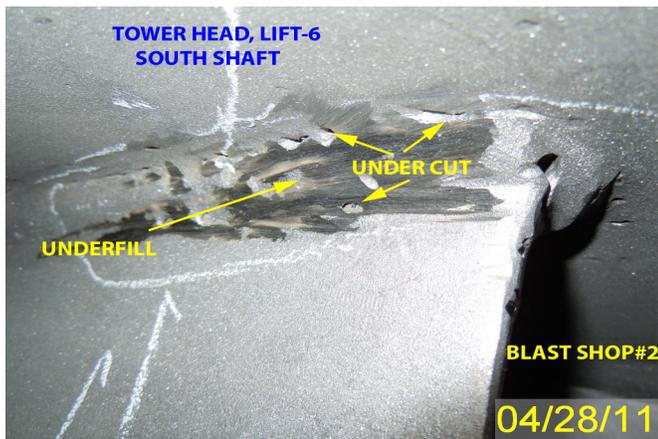
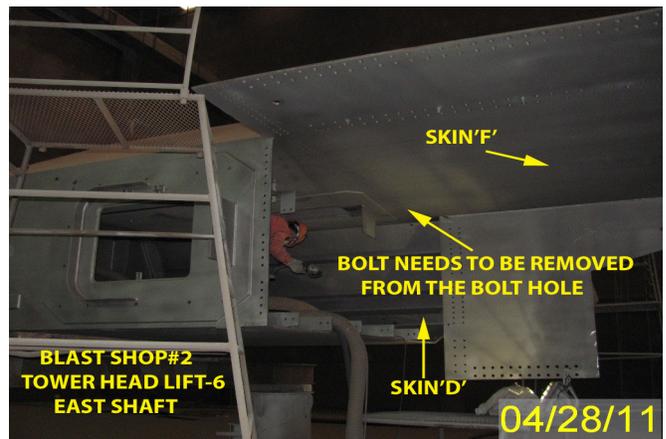
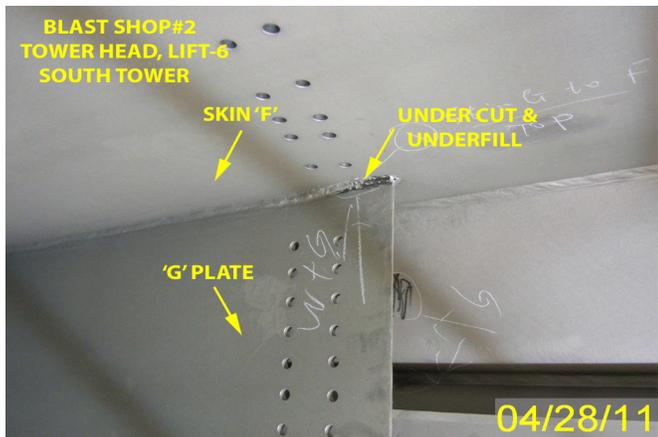
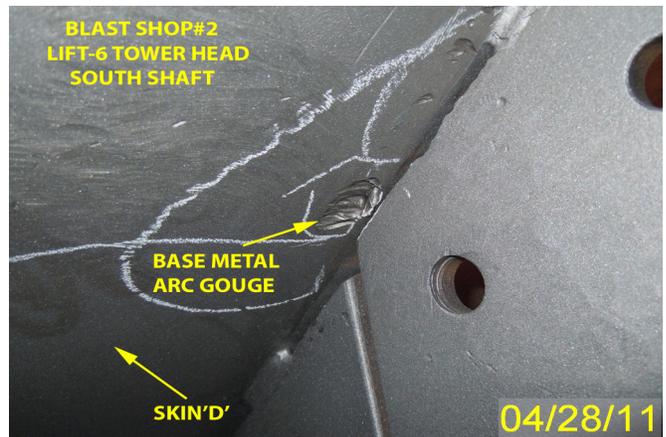
During the External & Internal post-blast visual inspection on South tower Lift-6, this Quality Assurance Inspector's (QA) discovered the defects required welding and Magnetic particle testing on weld and base material at the following locations:

- 1) Internal: Skin 'F' to 'G' weld– Undercut and Underfill – 100 mm from top of the weld.
- 2) Internal: Channel to top plate weld– Porosity – 130 mm from skin 'F'.
- 3) Internal: Base material arc gouge on skin 'D' – close to the weld of 2nd stiffener and approximately 1500 mm

from skin 'E'.

4) Internal: Skin 'A' stiffener to skin weld - Under fill – between 2nd longitudinal and 2nd transverse stiffeners from skin 'E', 1350 mm from bottom of the skin 'A'.

During the External & Internal post-blast visual inspection on East tower Lift-6, this Quality Assurance Inspector's (QA) discovered the defects required welding and Magnetic particle testing on weld and base material at the following locations:

1) Internal: Skin 'F' – Bolt needs to be removed from bolt hole – third (3rd) hole from skin 'D'.
