Contract #: 04-0120F4Cty: SF/ALA Rte: 80 PM: 13.2/13.9File #: 69.28**WELDING INSPECTION REPORT****Resident Engineer:** Siegenthaler, Peter**Address:** 333 Burma Road**City:** Oakland, CA 94607**Report No:** WIR-023361**Date Inspected:** 08-May-2011**Project Name:** SAS Superstructure**OSM Arrival Time:** 700**Prime Contractor:** American Bridge/Fluor Enterprises, a JV**OSM Departure Time:** 1900**Contractor:** Zhenhua Port Machinery Company, Ltd (ZPMC), Changxing Island **Location:** Shanghai, China

Orthotropic Box Girder (OBG) at Trial Assembly Areas

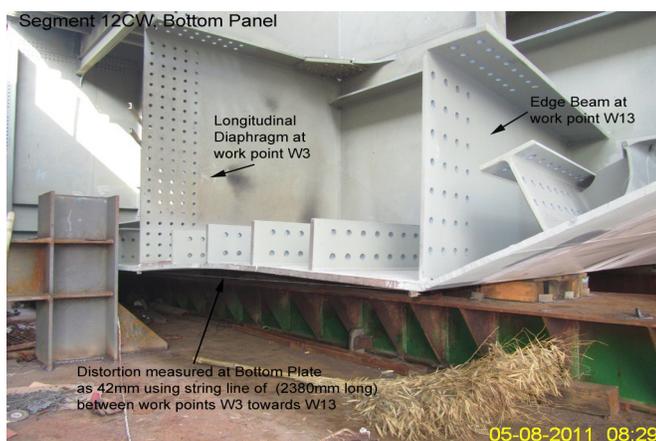
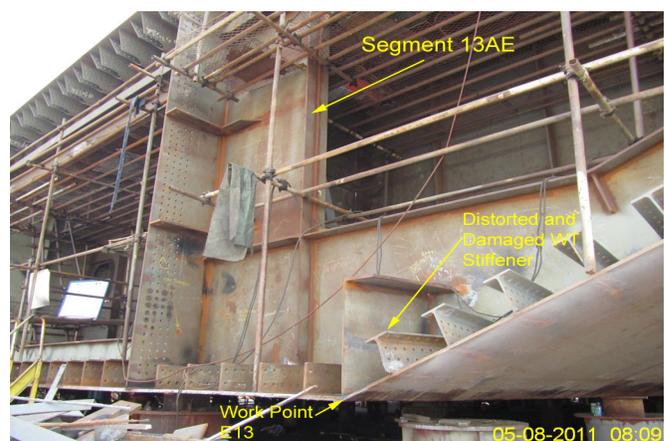
Incident Report generated at Segment 13AE (WT Stiffener)

This Quality Assurance (QA) Inspector wrote an Incident Report for Impact Damaged and Distorted, WT Stiffener at Side Panel, 1st from the Edge Beam E13 for Segment 13AE and PP 117.5.

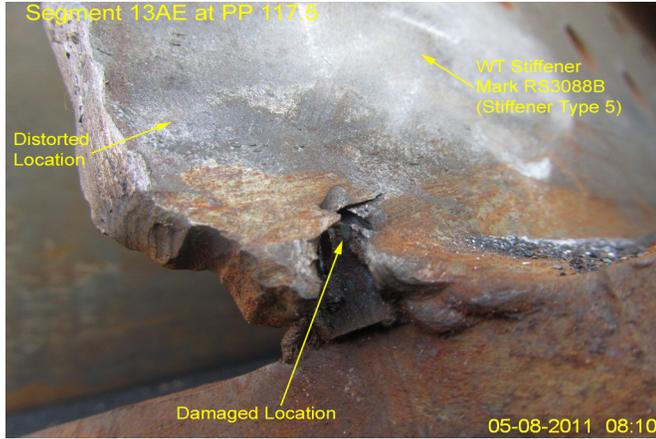
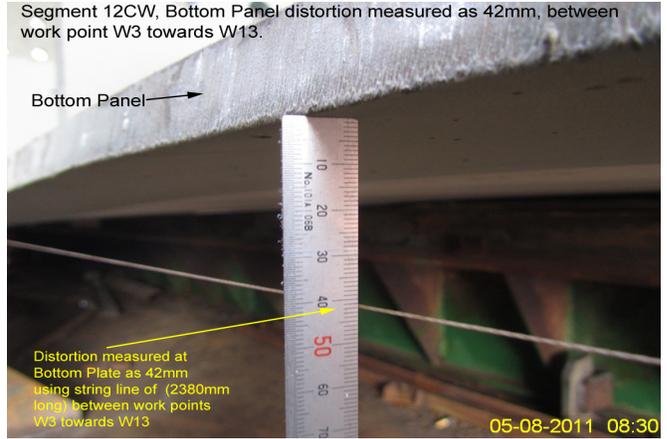
Incident Report generated at Segment 12CW (Bottom Panel Distorted)

This Quality Assurance (QA) Inspector validated the Incident Report by taking the pictures of distorted Bottom Panel, when the Segment 12CW was sitting flat on the saddle, on ZPMC Ship Zhenhua # 18, Forwarded the

After reviewing the pictures Non Conformance Report # ZPMC 0962 was generated and issued to ABF and ZPMC.
