**DEPARTMENT OF TRANSPORTATION**

Contract #: 04-0120F4Cty: SF/ALA Rte: 80 PM: 13.2/13.9File #: 69.28**WELDING INSPECTION REPORT****Resident Engineer:** Siegenthaler, Peter**Address:** 333 Burma Road**City:** Oakland, CA 94607**Report No:** WIR-023715**Date Inspected:** 15-May-2011**Project Name:** SAS Superstructure**OSM Arrival Time:** 700**Prime Contractor:** American Bridge/Fluor Enterprises, a JV**OSM Departure Time:** 1900**Contractor:** Zhenhua Port Machinery Company, Ltd (ZPMC), Changxing Island **Location:** Shanghai, China**CWI Name:** An Qing Xiang**CWI Present:** Yes No**Inspected CWI report:** Yes No N/A**Rod Oven in Use:** Yes No N/A**Electrode to specification:** Yes No N/A**Weld Procedures Followed:** Yes No N/A**Qualified Welders:** Yes No N/A**Verified Joint Fit-up:** Yes No N/A**Approved Drawings:** Yes No N/A**Approved WPS:** Yes No N/A**Delayed / Cancelled:** Yes No N/A**Bridge No:** 34-0006**Component:** OBG**Summary of Items Observed:**

OBG Seg 14W:

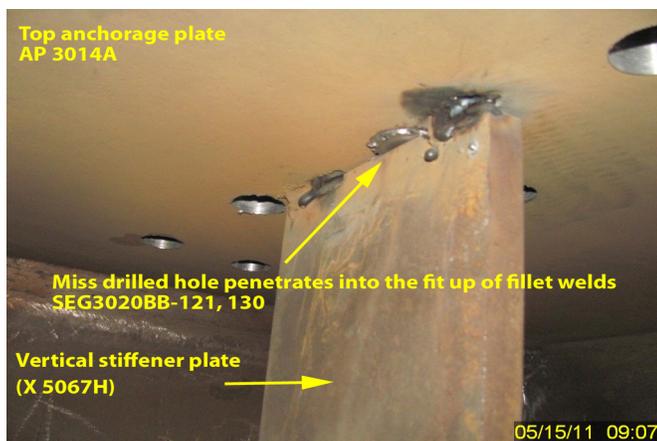
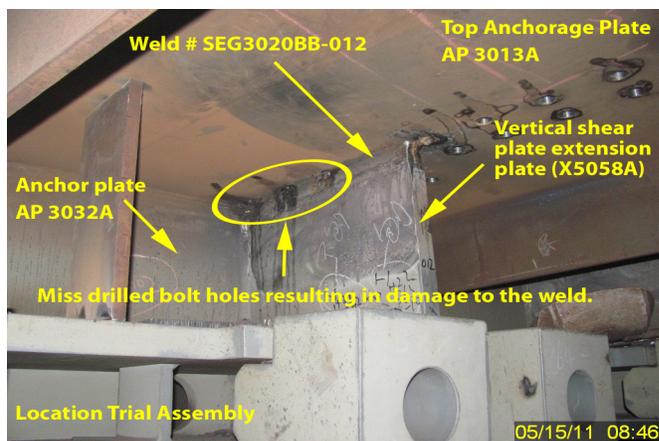
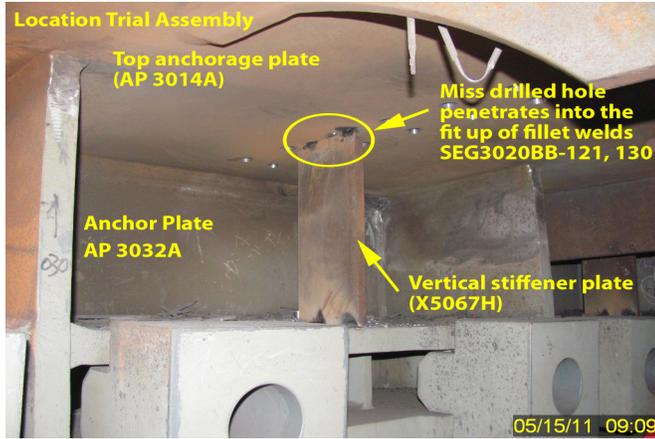
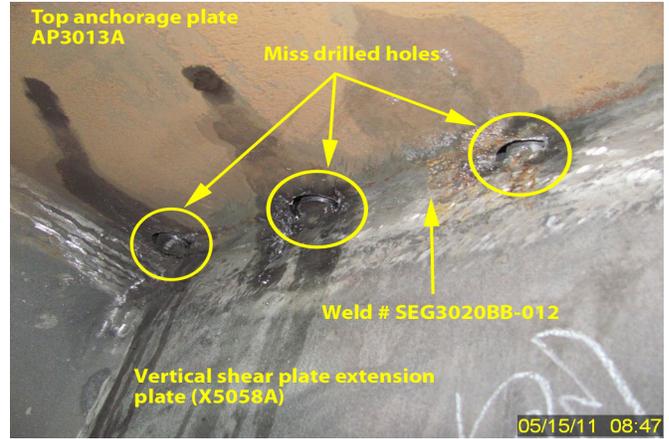
- ZPMC personnel have misdrilled a total of Four (4) 30mm diameter bolt holes resulting in damage to the weld below.
- The holes were match drilled in the Top Anchorage Plate (AP3013A), and due to the incorrect layout penetrate into the Vertical shear plate extension plate (X5058A) to the Top Anchorage Plate (AP3013A) CJP (completed joint penetration) T-joint weld at three (3) locations at panel point 126.

- A hole was match drilled in the Top Anchorage Plate (AP3014A), and due to the incorrect layout penetrates into the fit up and tack welded location of fillet welds (SEG3020BB-121 and 130) of Vertical stiffener plate (X5067H) to the Top Anchorage Plate (AP3014A) at one location at panel point 126.

- The members are identified as Seismic Performance Critical Member (SPCM).
- The damaged CJP weld is identified as SEG3020BB-012.
- The damaged welds are designated as Fracture Critical Welds (FCW).
