**DEPARTMENT OF TRANSPORTATION**

Contract #: 04-0120F4Cty: SF/ALA Rte: 80 PM: 13.2/13.9File #: 69.28**WELDING INSPECTION REPORT****Resident Engineer:** Siegenthaler, Peter**Address:** 333 Burma Road**City:** Oakland, CA 94607**Report No:** WIR-023720**Date Inspected:** 17-May-2011**Project Name:** SAS Superstructure**OSM Arrival Time:** 700**Prime Contractor:** American Bridge/Fluor Enterprises, a JV**OSM Departure Time:** 1900**Contractor:** Zhenhua Port Machinery Company, Ltd (ZPMC), Changxing Island **Location:** Shanghai, China**CWI Name:** Liu Hua Jie.**CWI Present:** Yes No**Inspected CWI report:** Yes No N/A**Rod Oven in Use:** Yes No N/A**Electrode to specification:** Yes No N/A**Weld Procedures Followed:** Yes No N/A**Qualified Welders:** Yes No N/A**Verified Joint Fit-up:** Yes No N/A**Approved Drawings:** Yes No N/A**Approved WPS:** Yes No N/A**Delayed / Cancelled:** Yes No N/A**Bridge No:** 34-0006**Component:** OBG components.**Summary of Items Observed:**

OBG Seg 13AW:

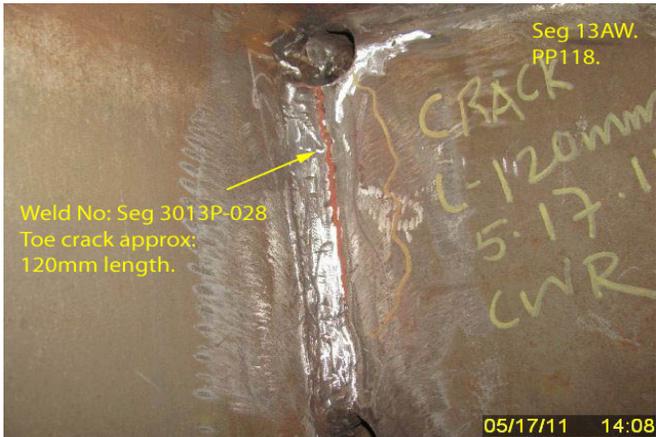
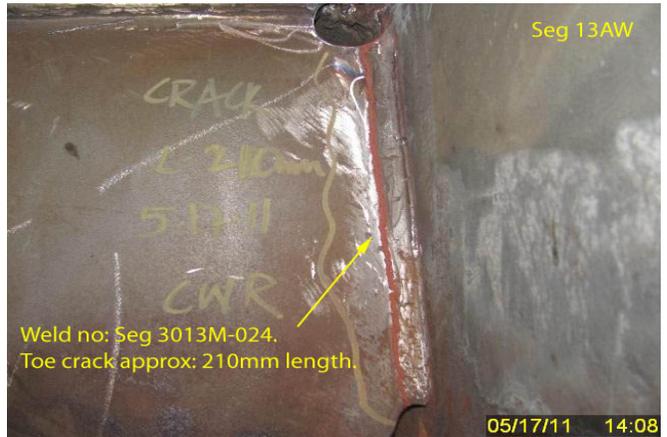
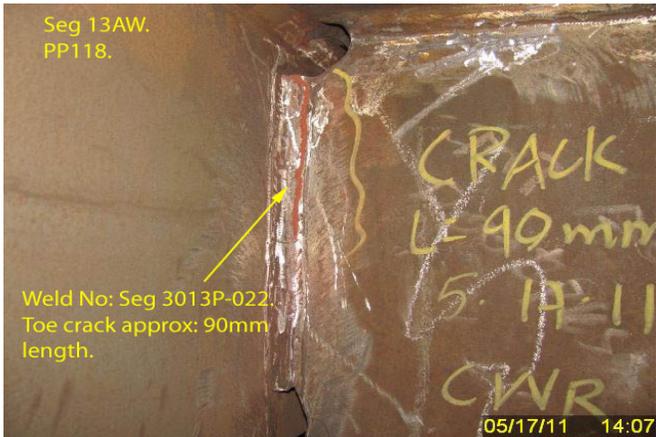
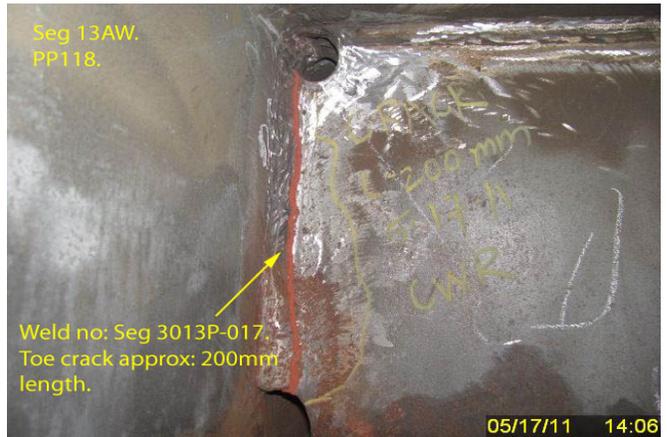
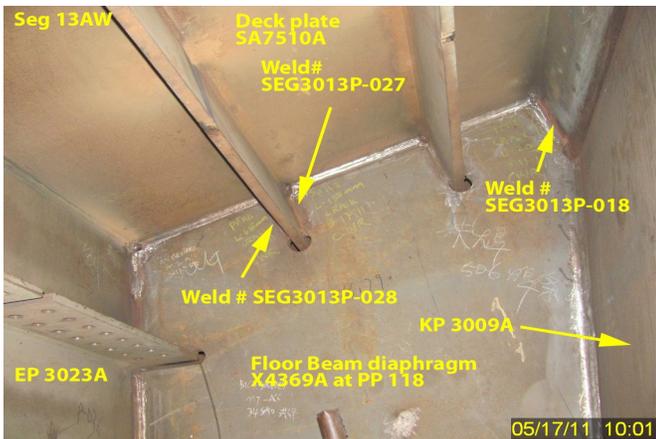
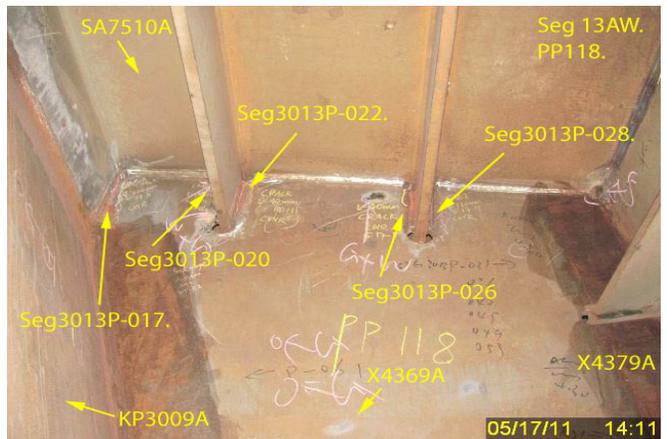
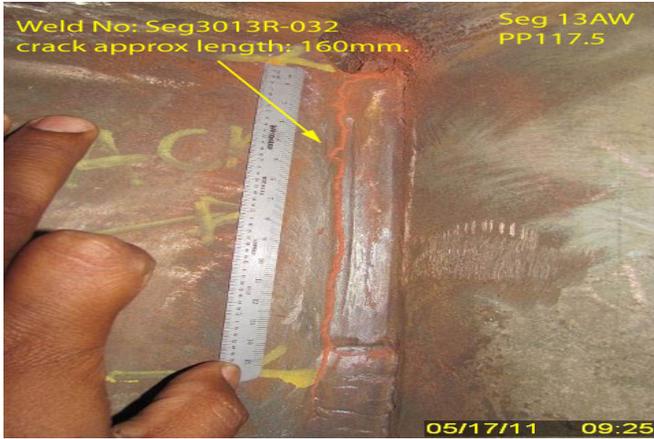
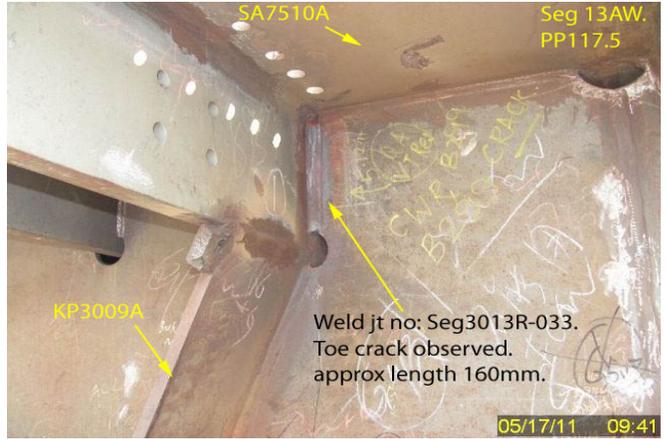
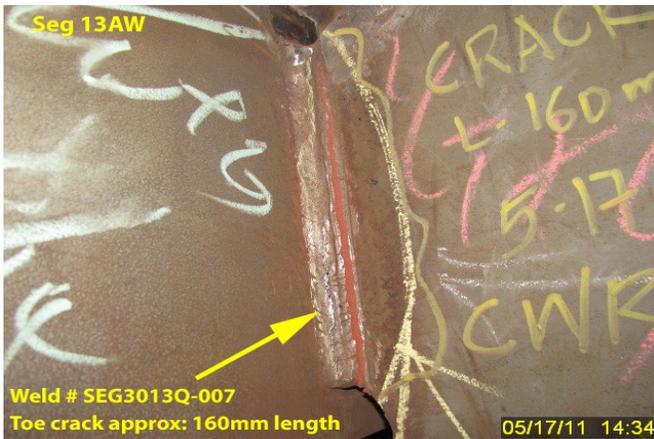
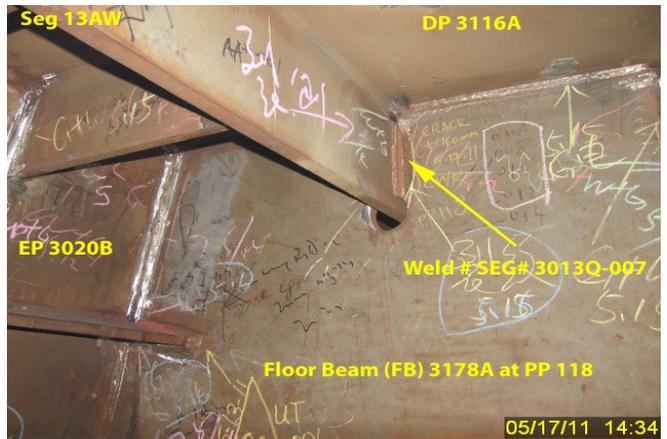
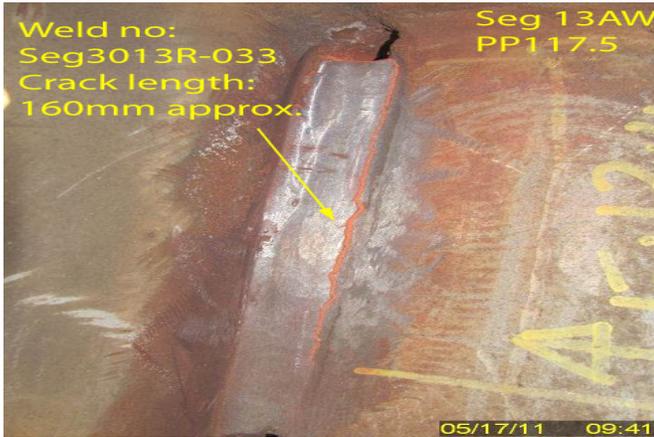
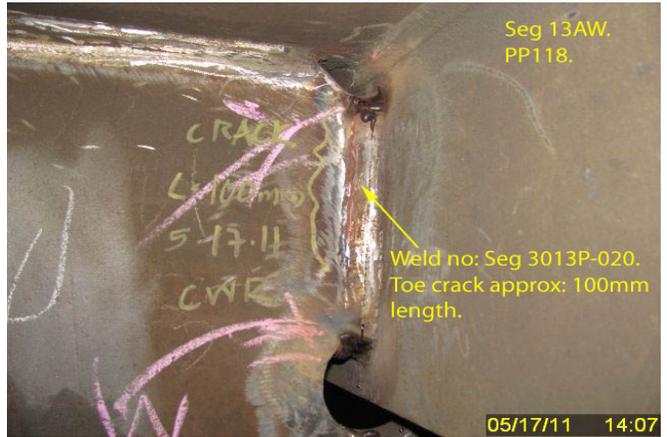
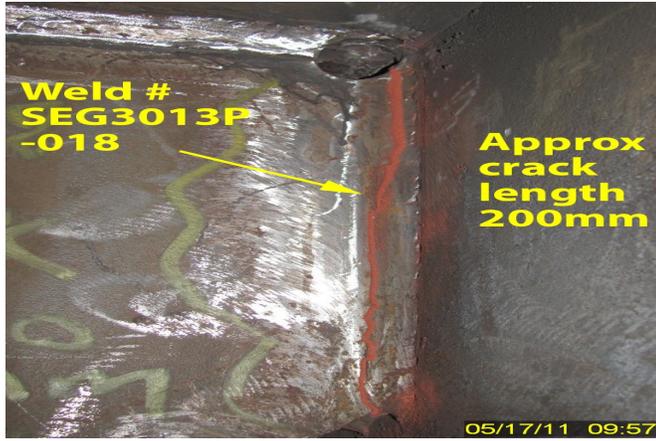
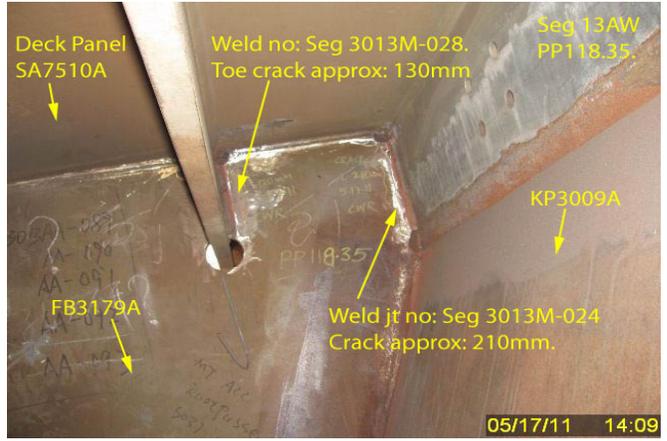
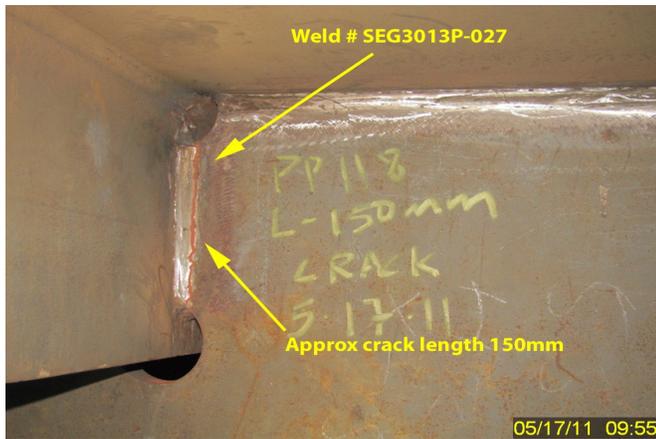
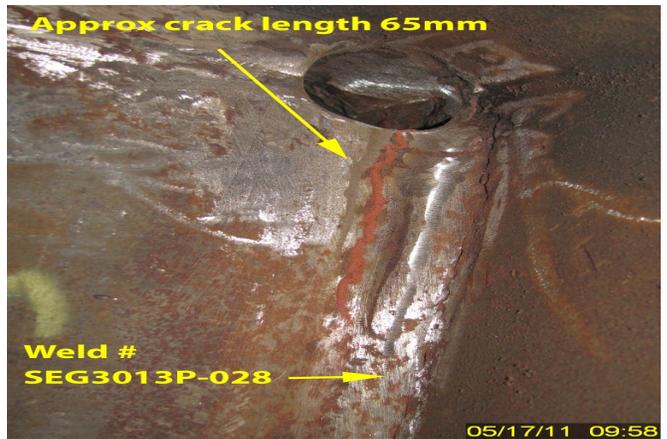
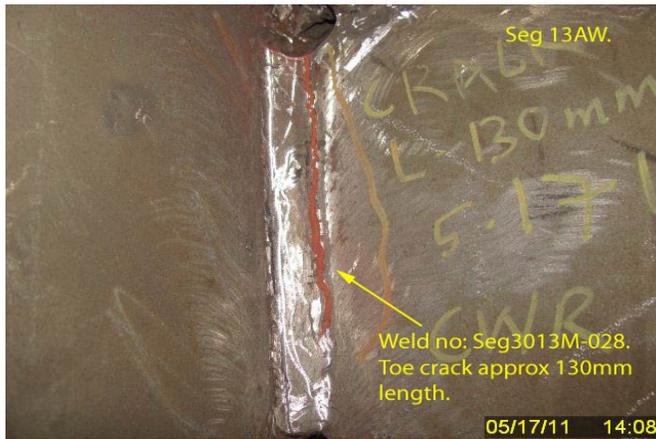
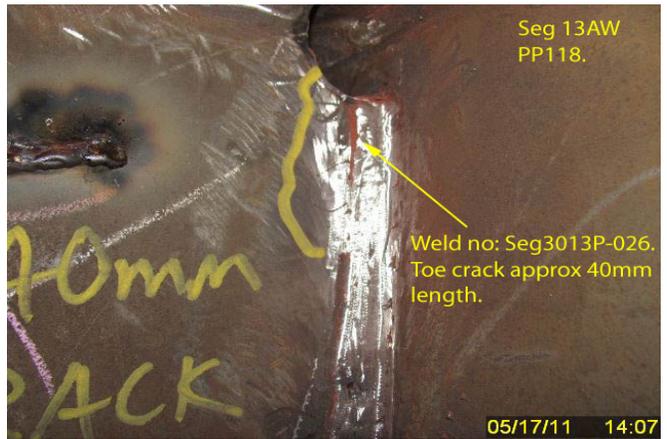
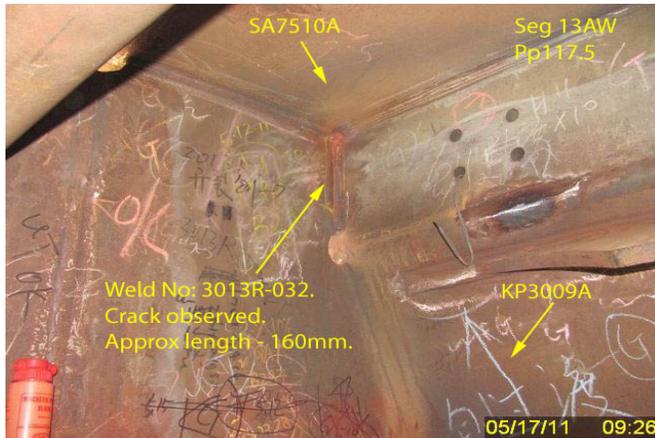
This QA Inspector, along with Mr. Umesh Gaikwad; performed inprocess Visual Inspection of welds (of Seg 13AW) at Panel Points (PP) 117.5, PP118 and PP118.35. Visual Inspection was done for the welds between Longitudinal Diaphragm (LD) 3034A to Edge Panel (EP) 3023A (for the welds at the inside of the segment). Besides various locations on the EP to FB welds, where the cope holes needs to be profiled corrected, following welds were observed to have toe cracks. Details are as mentioned below.

- 1) Seg3013R-032 and 033 (fillet welds at PP117.5 – identified earlier on Dt: 05/12/11).
- 2) Seg3013P-018 and 027 (fillet welds at PP118).
- 3) Seg3013P- 028, 017, 020, 022, 026, 028 (PP118).
- 4) Seg 3013M-024, 028 (PP118.35).

5) Seg 3013Q-007 (PP118).

See attached photo for details.
