DEPARTMENT OF TRANSPORTATION

Contract #: 04-0120F4Cty: SF/ALA Rte: 80 PM: 13.2/13.9File #: 69.28**WELDING INSPECTION REPORT****Resident Engineer:** Siegenthaler, Peter**Address:** 333 Burma Road**City:** Oakland, CA 94607**Report No:** WIR-023853**Date Inspected:** 17-May-2011**Project Name:** SAS Superstructure**OSM Arrival Time:** 700**Prime Contractor:** American Bridge/Fluor Enterprises, a JV**OSM Departure Time:** 1900**Contractor:** Zhenhua Port Machinery Company, Ltd (ZPMC), Changxing Island **Location:** Shanghai, China**CWI Name:** An Qing Xiang**CWI Present:** Yes No**Inspected CWI report:** Yes No N/A**Rod Oven in Use:** Yes No N/A**Electrode to specification:** Yes No N/A**Weld Procedures Followed:** Yes No N/A**Qualified Welders:** Yes No N/A**Verified Joint Fit-up:** Yes No N/A**Approved Drawings:** Yes No N/A**Approved WPS:** Yes No N/A**Delayed / Cancelled:** Yes No N/A**Bridge No:** 34-0006**Component:** OBG**Summary of Items Observed:**

OBG Seg 13AW:

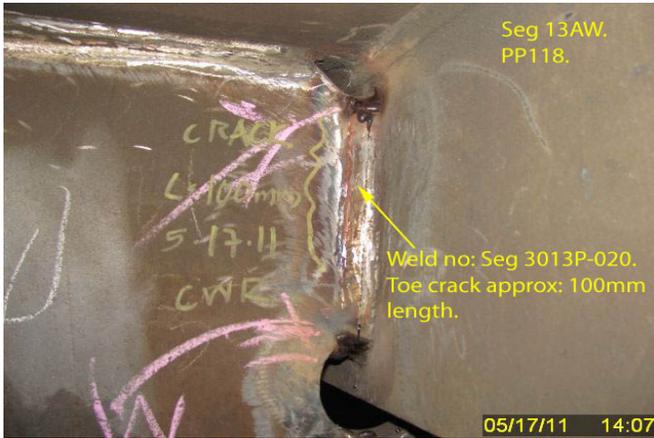
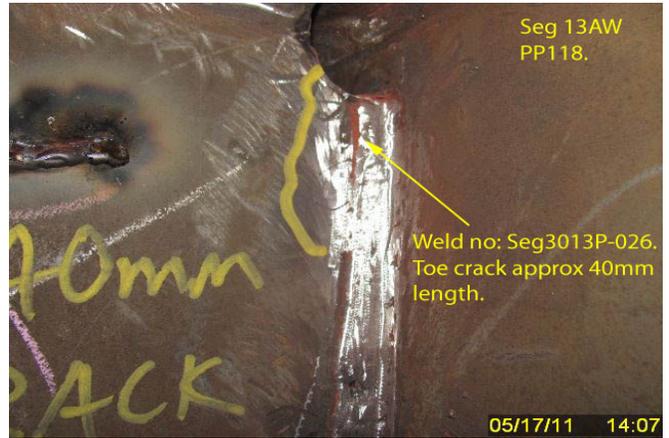
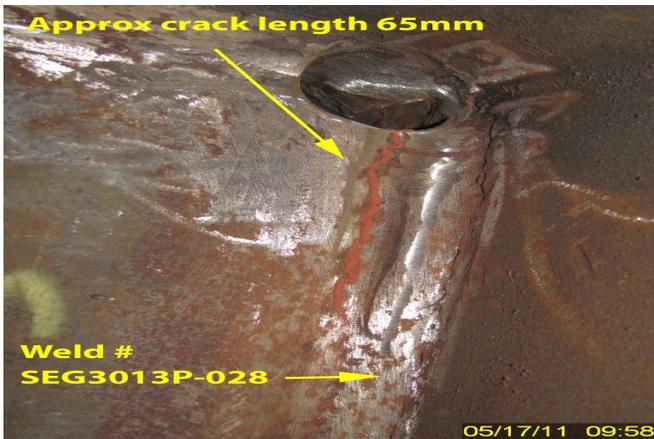
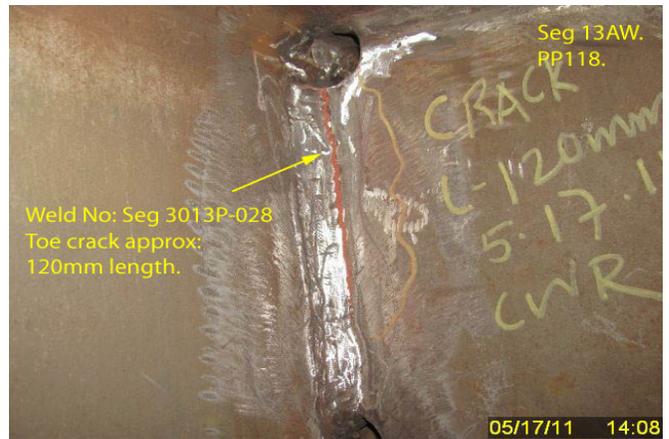
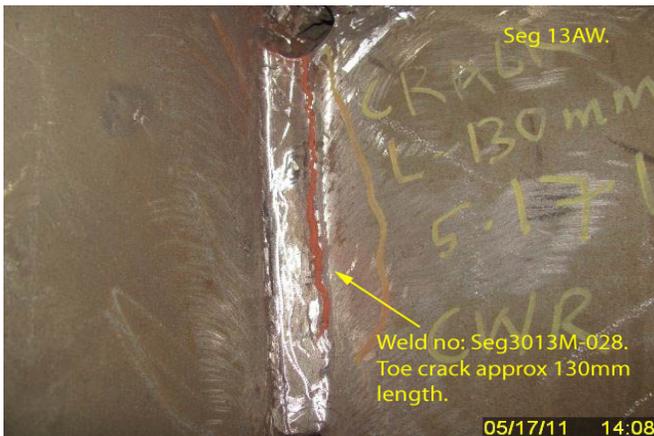
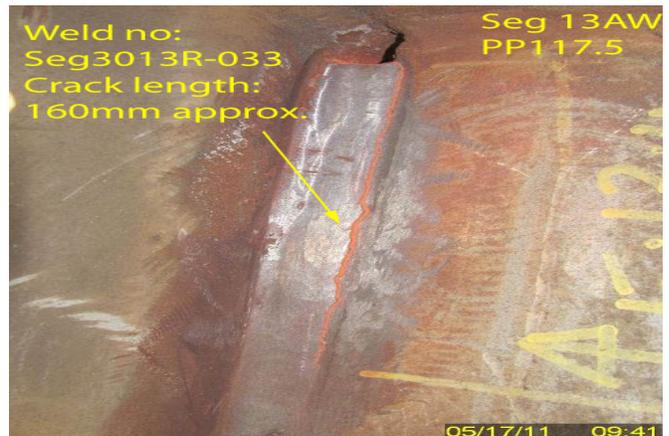
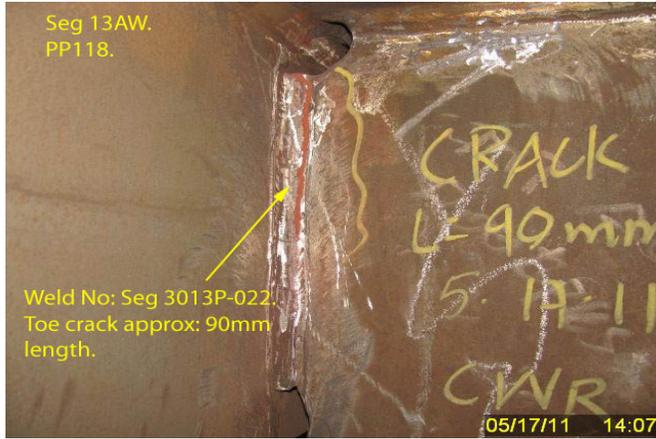
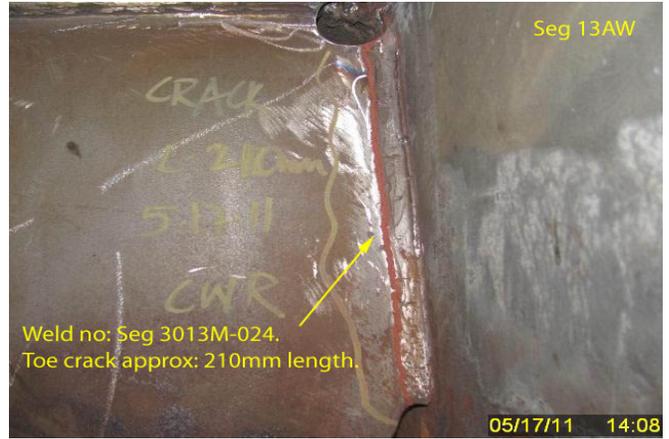
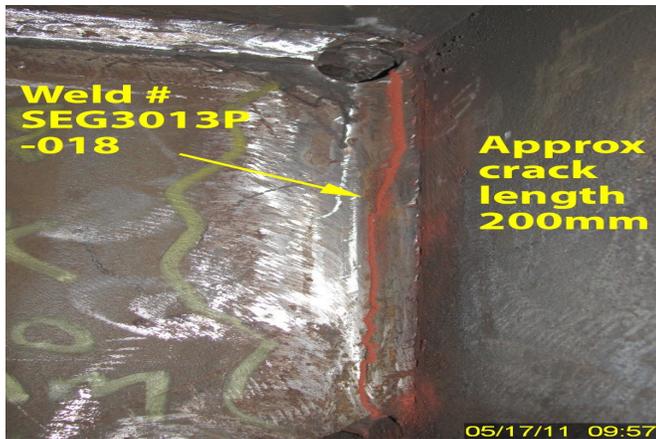
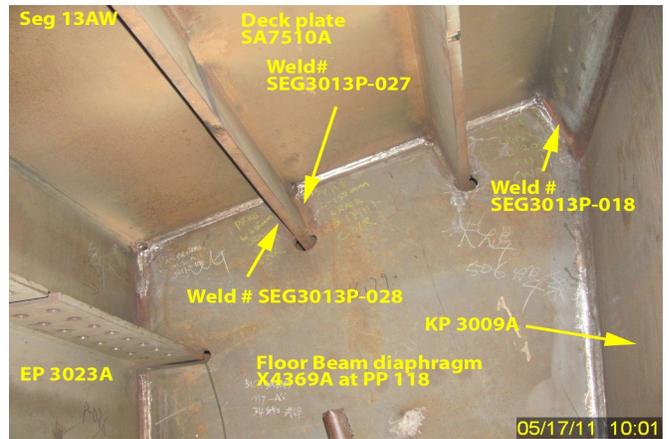
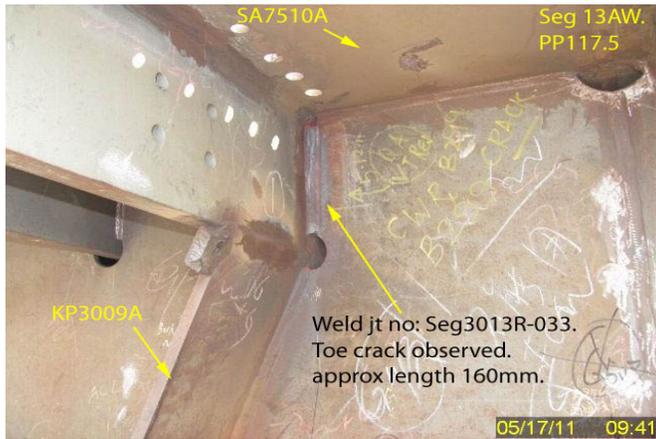
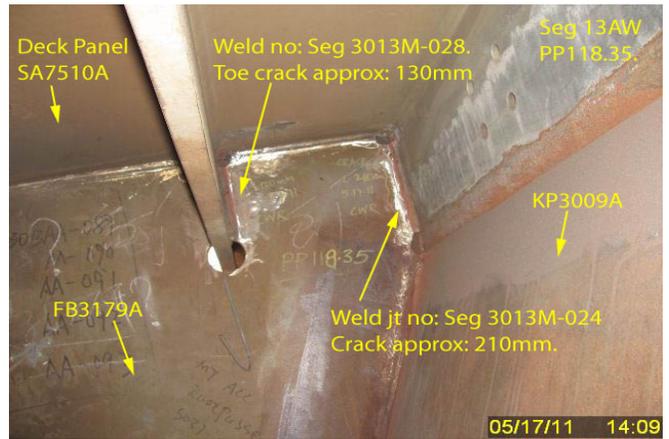
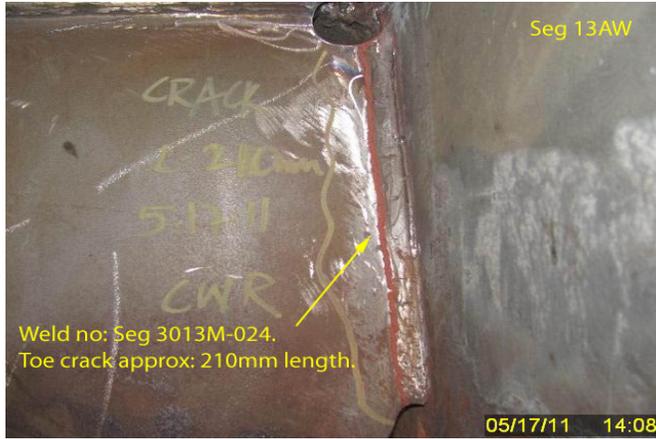
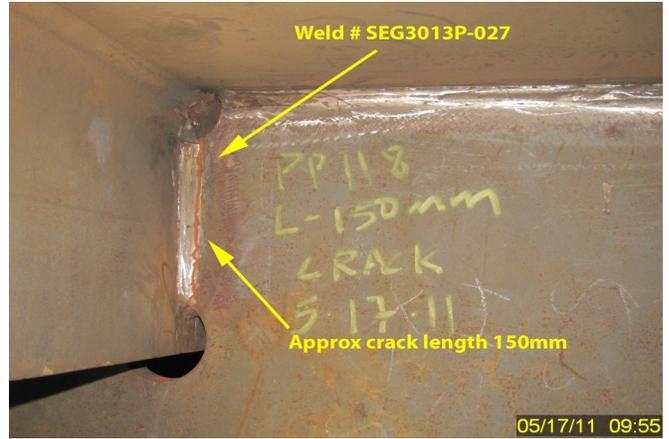
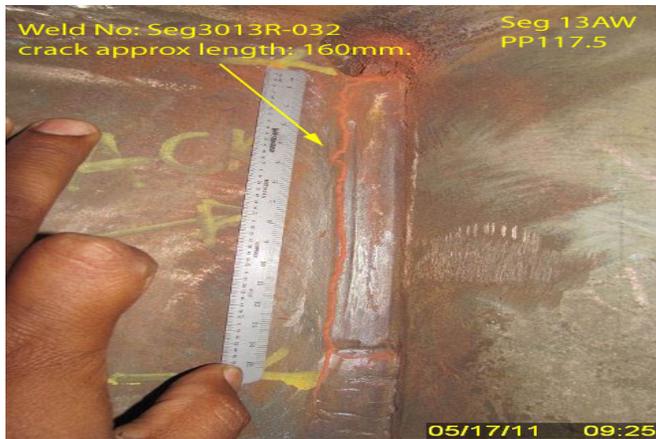
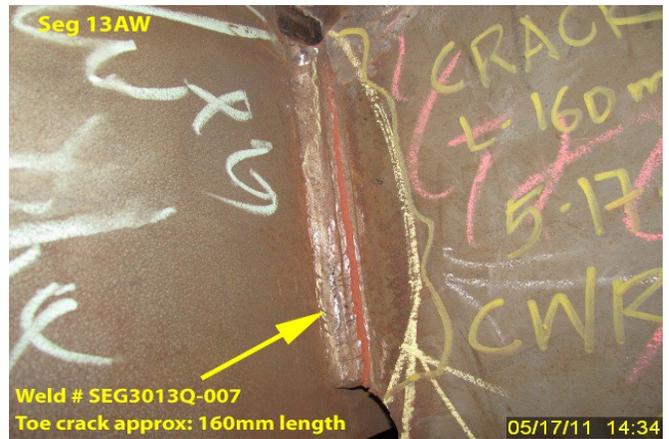
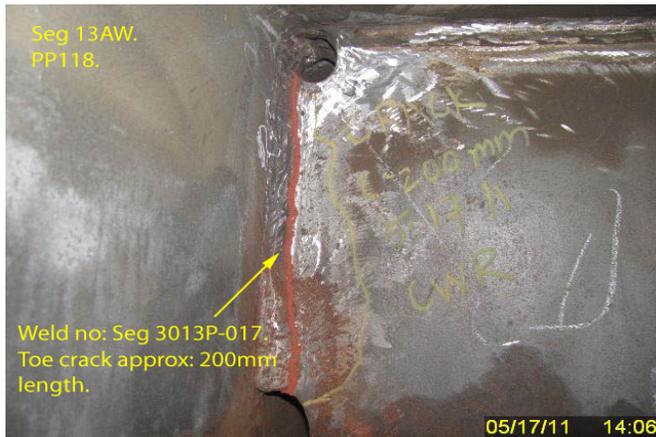
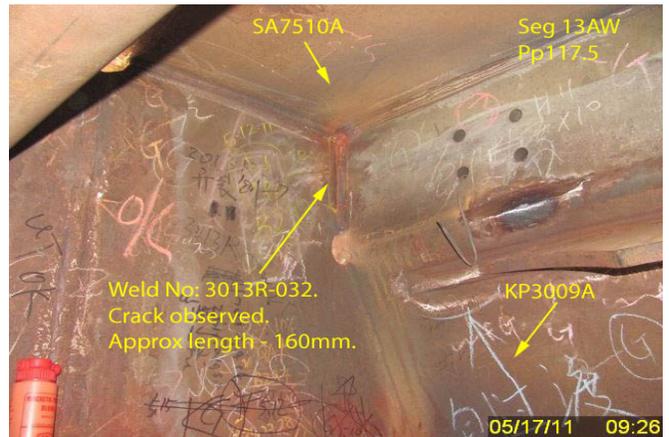
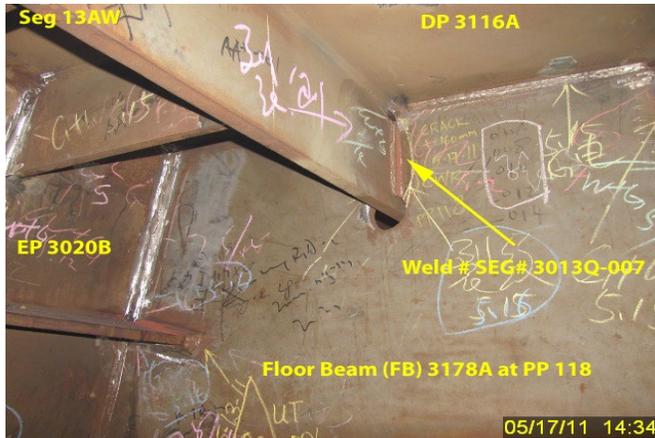
This QA Inspector, along with Mr. Shailesh Wadkar; performed in process Visual Inspection of welds (Seg 13AW) at Panel Points (PP) 117.5, PP118 and PP118.35. Visual Inspection was performed on the welds between Longitudinal Diaphragm (LD) 3034A to Edge Panel (EP) 3023A (on the welds inside of the Segment). At various locations on the EP to FB welds, this QA Inspector observed cope holes that require to be profiled correctly. In addition, the following welds were observed to have toe cracks. Details are as follows:

- 1) Seg3013R-032 and 033 (fillet welds at PP117.5 – identified earlier on Dt: 05/12/11).
- 2) Seg3013P-018 and 027 (fillet welds at PP118).
- 3) Seg3013P- 028, 017, 020, 022, 026, 028 (PP118).
- 4) Seg 3013M-024, 028 (PP118.35).

5) Seg 3013Q-007 (PP118).

This QA Inspector informed to ZPMC CWI, identified as Mr. An Qing Xiang. The weld locations were documented and forwarded to the CT Lead QA Inspector for further disposition.
