DEPARTMENT OF TRANSPORTATION

Quality Assurance and Source Inspection

Contract #: 04-0120F4Cty: SF/ALA Rte: 80 PM: 13.2/13.9File #: 69.28**WELDING INSPECTION REPORT****Resident Engineer:** Siegenthaler, Peter**Address:** 333 Burma Road**City:** Oakland, CA 94607**Report No:** WIR-023855**Date Inspected:** 16-May-2011**Project Name:** SAS Superstructure**OSM Arrival Time:** 700**Prime Contractor:** American Bridge/Fluor Enterprises, a JV**OSM Departure Time:** 1900**Contractor:** Zhenhua Port Machinery Company, Ltd (ZPMC), Changxing Island **Location:** Shanghai, China**CWI Name:** Mr. An Qing Xiang**CWI Present:** Yes No**Inspected CWI report:** Yes No N/A**Rod Oven in Use:** Yes No N/A**Electrode to specification:** Yes No N/A**Weld Procedures Followed:** Yes No N/A**Qualified Welders:** Yes No N/A**Verified Joint Fit-up:** Yes No N/A**Approved Drawings:** Yes No N/A**Approved WPS:** Yes No N/A**Delayed / Cancelled:** Yes No N/A**Bridge No:** 34-0006**Component:** Orthotropic Box Girder (OBG)**Summary of Items Observed:**

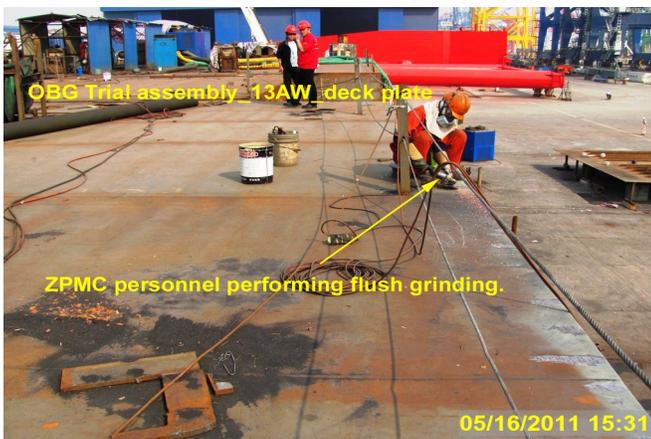
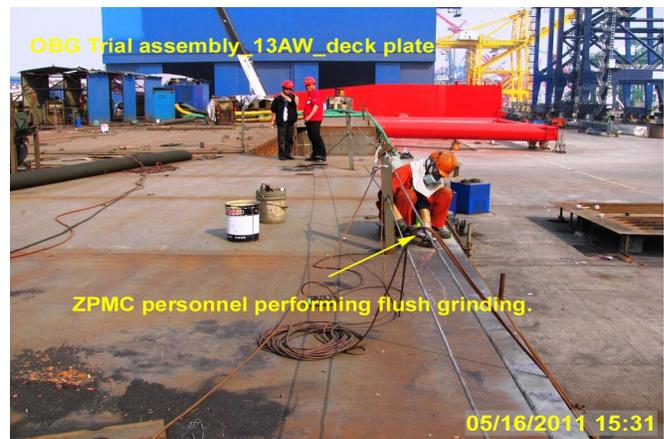
Segment:13AW

ZPMC personnel performing flush grinding for the base metal repaired areas on deck panel. See attached photos for further details.
